AAIB Bulletin

2/2022

Published 10 February 2022

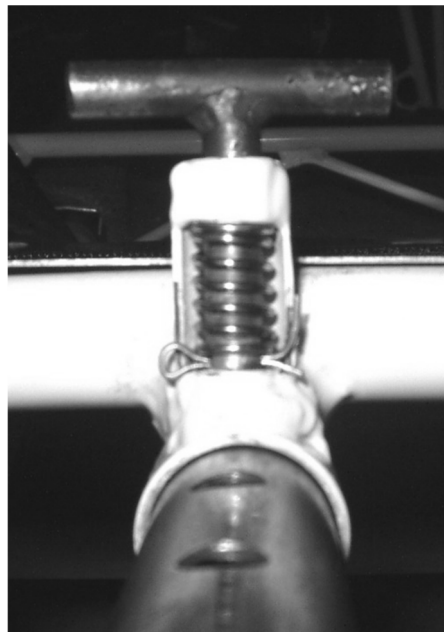
The seat is held in the selected position by a small spring-loaded pin centrally positioned at the front of the seat pan. The pin locates in equally spaced holes in a tube called an '*adjustment rail*' attached to the cockpit floor cross frame. Figure 3 shows the seat adjustment pin.

Image of seat pin from the aircraft assembly manual
(courtesy of the manufacturer)

Post-accident examination of the pilot's seat assembly showed that the seat pin was not correctly located in a hole in the adjustment rail. The damage and distortion to the adjustment rail was consistent with the seat being towards the rearmost extent of its travel when the aircraft struck the ground. Marks on the damaged adjustment rail showed that the seat adjustment pin and holes were slightly misaligned, with their centrelines offset (Figure 6), making it difficult for the pin to locate correctly.

The evidence indicates that the seat adjustment pin was not correctly located in one of the holes in the adjustment rail and therefore the seat was not locked in the fully forward position required by the pilot. Additionally, the seat adjuster backup strap, intended to prevent rearwards seat movement in case of pin failure, appears not to have been tightened.

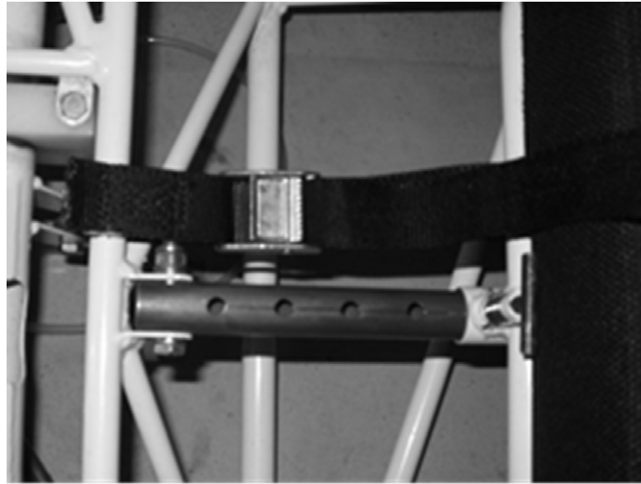
Figure 4

The seat has 150 mm of travel and is fitted with a 25 mm wide webbing loop and cam buckle which is designed to be tightened after seat adjustment. These are known as '*seat adjuster backup straps*' (Figure 4). The installation manual states that these are '*a safety backup in case of seat pin failure.*' The straps should be tightened before flight, after the seat position has been finally adjusted.

Image of the seat adjuster backup strap from the aircraft assembly manual (courtesy of the manufacturer)

Witness evidence also indicated that the pilot had found the seat adjuster backup straps “fiddly” to use. The pilot’s strap was found to be set at a length that would have allowed the seat to have travelled rearwards to around the full length of its travel, and therefore would not have secured the seat in the fully forward position as required by this pilot.

It is recommended that the Light Aircraft Association remind owners of this aircraft type of the necessity, after every seat position adjustment, to:

It is recommended that the British Microlight Aircraft Association remind owners of this aircraft type of the necessity, after every seat position adjustment, to:

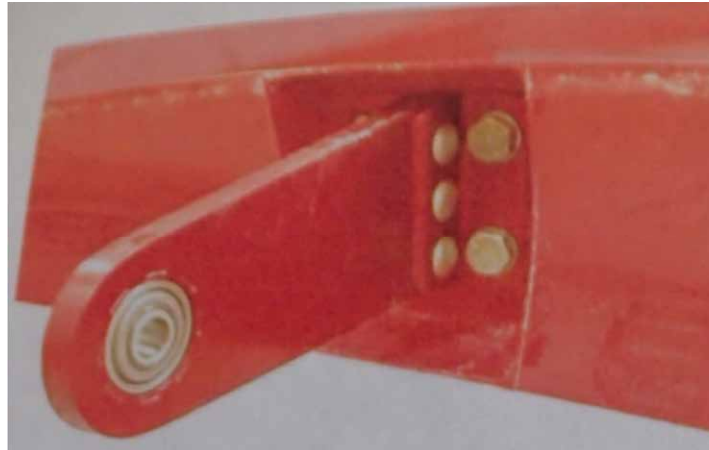
Figure 5

G-EDGY was fitted with aileron hinge attachment assemblies constructed from two aluminium, 2024-T3, 'L' shape brackets riveted to a flat distance piece containing a self-aligning bearing. These parts are anodised. The assembly is bolted to the rear spar of the wing and the aileron is attached by a bolt passing through the bearing (Figure 5). This standard of aileron hinge assembly has upgraded rivets compared to the original standard of aileron hinge assembly.

Image of centre hinge arrangement looking forward at wing rear spar

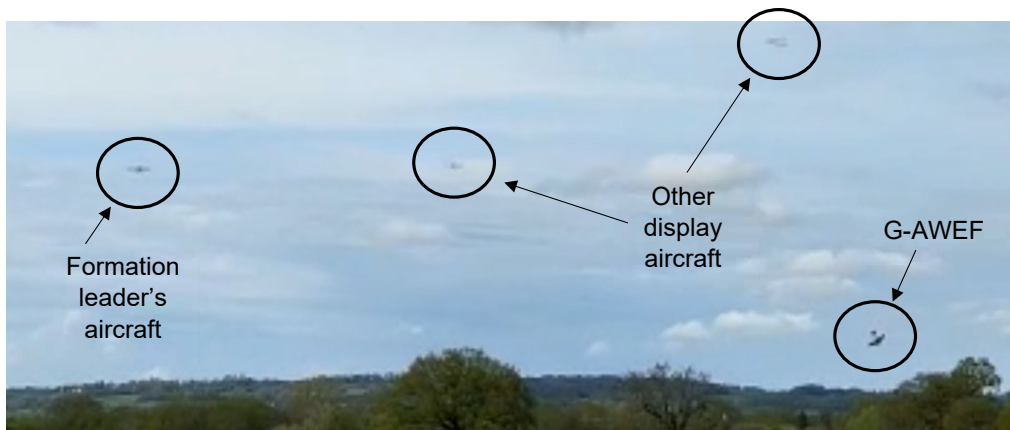
Figure 2

Mobile phone footage shot by a spectator at the airfield (used with permission)

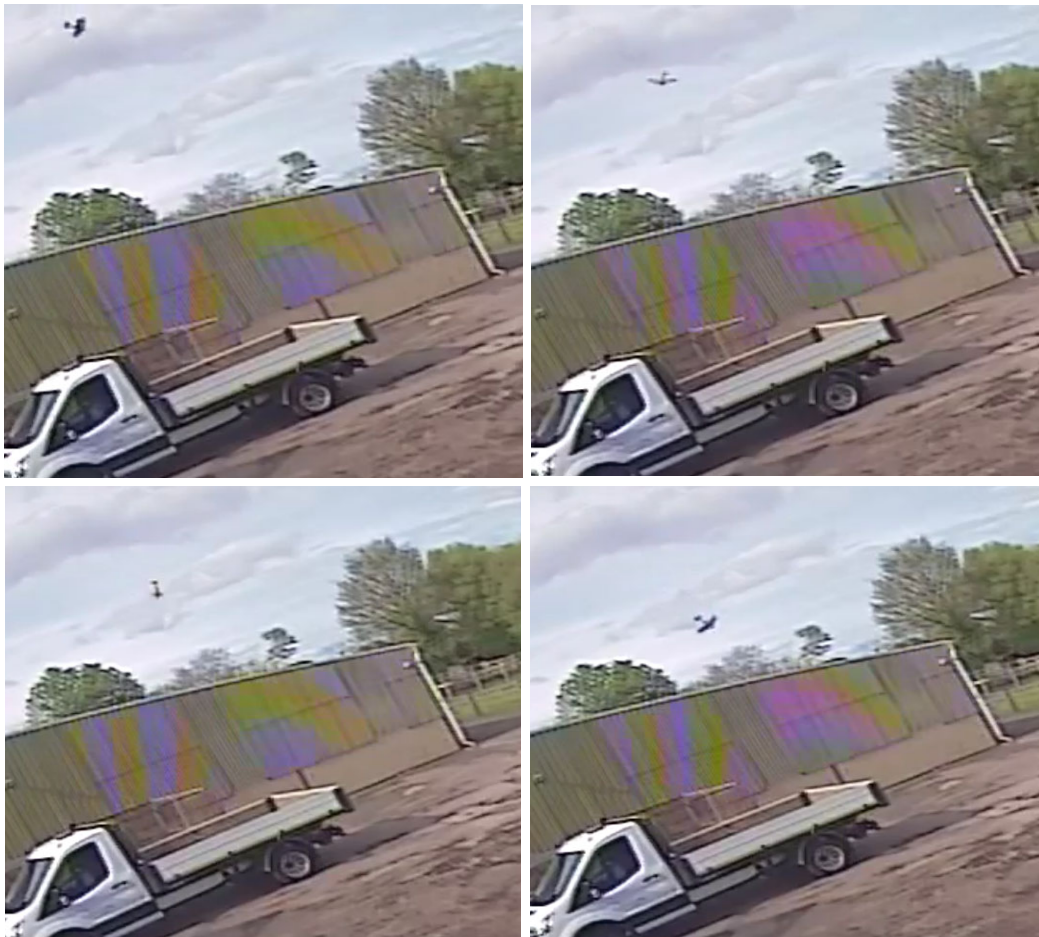
Figure 3

Montage from CCTV (used with permission)

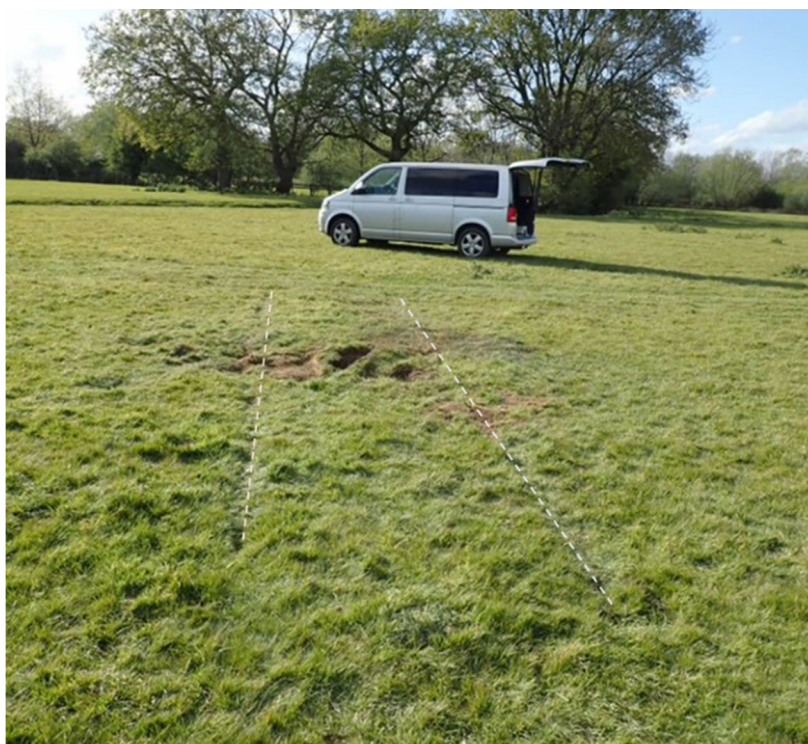
Figure 6

Marks left by the mainplane leading edges

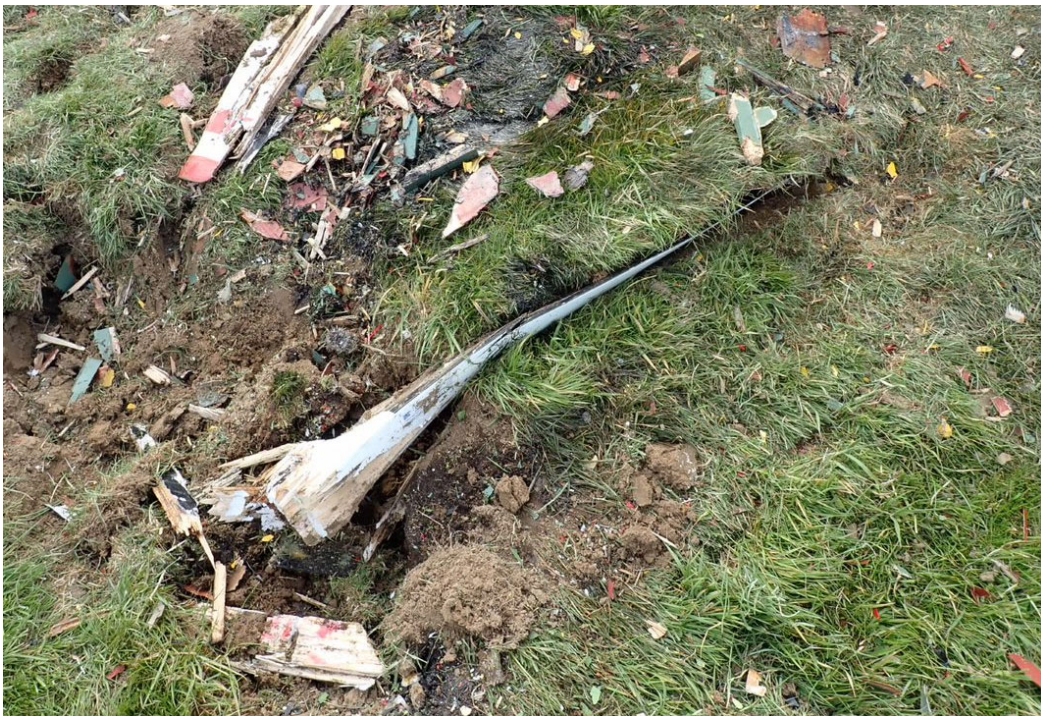
Figure 7

Propeller as found in the accident site (engine lifted clear)

One of the propeller blades had detached from its root, had fragmented, and was found lying beneath the aircraft. It was also split along its chord from tip to root on the largest fragment. The other blade was also detached at its root and had made a deep cut into the ground along its length. It had also bent forward and had started to break mid-way along its aerofoil section (Figure 7).

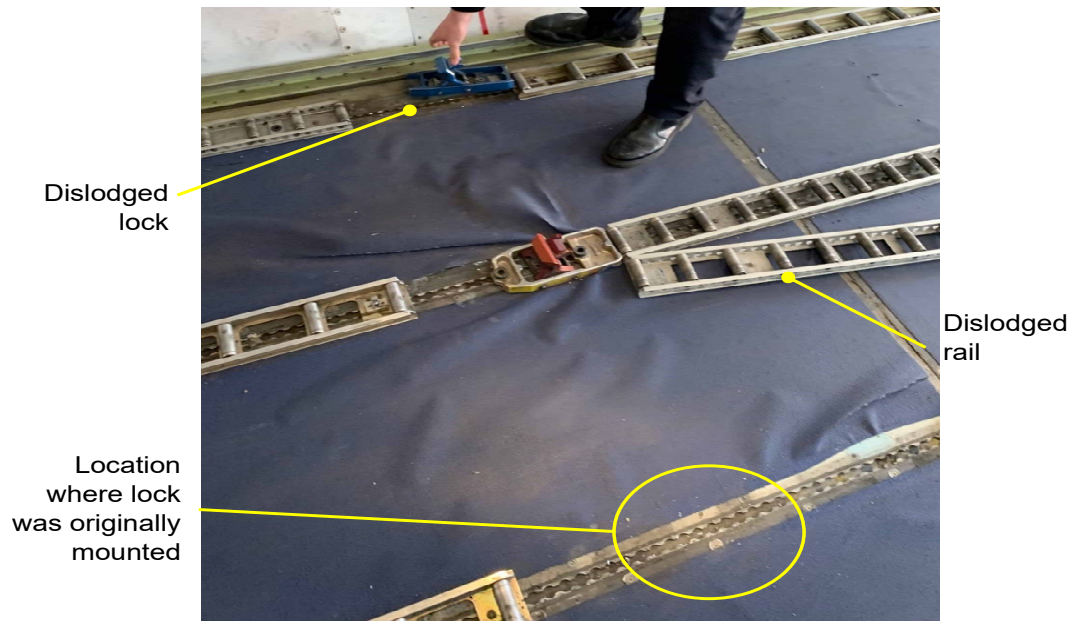
Figure 4

An investigation by the ground handling organisation identified that when the ULD in bay C3 was moved into location, the locks between bays C3 and C4 were not raised and remained in the DOWN position; however, the forward locks were raised. During the takeoff roll the slight thud heard by the crew was probably the ULD in bay C3 sliding rearwards to bay C4 and stopping against the forward locks which restrained the ULD in C5. During the landing the ULD would have slid forward as the aircraft decelerated, breaking the locks between bays C2 and C3 which were in the UP position. Its movement would then have been arrested when it hit the raised locks to the rear of the ULD in C1.

Damage to rails and locks between bays C2 and C3 (reproduced with permission)

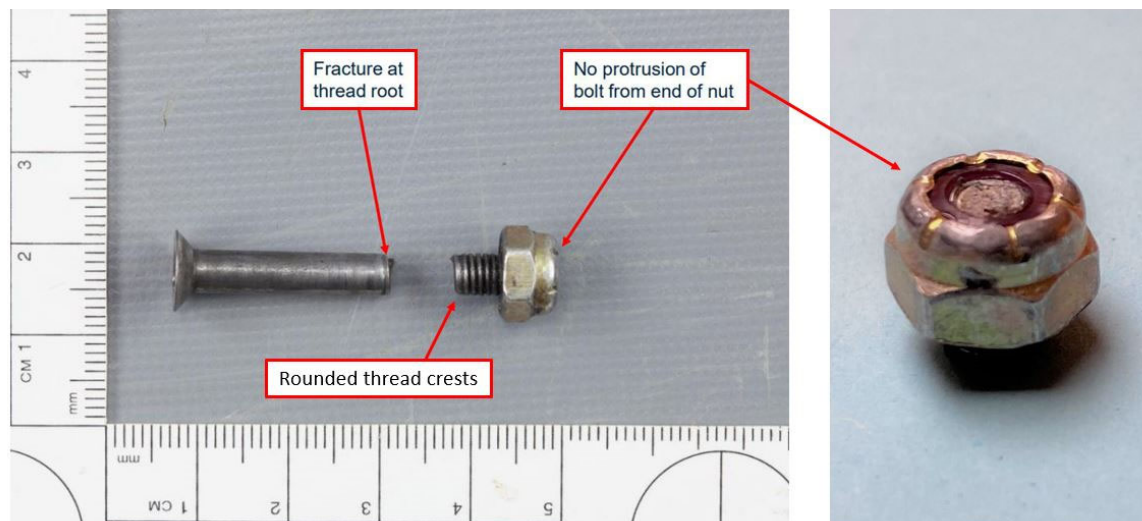
Figure 3

Fractured door latch pin screw (image courtesy of QinetiQ)

The forward latch pin screw was replaced and the testing was repeated. Whilst the repaired forward latch locked reliably, the unlocked condition of the rear latch could be reproduced. In this condition the door ajar cockpit indication extinguished and the lower door appeared to be flush but both the internal and external door handles were not in their fully closed positions, with the external handle protruding outwards (Figure 5).

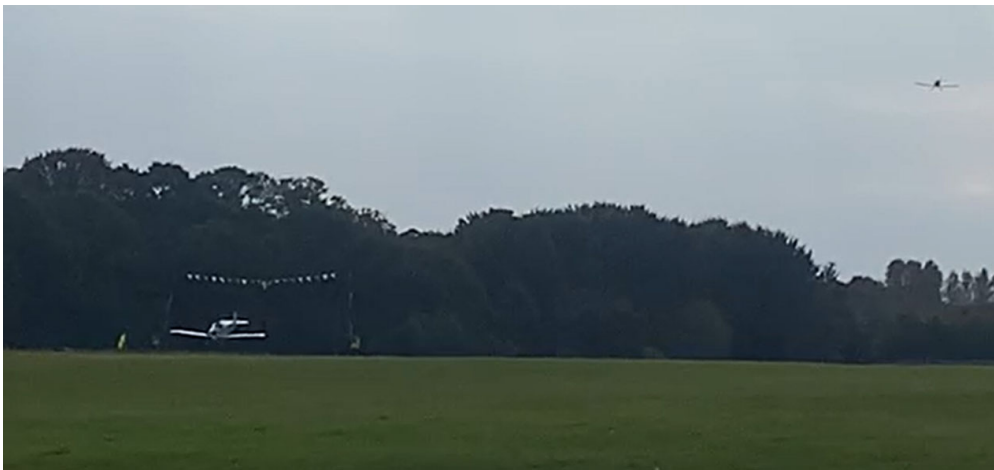
Figure 4
Accident aircraft pitched nose-down

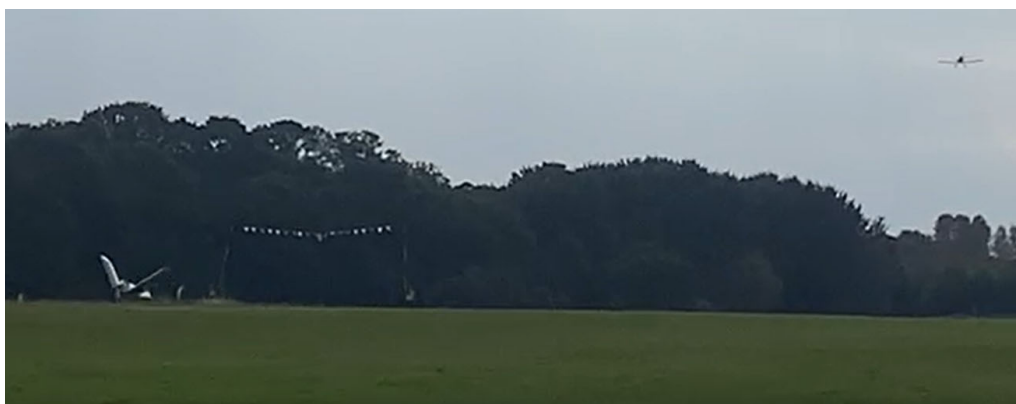
Figure 5
Accident aircraft as it struck the ground and the wings folded upwards

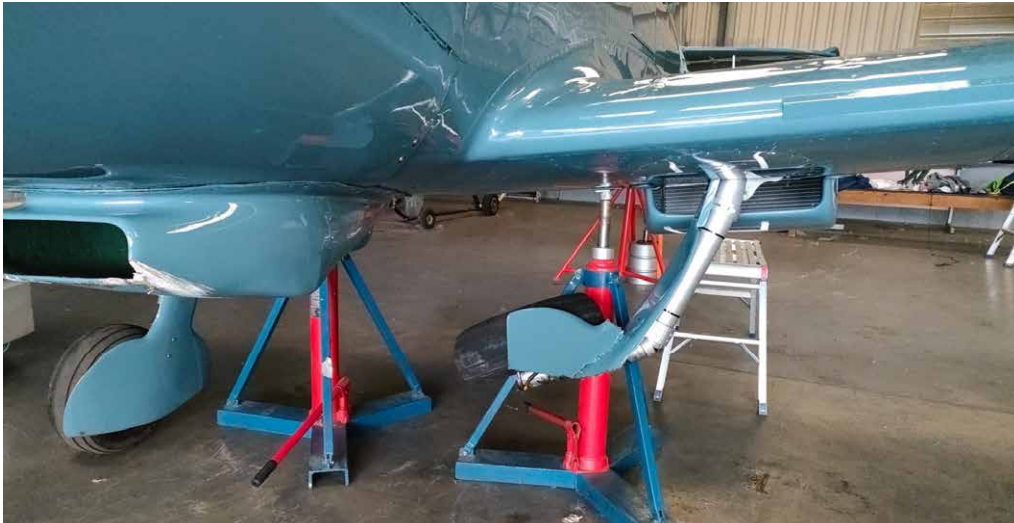
Figure 1

The pilot had recently purchased the aircraft and conducted a Permit to Fly revalidation check flight after various modifications had been embodied. The flight passed without incident and the pilot landed on Runway 21 at Newtownards Airport. The aircraft was slowing down on the runway centreline when it suddenly veered to the right. The pilot first applied left rudder and then full left brake but could not prevent the left wingtip, propeller and lower engine cowl scraping the runway. The aircraft came to rest off the runway with damage to both landing gear legs (Figure 1).

Landing gear damage
(Photograph used with permission)
