**ACCIDENT**

<b>Aircraft Type and Registration:</b>	Silent 2 Electro, G-CIRK	
<b>No &amp; Type of Engines:</b>	1 FES electric motor	
<b>Year of Manufacture:</b>	2013 (Serial no: 2054)	
<b>Date &amp; Time (UTC):</b>	23 April 2021 at 1305 hrs	
<b>Location:</b>	Wormingford Airfield, Colchester, Essex	
<b>Type of Flight:</b>	Private	
<b>Persons on Board:</b>	Crew - 1	Passengers - None
<b>Injuries:</b>	Crew - 1 (Serious)	Passengers - N/A
<b>Nature of Damage:</b>	Aircraft destroyed	
<b>Commander's Licence:</b>	Light Aircraft Pilot's Licence (Sailplanes)	
<b>Commander's Age:</b>	71 years	
<b>Commander's Flying Experience:</b>	295 hours (of which 55 were on type) Last 90 days - 13 hours Last 28 days - 13 hours	
<b>Information Source:</b>	AAIB Field Investigation

**Synopsis**

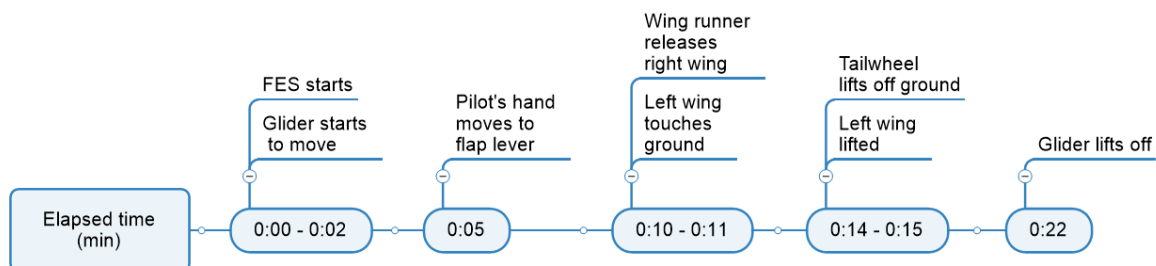
**Figure 5**  
Timeline of the pilot’s previous self-launch takeoff

The video of the pilot’s previous takeoff showed that approximately three seconds after the glider started to move, the pilot transferred his left hand from the instrument panel mounted FES control unit onto the flap lever (Figure 5). The flap lever appeared to be in the flap +1 position but the angle from which the footage was taken meant that this could not be positively confirmed. After a further five seconds, the wing tip runner released the right wing and the glider immediately started rolling left over a period of one second, until the left wing touched the ground. G-CIRK’s tail wheel lifted off the ground three seconds later, just before the glider rolled right into a wings level attitude. During the following six seconds, some minor oscillations were noted in all axes but the pilot appeared to correct these. The glider then lifted off and climbed in a nose up attitude to a height of about 30 ft agl, before the nose was lowered slightly, to what appeared to be an almost level pitch attitude, and a shallower climb was established. The video ended when the glider was at a height of about 45 ft agl.

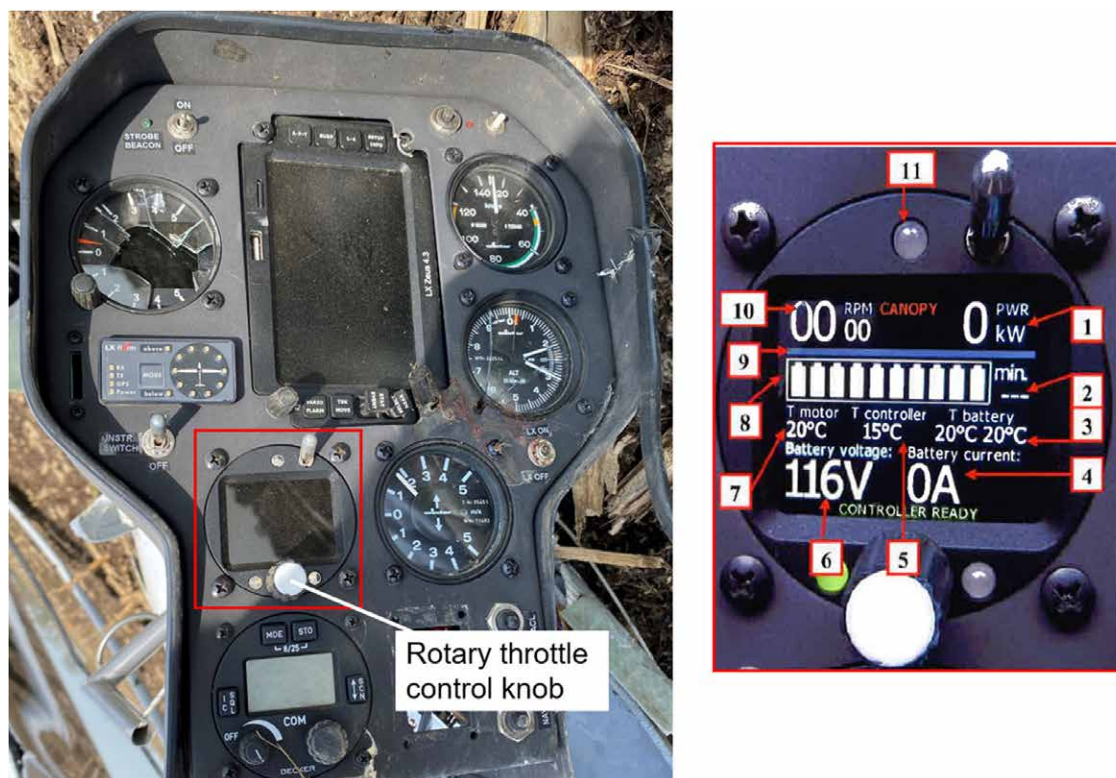
**Figure 7**

polymer batteries connected in series, providing a total voltage of 116 V. Power to the motor is controlled by a FES Control Unit (FCU) instrument mounted on the instrument panel (Figure 7). The FCU instrument displays propeller speed and battery charge levels, and it has a rotary throttle knob for controlling the motor speed. The knob does not have any stops and can be rotated continuously in either direction. Clockwise rotation increases rpm and anti-clockwise rotation decreases rpm. The motor is stopped by rotating the knob anti-clockwise with a few twists.

FCU instrument in the cockpit instrument panel (left) and enlarged detail (right)

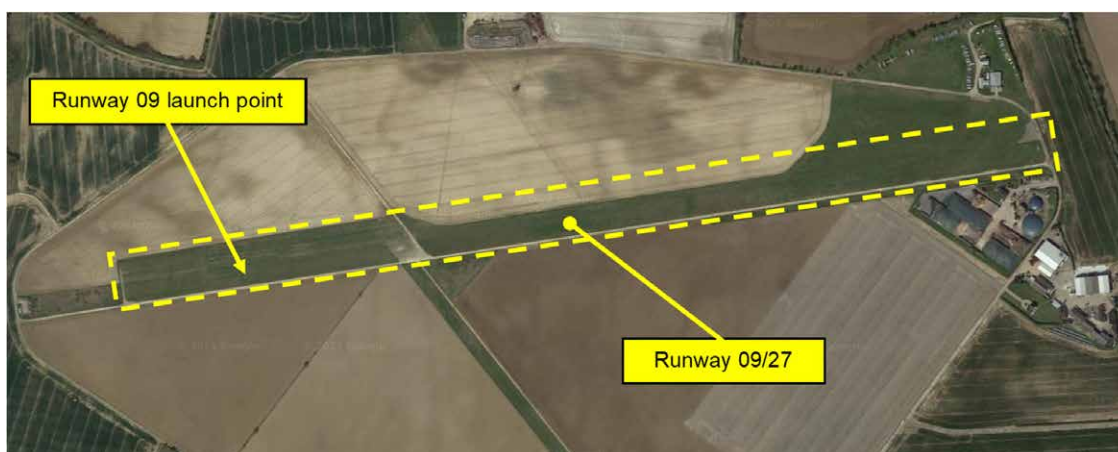
**Figure 10**

Wormingford is a grass airfield with a single runway designated RW09/27, approximately 1,600 m long and orientated 080°/260° M (Figure 10). The runway is bounded by a track to the south and arable land to the north.

The gliding club stated that the runway was proactively maintained, with any ruts being filled by hand and the surface routinely rolled to ensure it stayed “relatively flat and smooth.” The accident pilot described RW09 as being in “good condition.”

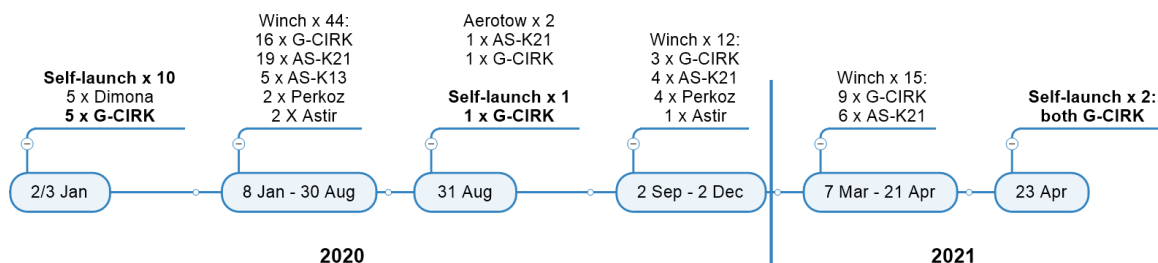
**Figure 12**

While the glider was self-launch capable, the pilot generally preferred to winch launch to conserve battery power in case he ran out of natural lift while cross-country flying. Prior to 23 April 2021 (the day of the accident), the pilot's previous self-launch was 8 months earlier, and that had been his first self-launch since completing his initial training in January 2020 (Figure 12).

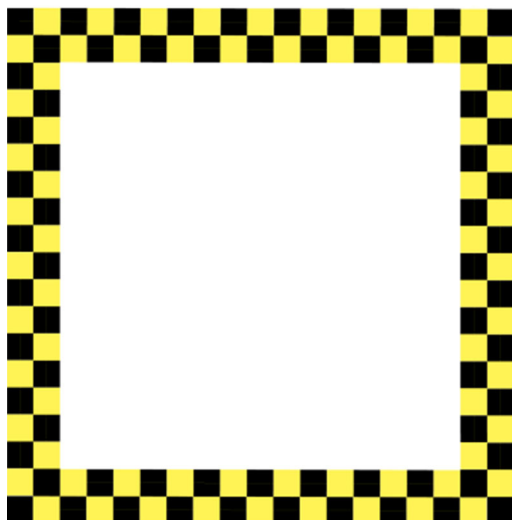
**Figure 15**

Two placards were affixed to the fuselage aft of the cockpit to warn people about the hazards from the rocket and parachute (Figure 14). These placards conformed to the requirements in ASTM F2316-12<sup>28</sup>. They did not conform to the placard requirements in BCAR Section S<sup>29</sup>, sub-section K on 'Microlight Parachute Recovery Systems', which require the 'DANGER' placard to be larger than that specified in ASTM F2316-12<sup>30</sup>, and which also require a double offset black and yellow chequered line to surround the parachute and rocket exit area (Figure 15). As an SSDR the Silent 2 Electro is not required to meet BCAR Section S; however, the CAA published Skywise article SW2021/91<sup>31</sup> on 29 April 2021 which stated that: 'The CAA strongly recommends that owners of SSDRs fitted with a BPRS comply with the requirements of BCAR Section S, Sub-Section K, to clearly identify the presence of the BPRS to emergency services and first responders in the event of an accident.'

From BCAR Section S, sub-section K, sample of double offset black and yellow chequered line which should surround the parachute and rocket exit area
