MCP-01

DECOMISSIONING, DISMANTLING and DISPOSAL of the MCP-01 INSTALLATION MCP-A-RP-00009

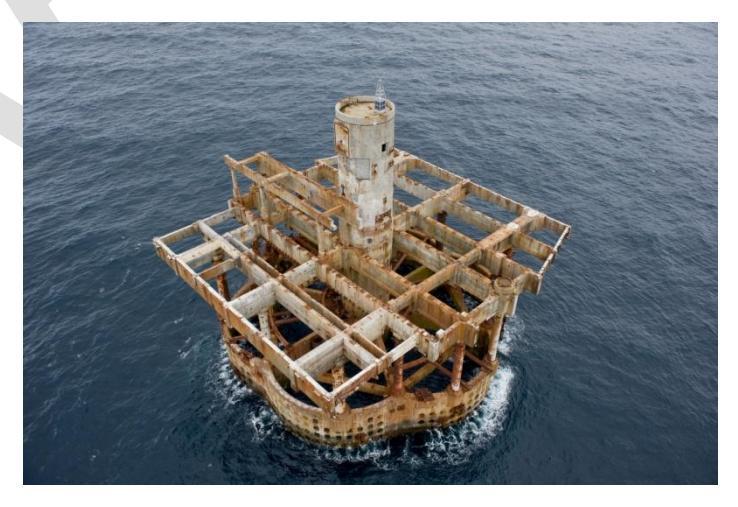
MCP01 - on completion of topside removal - 2009

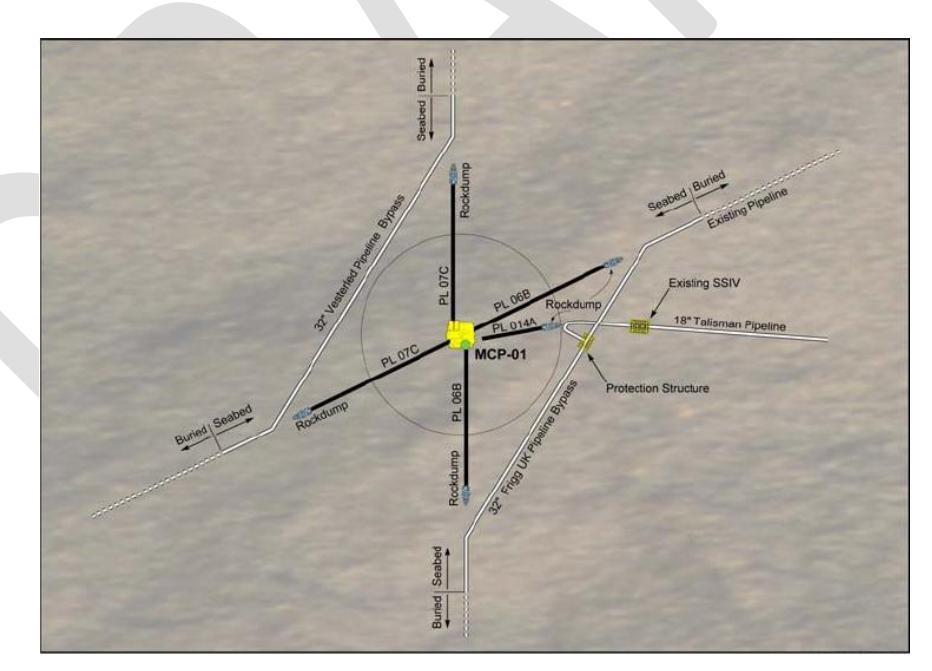
The pipeline bypass activity was conducted by TEPUK as a specific project during 2004 and 2005. This resulted in the 32" diameter pipelines that transport gases from the Frigg area to St. Fergus Gas terminal, being disconnected from MCP-01 and by-pass spools installed on seabed routing the pipes outside the 500m safety zone of MCP-01. A specific connection was made to allow the continued interface for the third party gases into the system. An independent report was issued in respect of this work.

Bypass routes for the Frigg UK pipeline, Talisman pipeline and the Vesterled pipeline at MCP-01

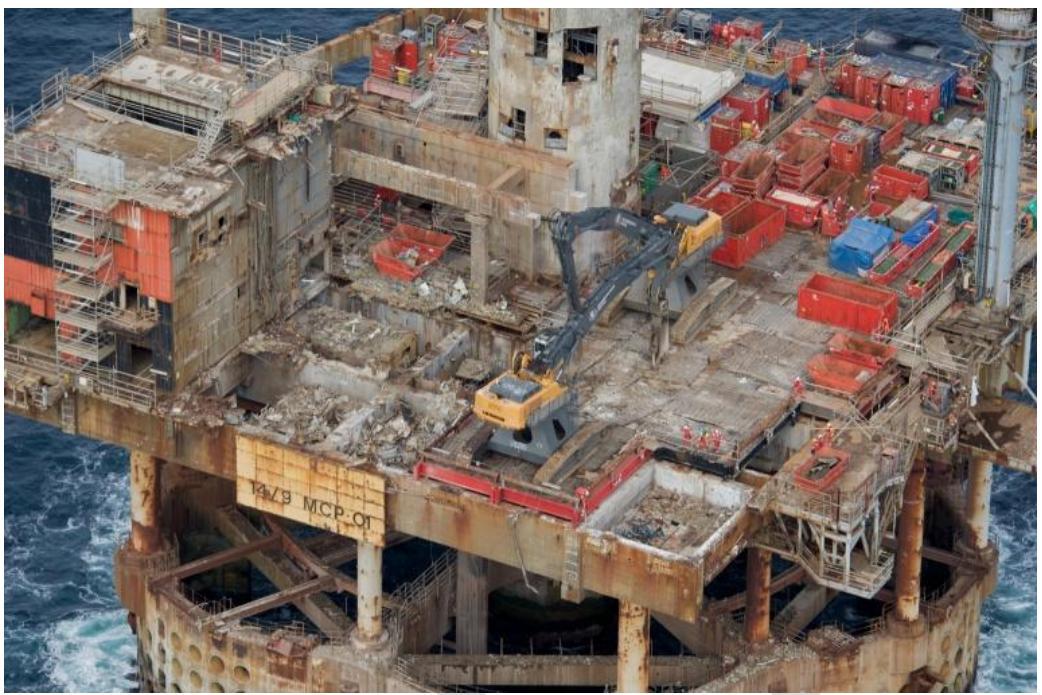
In the original FEED it was promoted that the use of large demolition excavators could improve efficiency and very significantly reduce risk by eliminating the need for personnel working in the hazard areas. In reality, when the machines were able to work they were indeed very efficient – processing up to 80 tonnes of materials per day. However the effort to be able to have them working required an inappropriate level of labour. The specific support decks that they required involved complex engineering and a lot of fabrication work. To meet the revised time schedule the quantity of decommissioning removal achieved using traditional manual work grew by around 300%.

MCP-01 - Piece Small Demolition in progress with excavators

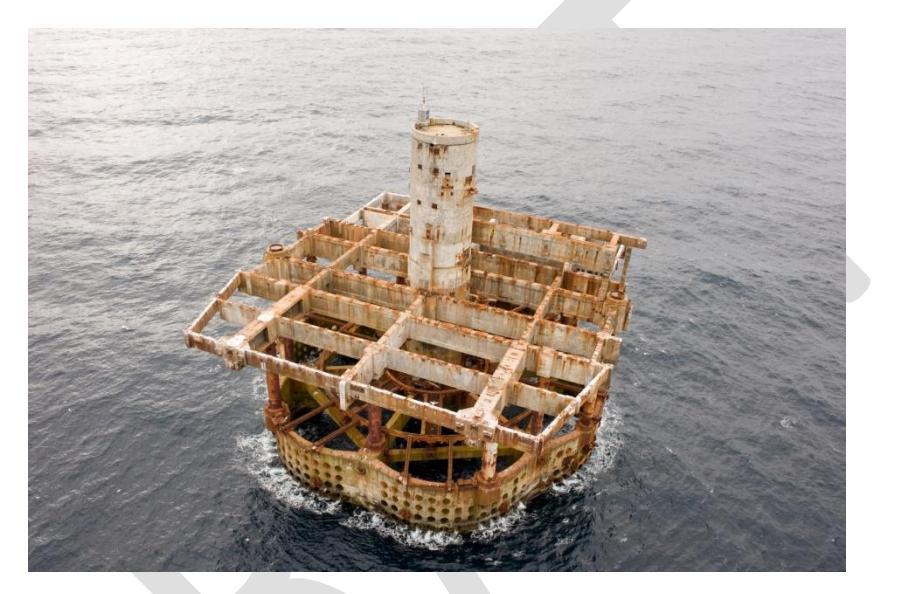
- The topside steel structure has been removed
- · A concrete core cap with a Nav-Aid has been installed
- · Agreed steel on the breakwater has been left in place

• All stairs and ladders from sea up to break water have been removed, as have staircases and ladders from break-water and further up to main deck.

MCP-01 - All topsides removed

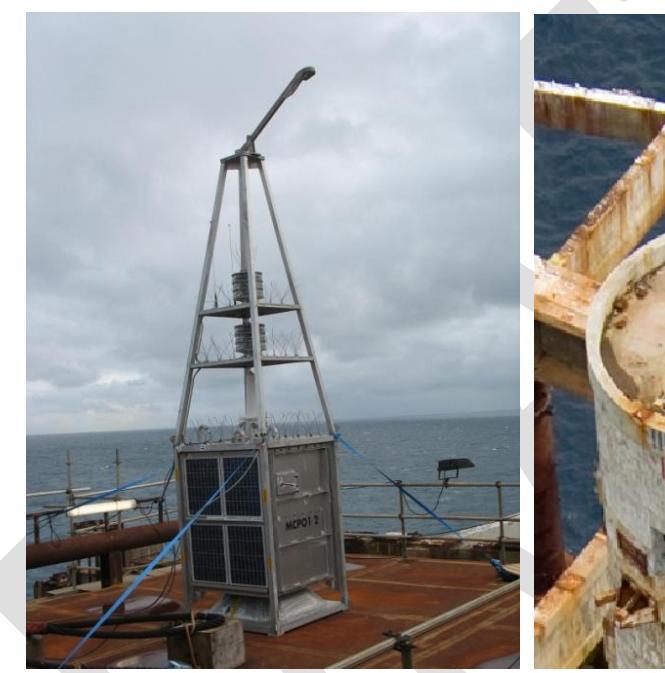
AtoN awaiting installation

MCP-01 with AtoN on Centre Core Cap

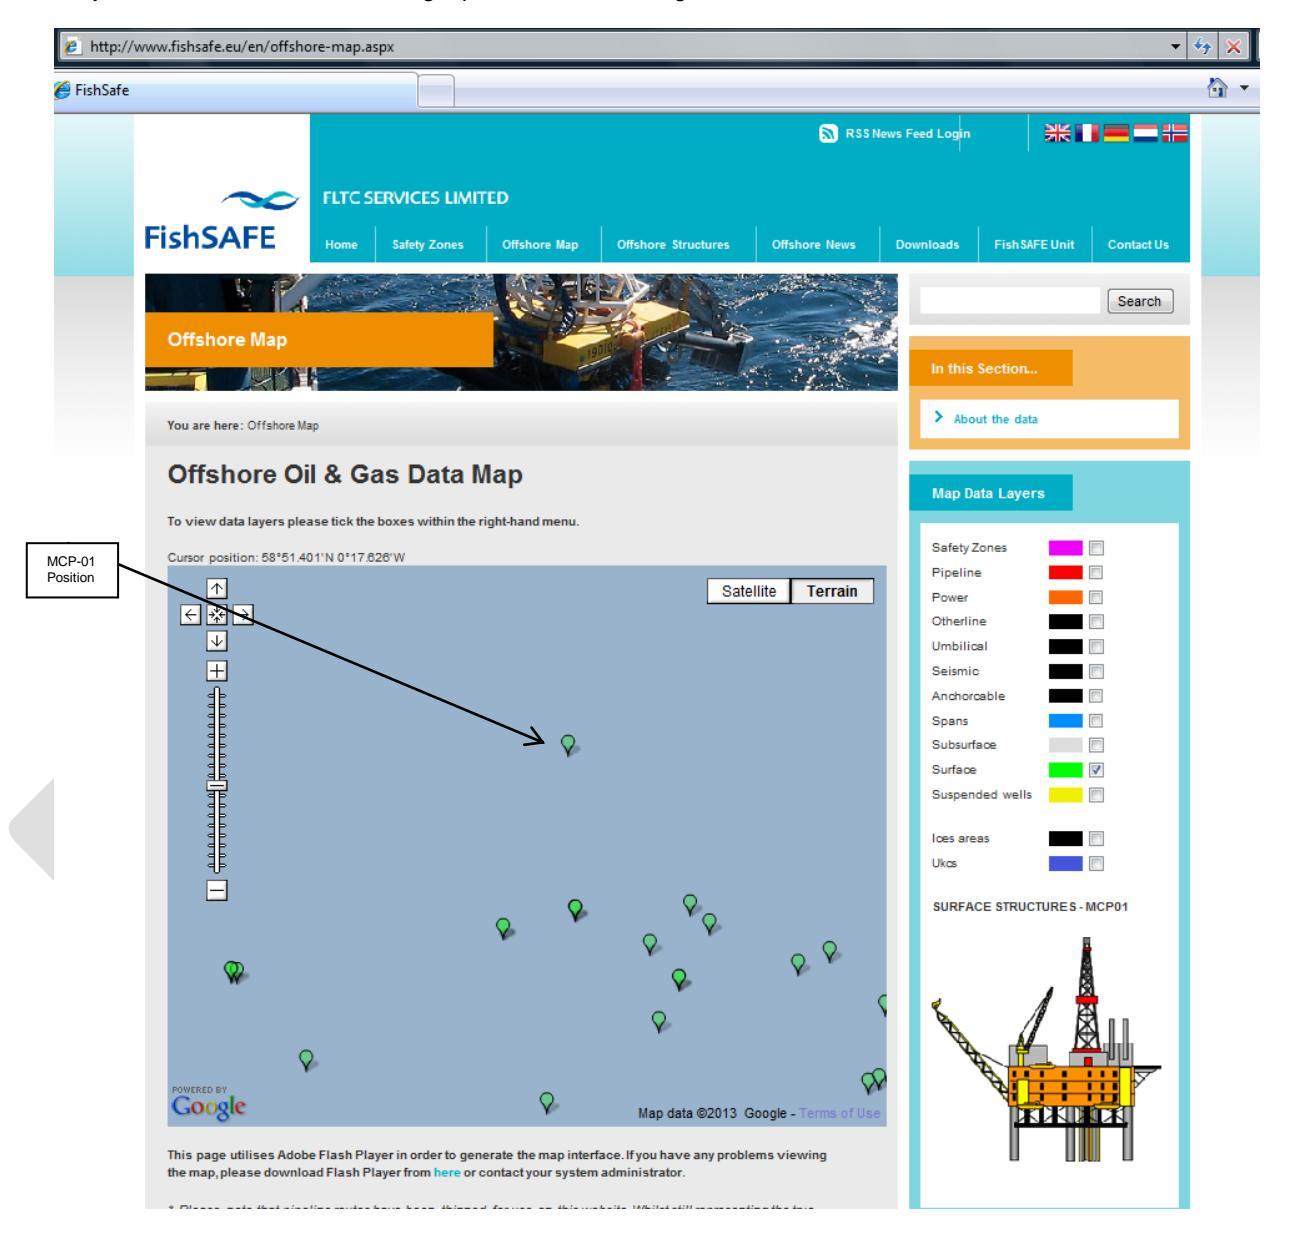
At present they are unable to reflect the precise status of the structure i.e. topsides removed and AtoN installed on the remaining sub-structure and the site continues to show the position and exclusion zone. They are also unable to show the light pattern and racon signal associated with the MCP01 site.

Screen dump from FishSAFE
