Frigg Field Cessation Plan

Close Out Report

Stavanger 12 May 2011

TOTAL E&P NORGE AS

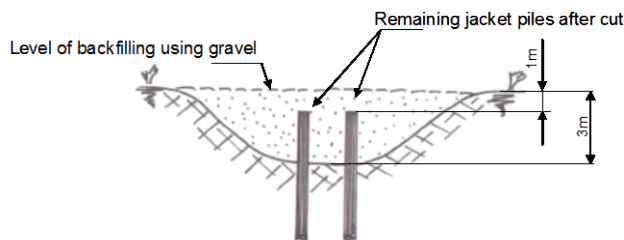
Figure 13. Seabed profile after piles were cut

A dredged excavation three metres deep was required around each pile cluster to allow a ROV to cut the steel jacket piles a minimum of one metre below the seabed, as illustrated in Figure 13. On Figure 14 the foot print after the jacket has been removed is shown in a multi beam echo sounder picture.

The Environmental Impact Assessment in the Frigg Field Cessation Plan [1] defined the need to cover the remaining jacket piles in the dredged areas and as they could represent a potential obstruction to future bottom trawl fishing. Consequently, gravel has been placed where the seabed have been dredged to facilitate the cutting of the jacket piles, see illustration on Figure 13. The seabed profiles after the removal of the two 26" pipelines from DP2 to TCP2 are also clearly visible on the lower part on Figure 14.

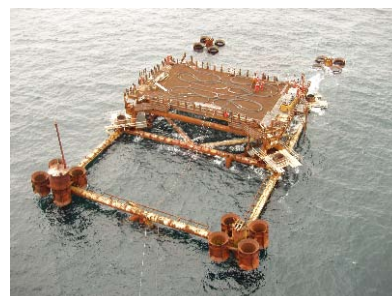
Figure 15. Work platform on DP1 jacket

DP1 was the first installation to arrive on the Frigg Field in 1974. During the launch operation, however, the ballast tanks providing buoyancy to the steel jacket collapsed, resulting in loss of control and the structure hit the seabed. The structural damage was so severe that repair or reuse was not possible. During the Cessation Project lifting the damaged steel jacket in one piece was therefore not an option owing to the uncertainties about its structural integrity. Instead, the jacket was cut into stable and liftable sections.

To overcome the challenge of working in the splash zone for the preparation of the lifting of the top section of the damaged jacket, a work platform and spreader frame was installed as shown in Figure 15. The system functioned very efficiently and contributed to a safe operation within the set weather criteria. Personnel could access the tops of the jacket legs to remove the cap plates and install the internal lift tools. The top section, representing about one-third of the jacket, was removed in one lift by S7000, see Figure 16.

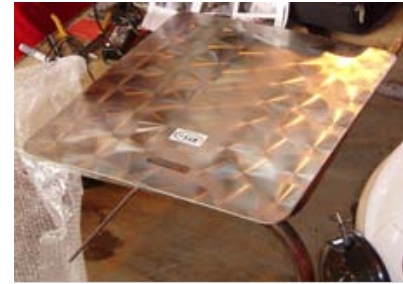
Figure 21. The Flat Jack Weighing system

The weight of the TCP2 MSF was originally estimated to be at the very limit of the lifting capacity of S7000 given for the lifting radius required. Hence, it became mandatory to check the exact weight and the centre of gravity of the MSF to determine whether it would be necessary to reduce the weight by piece small removal of sections.

Conventional weighing system could not be used due to the very limited space between the MSF and the three concrete columns after being cut free with diamond wire. A weighing system using flat jacks was therefore developed (Patented by IWS AS), see Figure 21, and certified by the DNV. It required simple preparations but delivered the weighing accuracy needed.

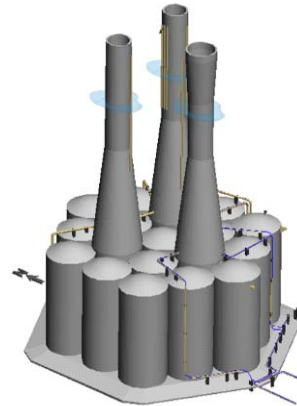
Figure 24. External steelwork on TCP2 Concrete Substructure

All the identified steelwork above and below water has been removed except for three items. The 5.8 tonne pull-in sheave located on concrete base slab next to the seabed turned out to be impossible to remove despite applying a force of 50 tonnes after all the bolts were cut. As this item would not represent any obstructions to fishing, MPE has agreed to TOTAL Norge's recommendation to leave it in place.

Abseilers were used extensively to remove the items above water. Below water, the steelwork was cut using various underwater cutting tools attached to a ROV operated from the platform deck. All the steel was brought to the deck and placed in containers and transported to the onshore disposal facility where all was recycled.

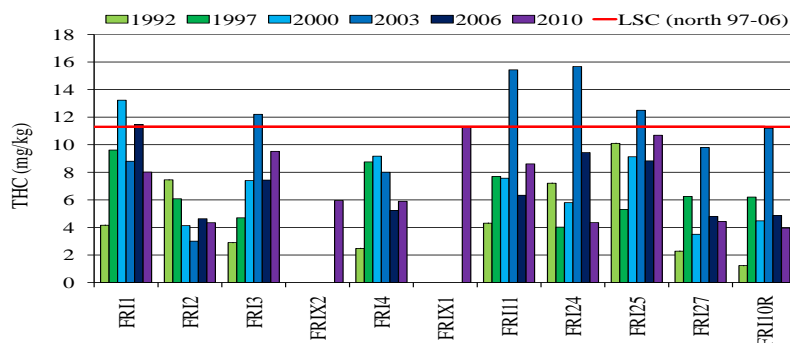
Figure 62. Total Hydrocarbon Content (TCH) measured on the Frigg Field since 1992 compared to LSC₉₇₋₀₆ (red line).

The conclusion from the 2010 survey is that all stations within the Frigg Field consist mainly of sand (94-99 %) where the content of the total organic matter is low (0.45-0.76 %). The concentrations of the Total Hydrocarbon Content (THC) are low (4-11 mg/kg), and none of the measured THC-concentrations are above the Level of Significant Contamination² (LSC), as shown on Figure 62

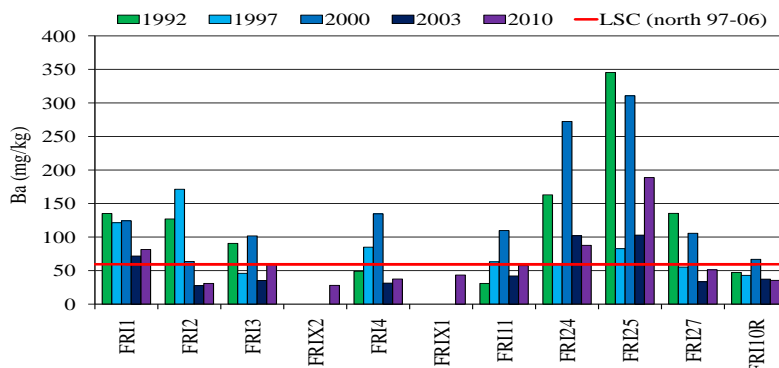
Figure 63. Barium (Ba) concentration measured on Frigg Field since 1992 compared to LSC₉₇₋₀₆ (red line).

The concentrations of barium (Ba) are in the range from 28 to 189 mg/kg. Three stations have Ba-concentrations above LSC-level. A number of the stations have metal concentration larger than the LSC (north97-06) as shown on Figure 63 and these elevated levels are most pronounced where the fauna is slightly different from the other field stations.

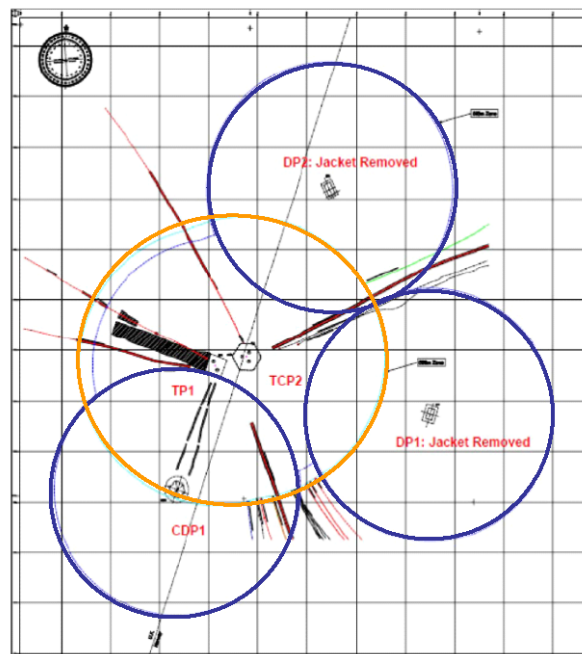
Figure 65. Area covered in the trawl tests in 2008 (within brown circle) and in 2010 (within brown and blue circles)

Both the “chain net” and the bottom trawl passed the area successfully. Consequently the SFF issued a “Clear Seabed Certificate” which is attached to Appendix 1, Table 25, documenting that the seabed covered was free from any obstructions which could prevent any future bottom trawl fishing.

Three locations prevented the “chain net” to pass. On one location the “chain net” got stuck and was lost and the trawler had to go to Shetland for a replacement before continuing. However, the bottom trawl sweep using a normal trawl net was performed successfully.

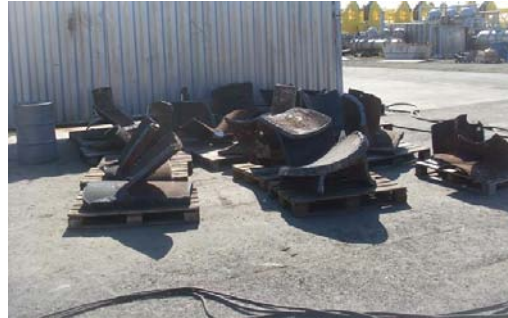
Figure 70. Part of nodes cut out from the DP1, DP1 and QP jackets ready to be sent to the laboratory

A number of representative nodes have therefore been cut from the DP2, QP and DP1 steel jackets at different locations and sent to a laboratory for detailed inspection to check their structural response, see Figure 70.
