Report on the investigation of two catastrophic engine failures, one resulting in a fire, on board the ro-ro passenger ferry

***Wight Sky***

at the entrance to Lymington River and before berthing at Lymington Pier on 26 August and 14 December 2018

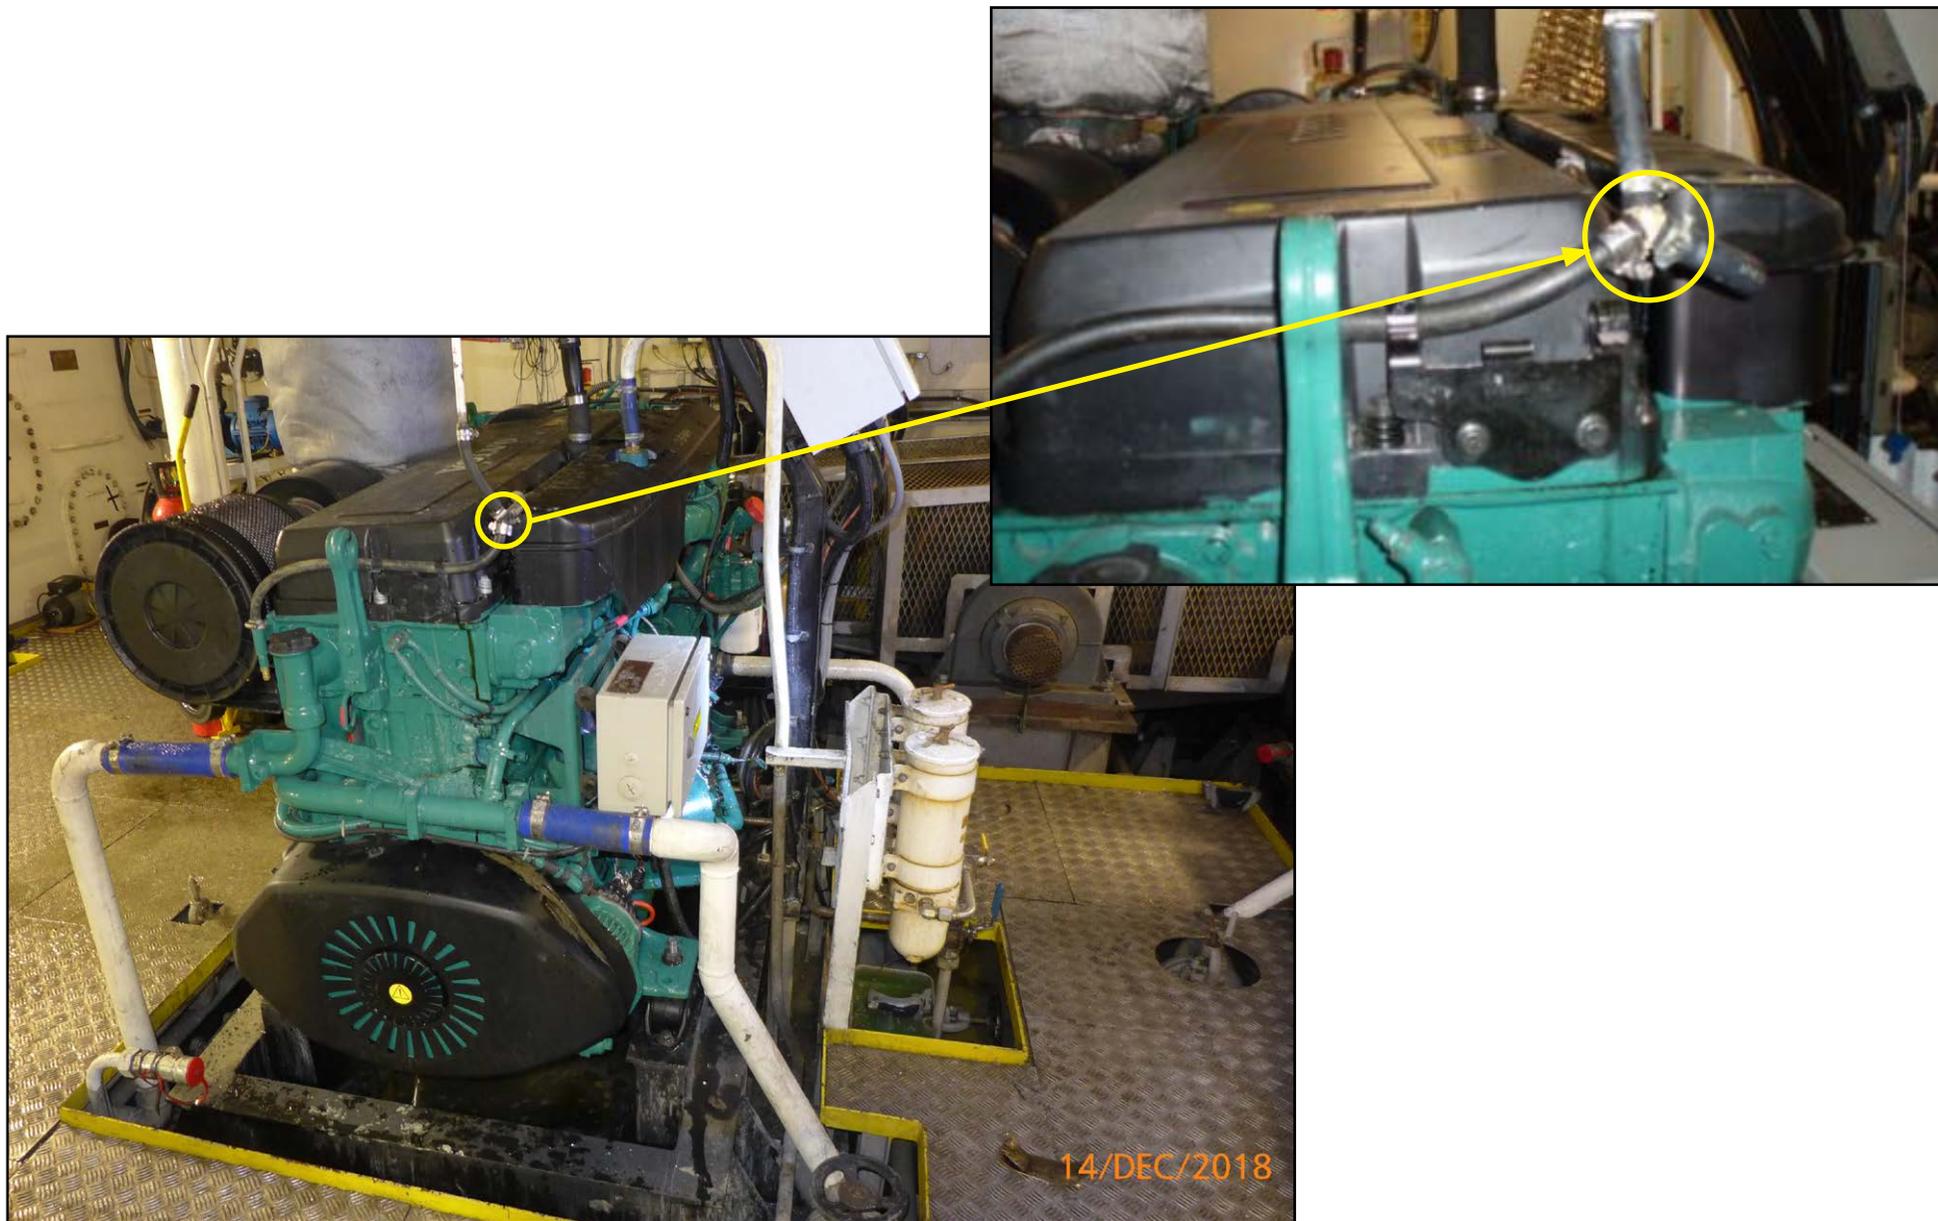
Figure 15: Coolant system T-piece

After about 18 months’ operation, the vessels started to suffer from cylinder liner failures. These were thought to be a result of difficulty in venting the HT cooling system and Volvo Penta advised the installation of a T-piece to aid effective venting of the engines’ cooling water saddle tanks (**Figure 15**). Following the two catastrophic engine failures in 2018, Volvo Penta was unable to determine the justification for the T-pieces and advised their removal, along with a revision to the pipework design to remove the U-bend in the systems and a change to pressure relief caps rated at 75kPa (**Figure 16**).

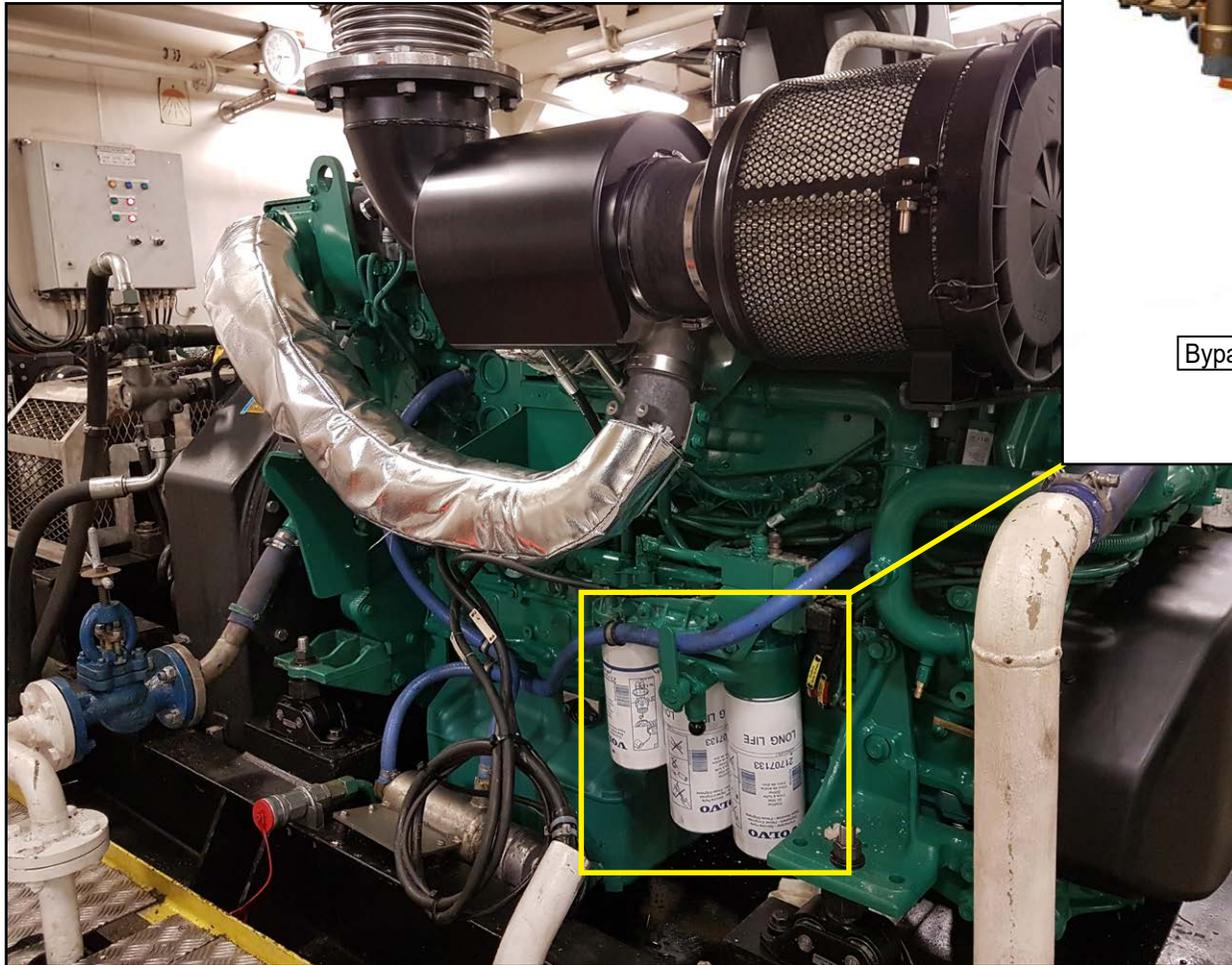
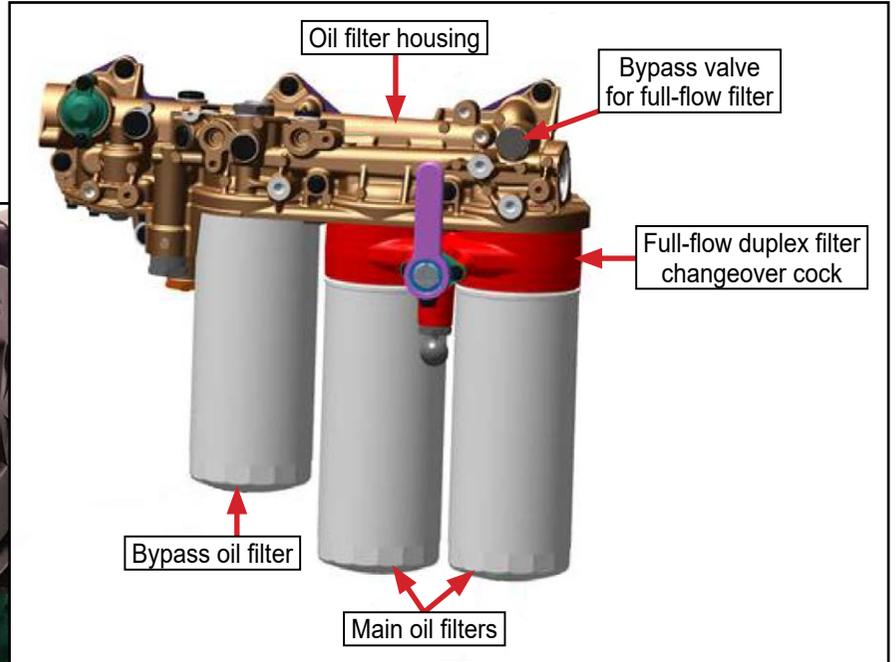
Figure 19: D16 MH lubricating oil filters (with changeover cock)

During Volvo Penta's investigations into the causes of the Wightlink engine failures, a design error was identified with the oil filter arrangement. It was discovered that, at full engine speed, the full-flow filters' bypass valve opened slightly and allowed 10 to 20% of unfiltered oil to flow through the circuit. The overflow valve for the main filters was affected by the pressure drop caused by the changeover cock. In April 2019, Volvo Penta informed Wightlink and subsequently issued a D16MH/MG service bulletin for the overflow valve spring replacement. In Wightlink's case, as the changeover cock was no longer required to meet classification society requirements, Volvo Penta advised its removal from the oil filter block. This work was completed on the W-Class vessels (**Figure 20**).
