Report on the investigation of  
the fatal person overboard from the motor cruiser  
***Diamond Emblem 1***  
at Great Yarmouth Yacht Station, River Bure, England  
on 19 August 2020

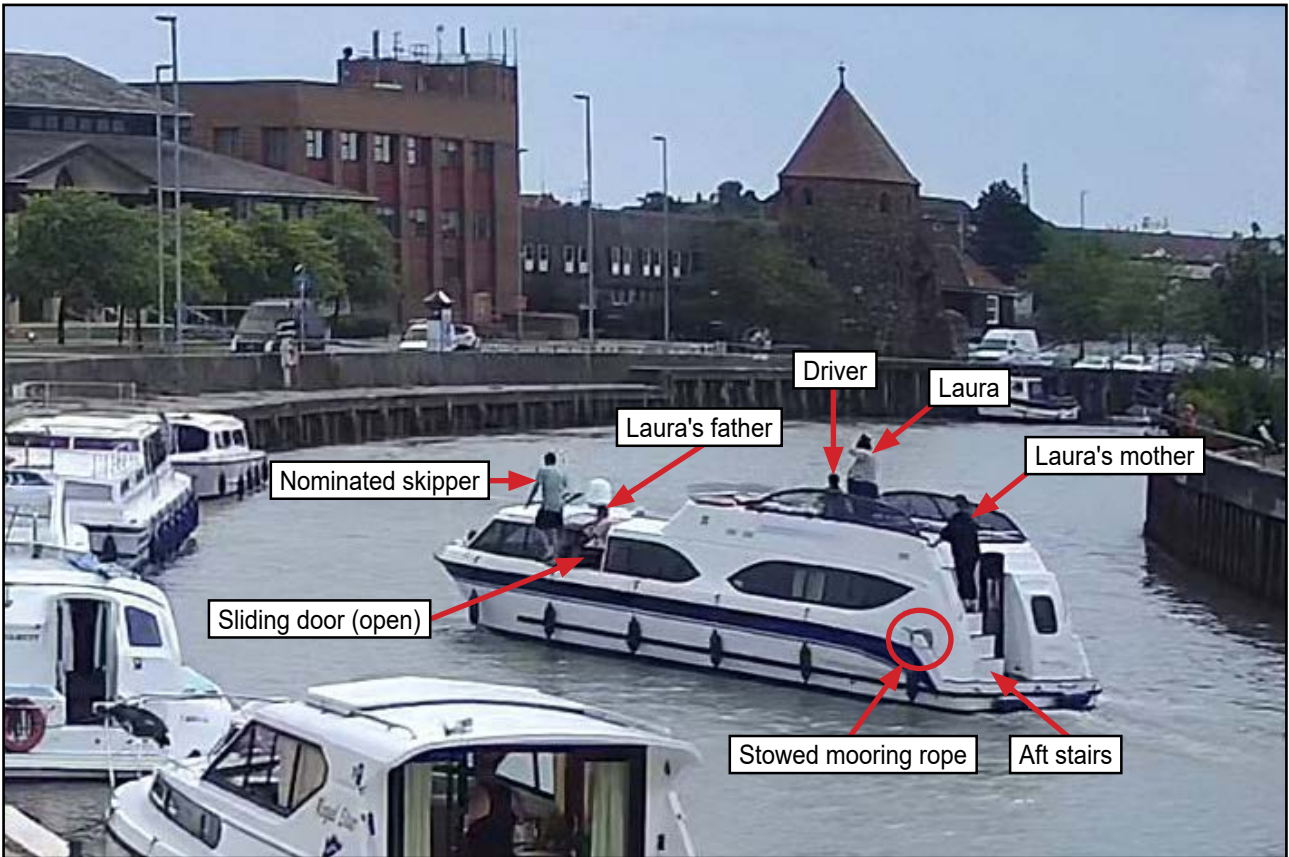
**Figure 6:** *Diamond Emblem 1* approaching the moored boat *Challenger* at 1317:38, showing the five adults

At about the same time, the driver tried to slow the boat by pulling the propulsion control lever into reverse and her father put his head up through the cabin space sliding door to see what was happening. Shortly after the exchange with the ranger, the driver began to turn *Diamond Emblem 1* to port. The driver then pulled the propulsion control lever to its full reverse position. As *Diamond Emblem 1*'s engine pitch increased, its speed toward the boats moored on the riverbank also increased. As they neared the moored boats, the nominated skipper walked swiftly to the forward deck and Laura's father climbed back down into the cabin space (**Figure 6**).

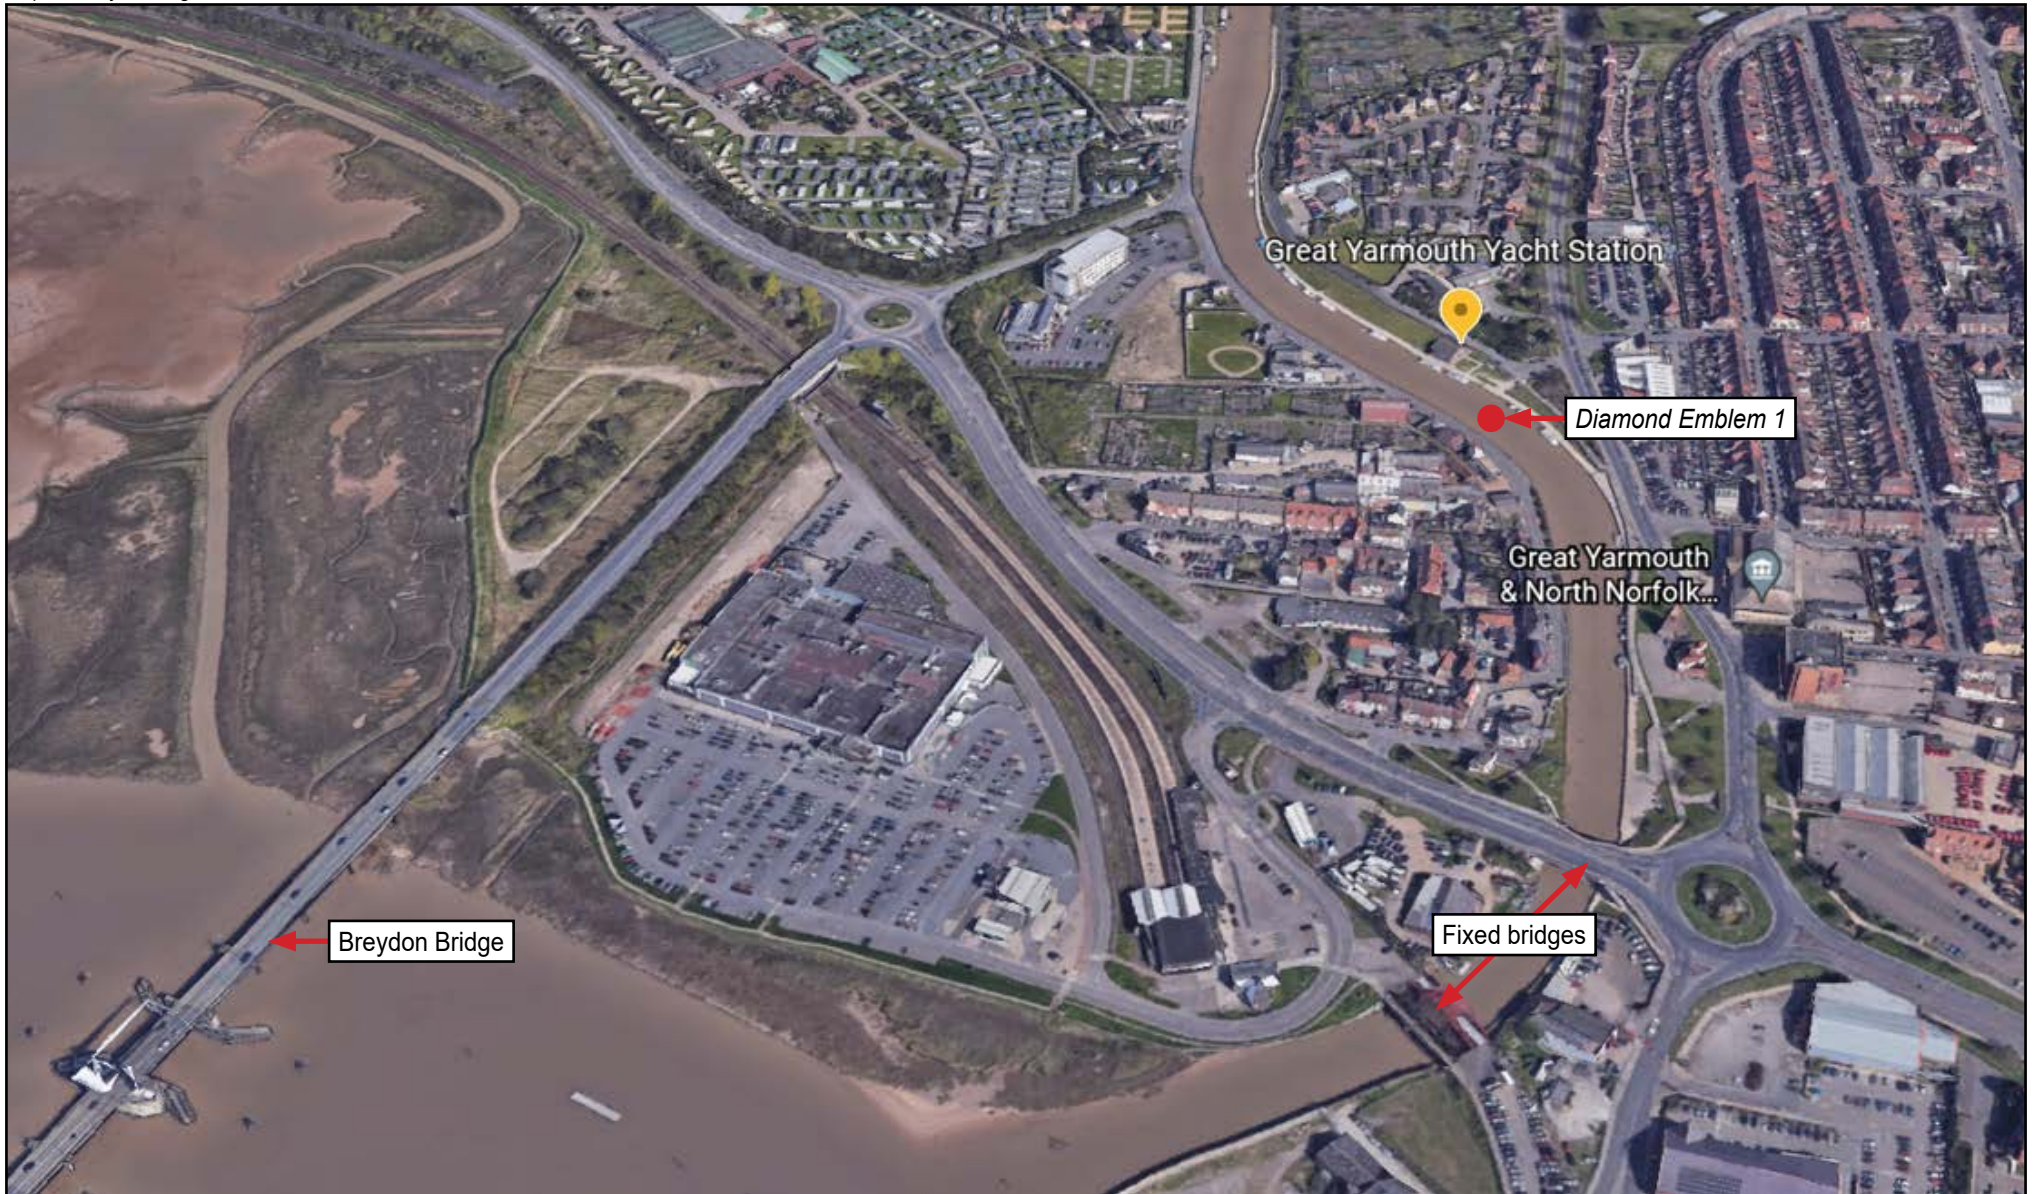
**Figure 9:** Location of *Diamond Emblem 1* at the time of the accident

Great Yarmouth Yacht Station is about a 10-minute walk from the town centre and there are two fixed bridges between it and the entrance to Breydon Water (**Figure 9**). Boats should always approach the moorings against a running river tide and the ideal time to arrive at the yacht station was at slack low water. This made it easier to manoeuvre onto the moorings and allowed boats to pass under the bridges and turnaround if required. Slack water began about 1 hour after low water and lasted about 2 hours.

The height of the river at the yacht station can vary from about 2m at low water to about 4m at high water. To help boat drivers assess whether there was enough headroom to pass safely under the bridges into Breydon Water, a river gauge was positioned on the bank opposite the yacht station. When *Diamond Emblem 1* passed the yacht station, the gauge was reading 2.6m.

A label positioned on the lower helm console stated that the height of *Diamond Emblem 1* with its upper deck windscreen and canopy lowered was 2.52m. *Diamond Emblem 1*'s windscreen and canopy side screens were in place and the driver was conscious that there was insufficient headroom under the bridges for the motor cruiser.

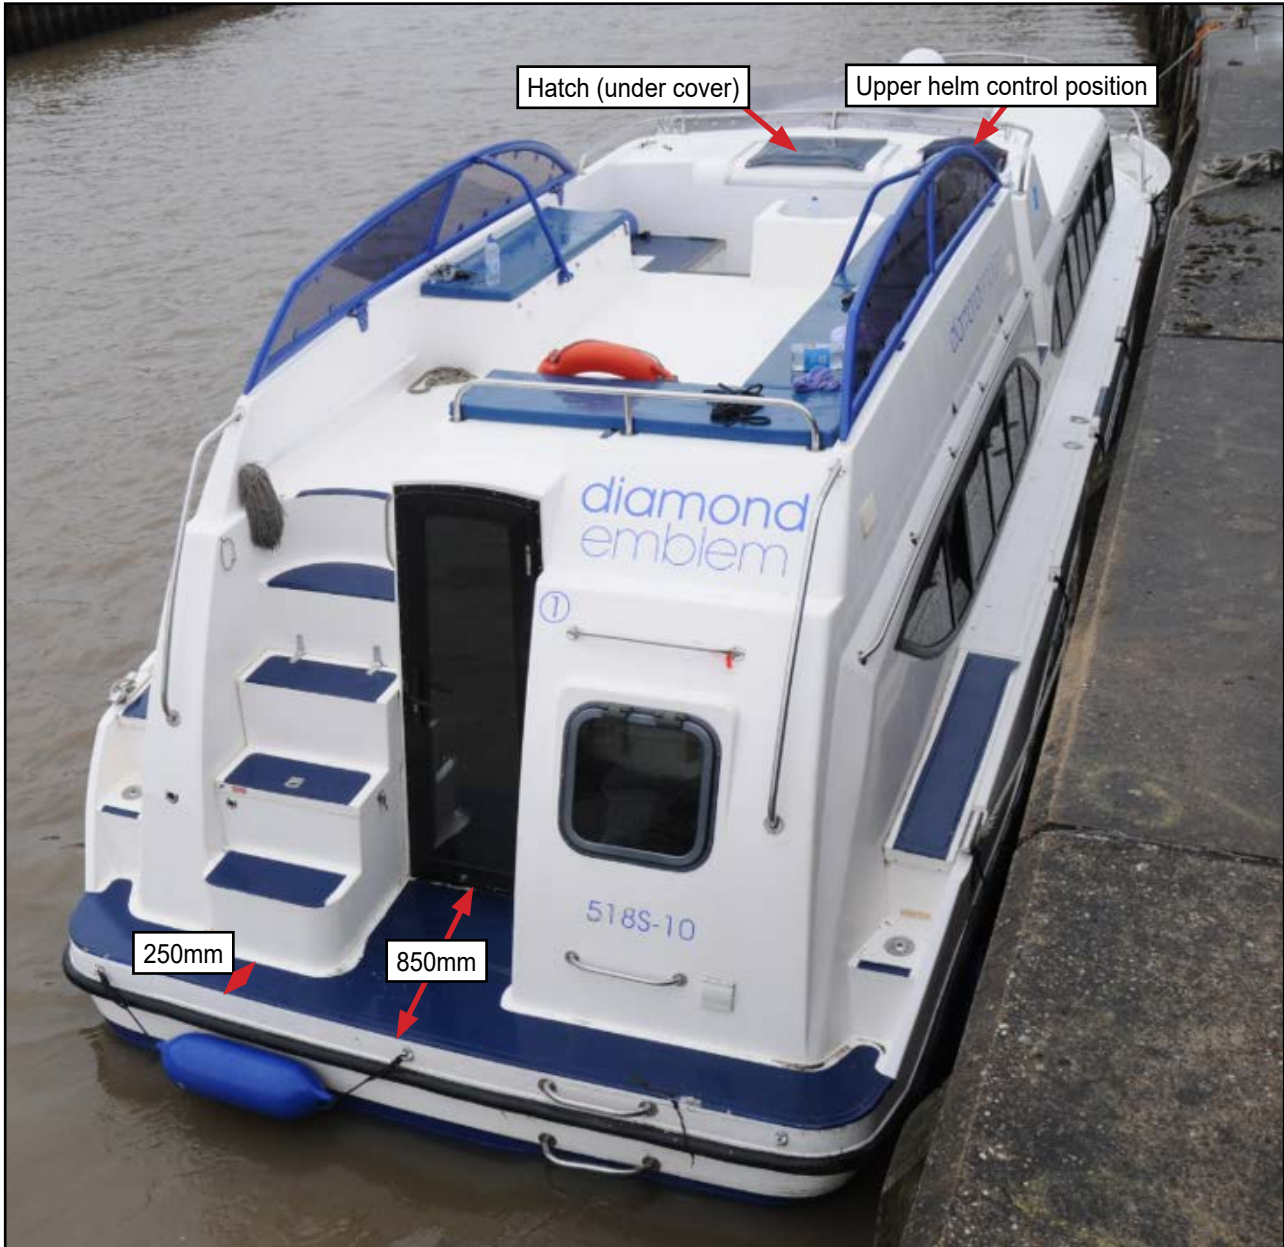
**Figure 10:** Aft deck and staircase between upper and lower decks on *Diamond Emblem 1*

In addition to the aft deck door and sliding door on the port side, there was a hatch in the cabin space roof above the forward saloon area and a hatch adjacent to the upper helm control position that opened into one of the cabins below (**Figures 3b and 10**). When *Diamond Emblem 1* arrived at Great Yarmouth Yacht Station, the hatch adjacent to the upper helm control position was closed. However, the port side door and forward hatch were both open and communication between the upper deck and cabin space was achieved by shouting or relaying verbal messages through the side door and forward hatch. The horizontal and vertical separation between the helm positions was 4.5m and 1.5m respectively.

*Diamond Emblem 1*'s narrow aft deck was in constant use by those on board and its unprotected edge was directly above the boat's propeller. Furthermore, the aft-facing external staircase, which acted as the main thoroughfare between decks, terminated just 250mm from the edge of the aft deck (**Figure 10**). Nonetheless, this distance still exceeded the minimum working deck width of 100mm for a category D boat stipulated in ISO 15085:2003 and would have been deemed acceptable if this standard had been referred to when preparing the DoC. Despite this, each use of the staircase and aft deck exposed the vessel's occupants to the risk of falling overboard. Undoubtedly, the position of the staircase outside the accommodation was intended to maximise the boat's internal living space; however, this design principle also increased the risk of someone falling overboard from the narrow unprotected aft deck. This risk was mitigated by the need for the occupants to use the provided handholds. However, passive collective fall prevention, which protects everyone on board without needing them to take any action, was not considered while designing the vessel's aft area. Therefore, the risk of falling overboard while not using a handhold remained uncontrolled. Had guardrails, like those fitted around *Diamond Emblem 1*'s forward deck, been fitted to the aft deck at a sufficient height, it is unlikely that Laura would have gone overboard despite having been knocked off her feet when the boat hit the wall.

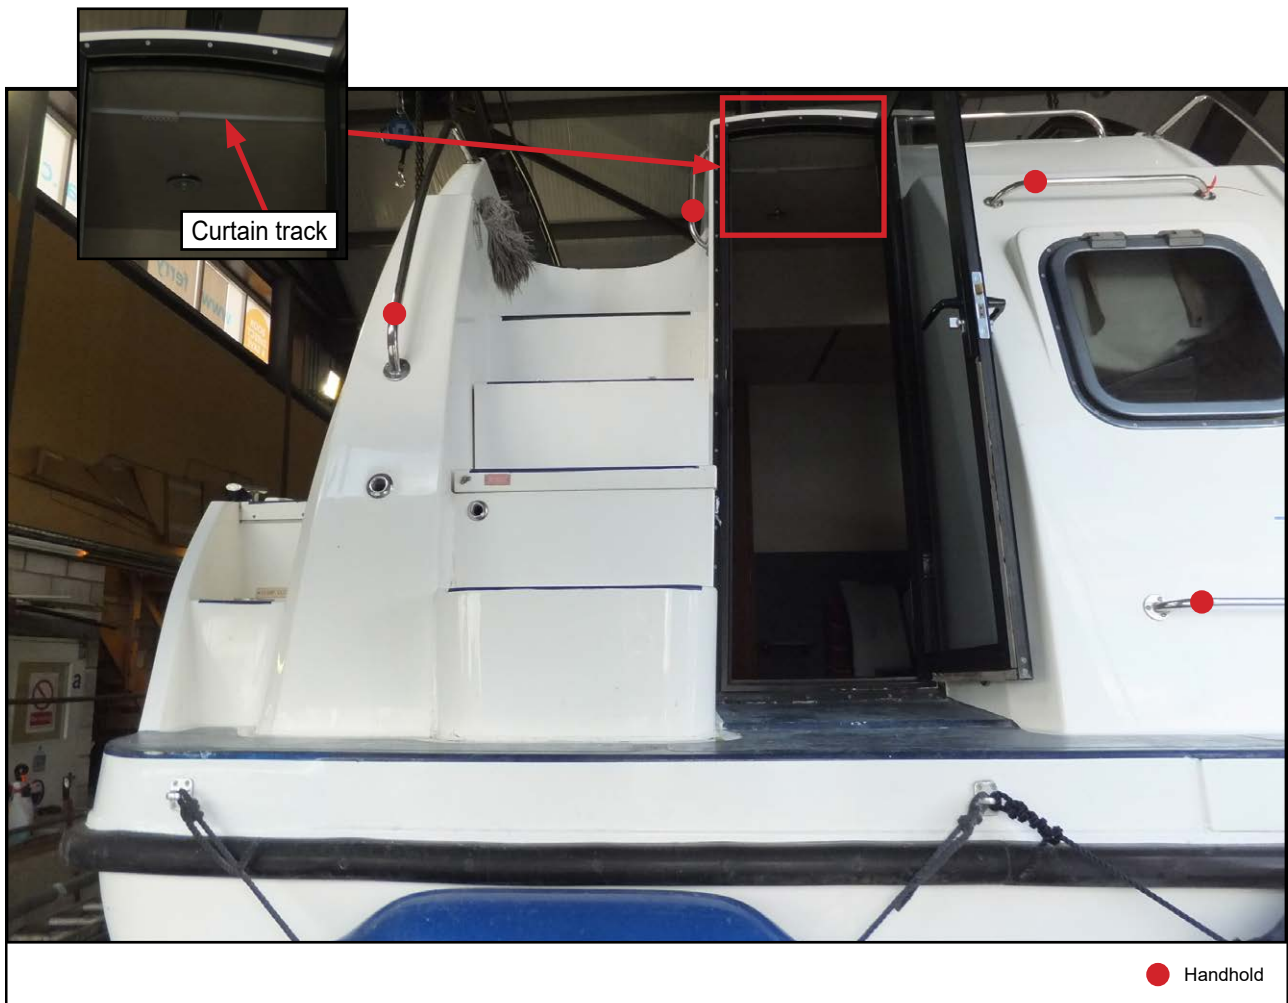
**Figure 11:** View of *Diamond Emblem 1* stern, showing handholds and (inset) ceiling-mounted curtain track inside aft doorway

The main handrail for the steps leading from the aft deck to the upper deck was positioned on the outboard side of the steps (**Figures 10** and **11**). There was a short vertical handrail at about head height level on the inboard side of the steps that could be used when passing through the aft deck door. There was also a horizontal handrail on the other side (starboard) of the door opening.

Immediately before the accident, Laura was facing the stern of the boat as she climbed down from the upper deck to the aft deck and initially held onto the handrail on the outboard side of the steps. She was unable to use the small handhold on the inboard side of the steps as her mother, who was standing on the aft staircase, was holding onto it. Having descended the stairs, Laura opened the door into the cabin at the exact moment that the boat hit the wall. As the door opened outwards, the handrail on the starboard side of the door was out of reach. Therefore, with none of the handrails readily accessible to her, she appeared to grab hold of the curtain that was hanging inside the doorway, maybe in an attempt to arrest her fall. Unfortunately, the curtain detached from its fastenings on the cabin ceiling (**Figure 11**) and went overboard with Laura as she was thrown violently backwards into the water between the wall and the boat's stern. Had she been able to hold on to, or grab, a fixed handrail she might have been able to interrupt her fall.

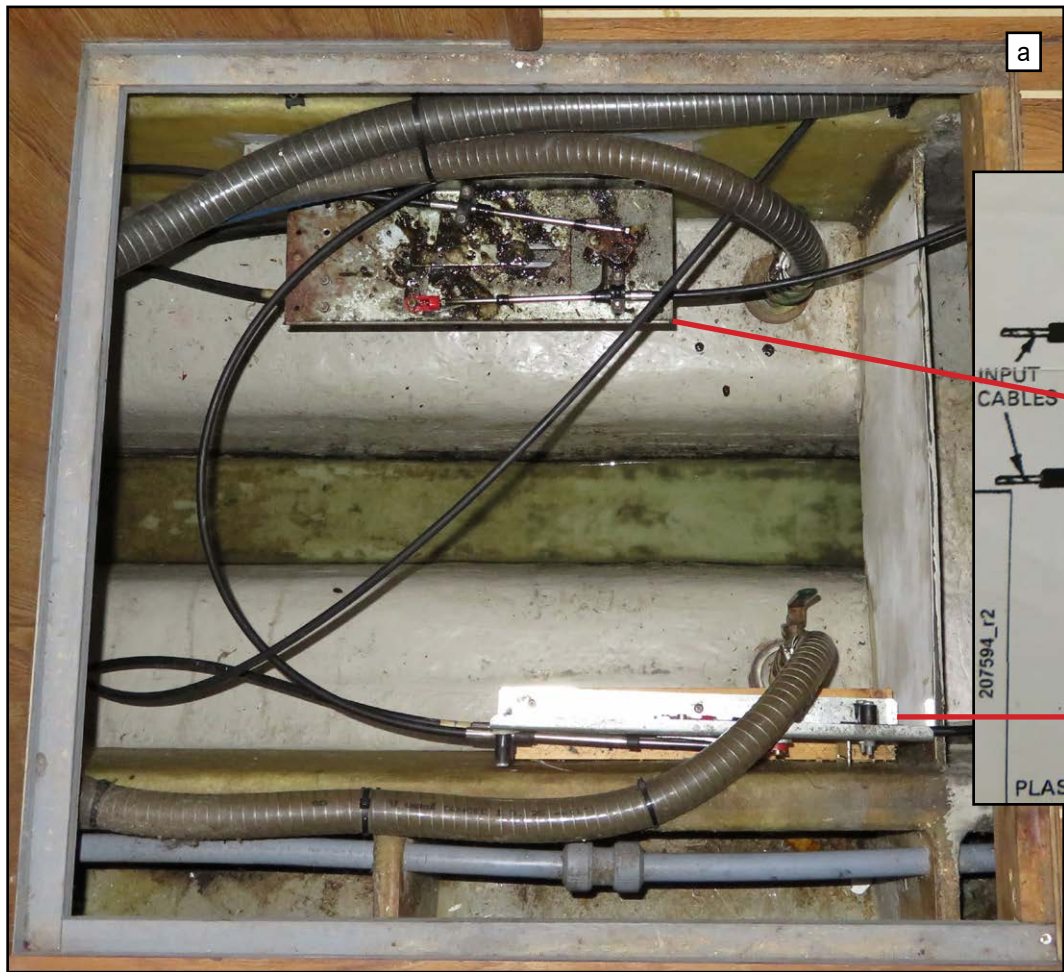
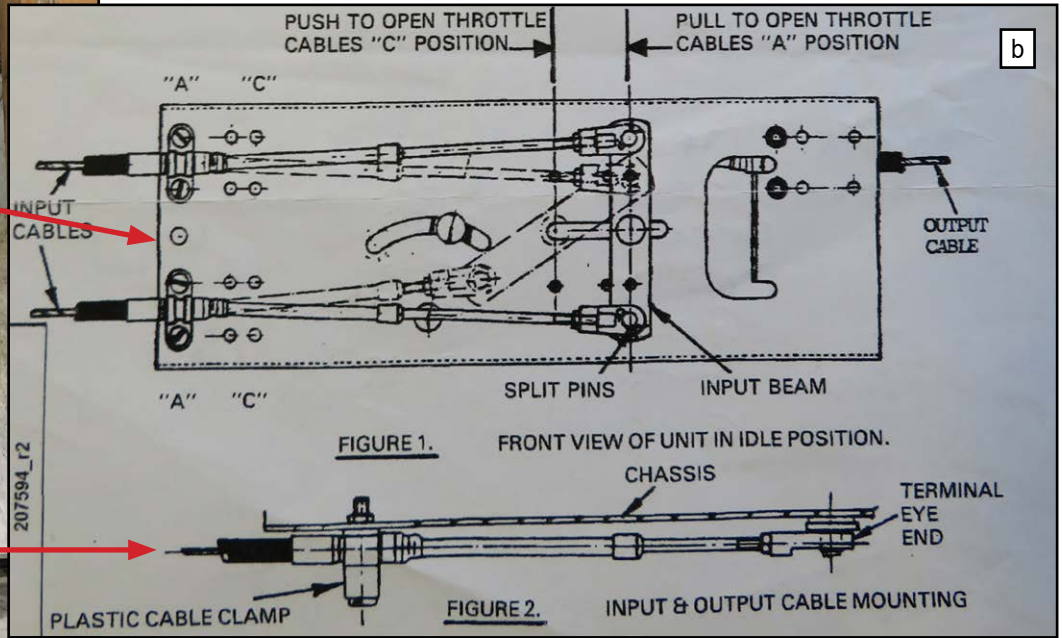
**Figure 13:** Teleflex control system for direction and propulsion (throttle) control (a) and Teleflex control system schematic drawing (b)

The control levers were connected to the engine propulsion and hydraulic system's directional control spool valve via Teleflex push/pull cables. Moving the propulsion control lever forward or back from its neutral detent first engaged the hydraulic directional control spool valve. This caused the propeller to rotate in the direction selected at its slowest speed. Moving the control lever further activated the engine's propulsion control. These sequential steps ensured that the hydraulic spool valve was first set to the boat's desired direction of motion of the boat (forward or reverse) before increasing the engine and therefore propeller speed (**Figures 13a** and **13b**). Labels at the upper and lower helm control positions indicated that engine speeds of 1000 revolutions per minute (rpm) and 1400rpm corresponded to boat speeds of 4 miles per hour (mph) and 6mph respectively. An interlocking system ensured that the direction the hydraulic propulsion motor was turning could only be altered from the selected helm control position.
