# Rail Accident Report

## Runaway of a road-rail vehicle at Belle Isle Junction 16 May 2021

Report 04/2022  
May 2022

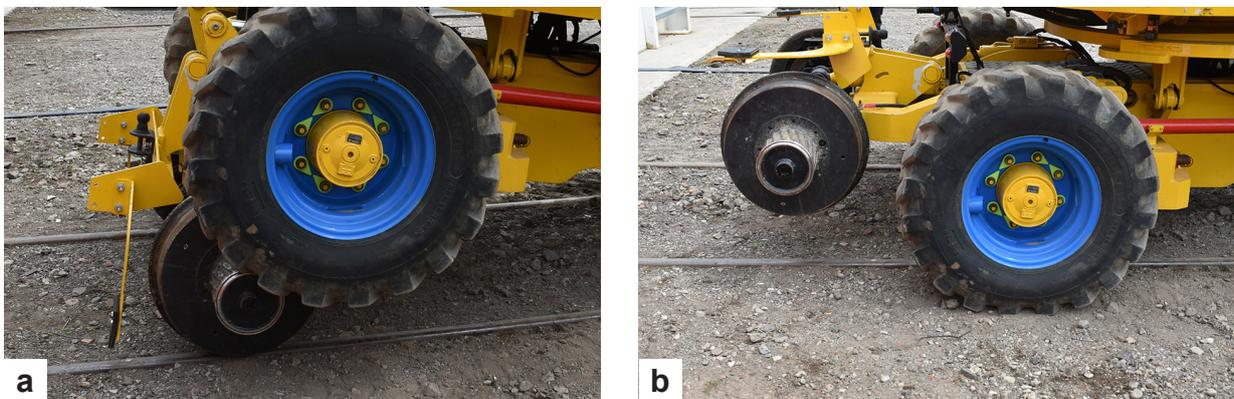
Figure 4: MEWP rail axle configurations in (a) rail configuration and (b) road configuration

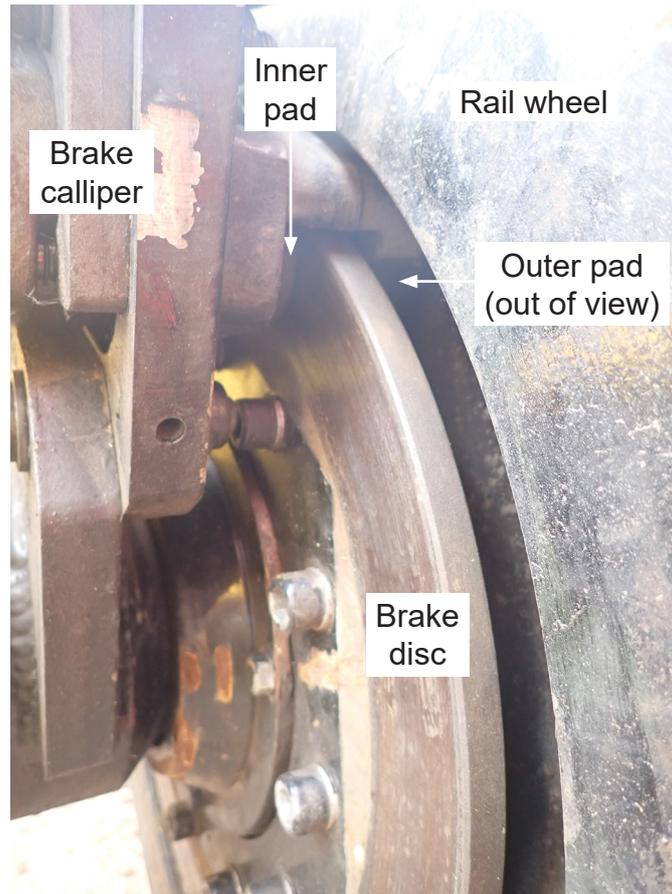
- 34 The DRWB system is intended to be fail-safe. Braking is achieved by callipers pushing pads onto each side of discs that are mounted on the rail axles. The brake force is provided by springs holding the brake pads against the disc. When the MEWP is commanded to move, pressurised hydraulic fluid is admitted to the brake callipers which acts against the spring, releasing the brake. This ensures braking even when there is no hydraulic pressure. In service, the hydraulic pressure is applied by opening an electrically operated valve referred to as the 'park brake valve'.

- 39 Over time, the DRWB brake pads wear down and the spring clamping force, and consequent braking force, is reduced. To compensate for wear, the calliper needs to be manually adjusted. The procedure for checking the brake pad to disc clearance is defined in maintenance instruction AJH077, produced by Hargreaves. This specifies a three-month periodicity for the check and describes what to do if adjustment is necessary.

Figure 6: DRWB calliper and disc arrangement
