AAIB Bulletin S1/2022

SPECIAL

ACCIDENT

Aircraft Type and Registration:	Piper PA-28R-200-2, G-EGVA	
No & Type of Engines:	1 Lycoming IO-360-C1C piston engine	
Year of Manufacture:	1976 (Serial no: 28R-7635229)	
Date & Time (UTC):	2 April 2022 at 0920 hrs	
Location:	Approximately 20 nm west of Le Touquet	
Type of Flight:	Private	
Persons on Board:	Crew - 1	Passengers - 1
Injuries:	Crew - 1 (missing)	Passengers - 1 (missing)
Nature of Damage:	Aircraft missing	
Commander's Licence:	Private Pilot's Licence	
Commander's Age:	69 years	
Commander's Flying Experience:	200 hours (of which 4.7 were on type) Last 90 days - 1.3 hours Last 28 days - 0.7 hours	
Information Source:	AAIB Field Investigation

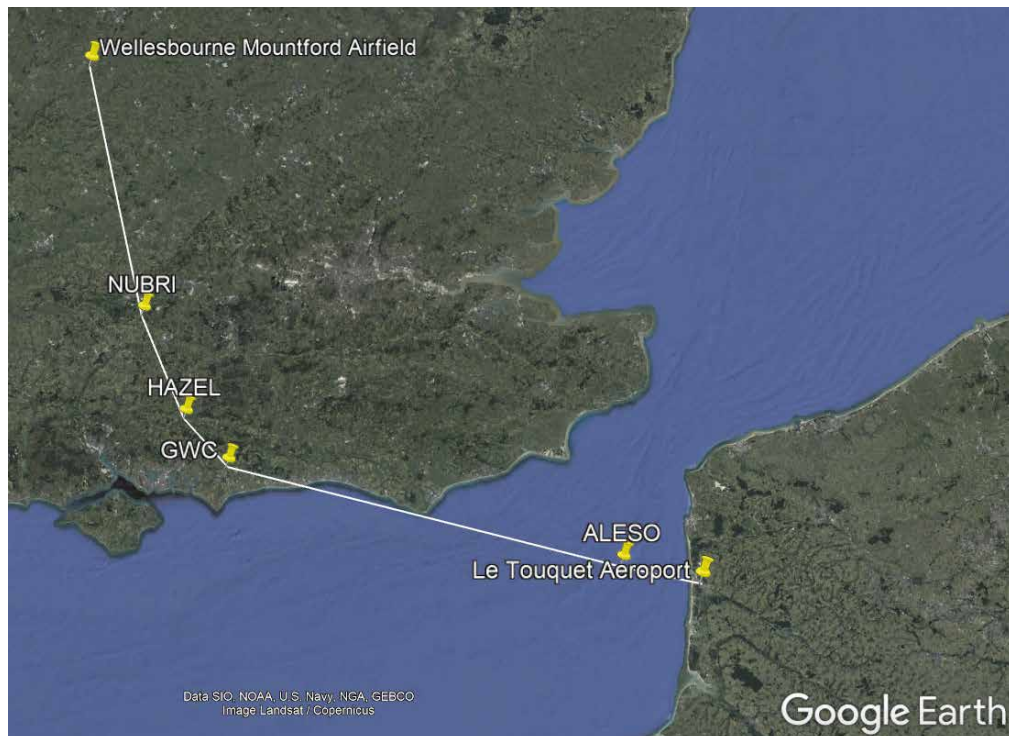
**Figure 1**

Filed flight plan route via waypoints 'NUBRI', 'HAZEL', 'GWC' and 'ALESO'

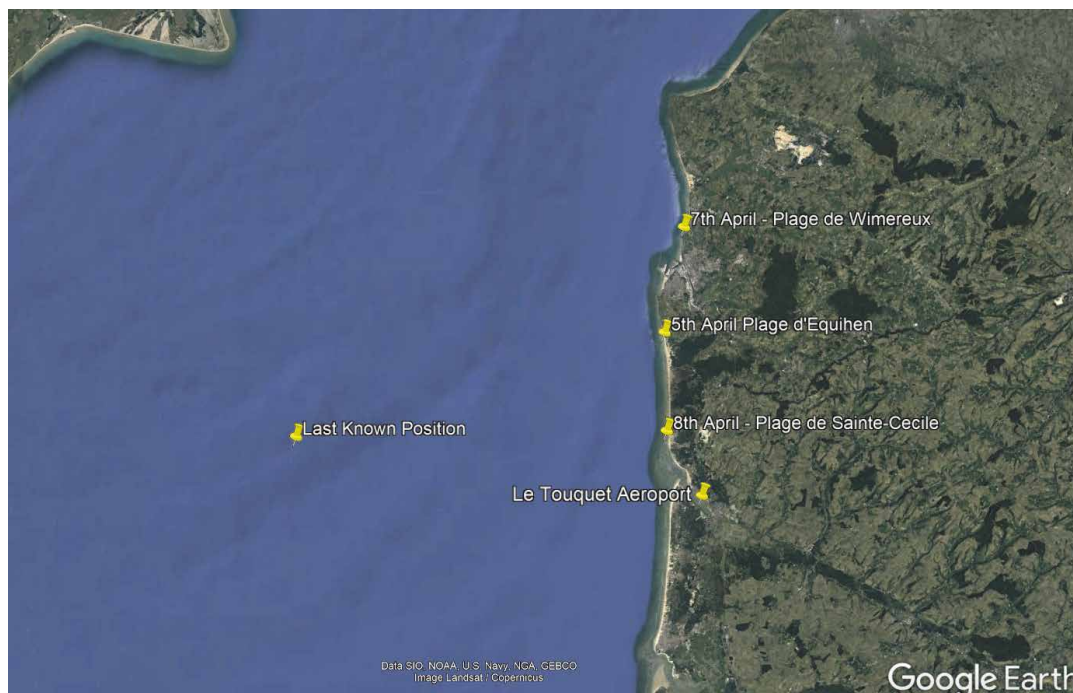
In the days after the accident several items were found on the French coastline which had come from the aircraft. On 5 April 2022 a bag belonging to the left seat pilot was found at Plage d'Equihen, containing his flying licence, logbook and other flight documents. On 7 April 2022 a kneeboard belonging to the right seat pilot was found at Plage de Wimereux and on 8 April 2022 a seat from G-EGVA was found on Plage de Sainte-Cecile. Figure 5 shows the approximate location of each item found and the final known position of G-EGVA.

Location of items found on the French coastline

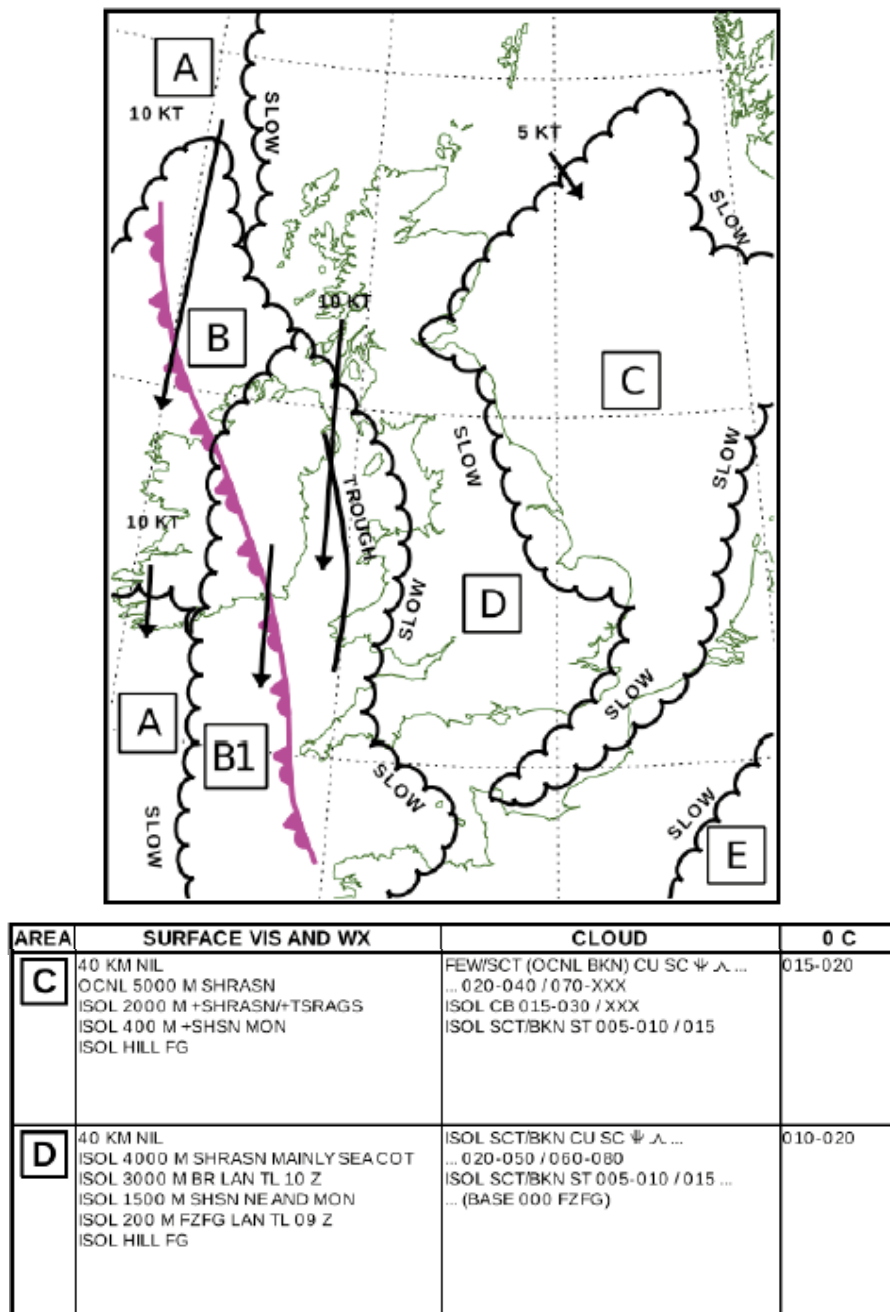
Figure 9

An extract from the Met Office UK low-level forecast chart (F215) issued on the morning of the 2 April 2022 is shown in Figure 9. The forecast was valid between 0200 hrs and 1100 hrs. Initially the flight would have been in Area D. The conditions were forecast to be generally 40 km visibility with scattered or broken (SCT/BKN) cloud with a base between 2,000 and 5,000 ft amsl. However, there would be isolated (ISOL) patches of mist (BR)

reducing visibility to 3,000 m at times, with a further risk of visibilities reducing to 200 m in freezing fog (FZFG) until 1000 hrs. Associated with this there would be scattered or broken (SCT/BKN) cloud with a base between 500 and 1000 ft, lowering to the surface at times in fog.

Extracts from the Met Office F215 valid 2 April 2022 between 0200 – 1100 hrs

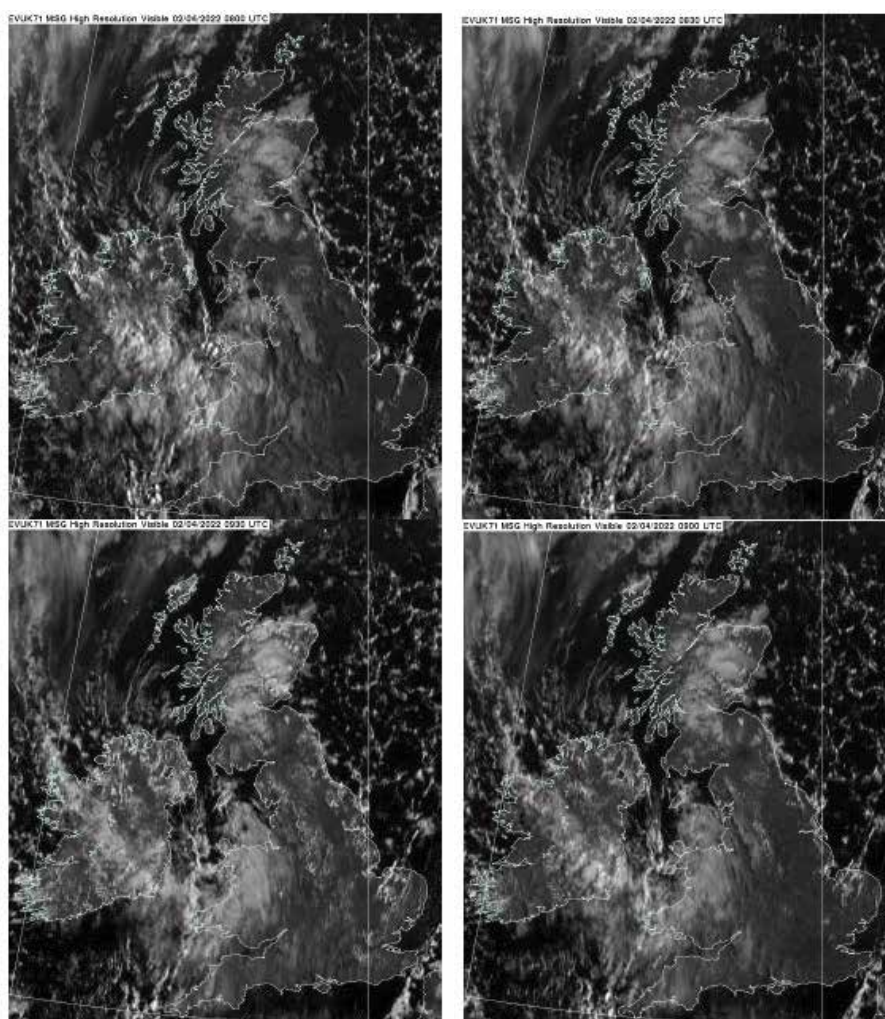
Figure 10

Satellite images taken at half hour intervals between 0800 hrs and 0930 hrs on 2 April 2022 are shown in Figure 10. The images show small amounts of cloud across mainland southern England, with clearer skies across the south-east. A band of cloud lay through the Dover Strait into northern France at 0800 hrs, moving slightly westwards through this time period. The white colour of the cloud in the imagery indicates higher cloud tops which, along with the shape of the cloud structure, suggests showery activity.

Satellite Imagery between 0800 hrs and 0930 hrs on 2 April 2022
