AAIB Bulletin:	G-LNDN	AAIB-27528
SERIOUS INCIDENT		
Aircraft Type and Registration:	MD 900, G-LNDN	
No & Type of Engines:	2 Pratt & Whitney Canada PW207E turboshaft engines	
Year of Manufacture:	2008 (Serial no: 900-00125)	
Date & Time (UTC):	25 July 2021 at 2014 hrs	
Location:	In flight between Royal London Hospital and RAF Northolt, Greater London	
Type of Flight:	Commercial Air Transport	
Persons on Board:	Crew - 2	Passengers - 2
Injuries:	Crew - None	Passengers - None
Nature of Damage:	Water damage to Symbol Generator and right Electronic Engine Controller	
Commander's Licence:	Airline Transport Pilot's Licence (Helicopters)	
Commander's Age:	58 years	
Commander's Flying Experience:	12,360 hours (of which 2,090 were on type) Last 90 days - 35 hours Last 28 days - 10 Hours	
Information Source:	AAIB Field Investigation

Synopsis

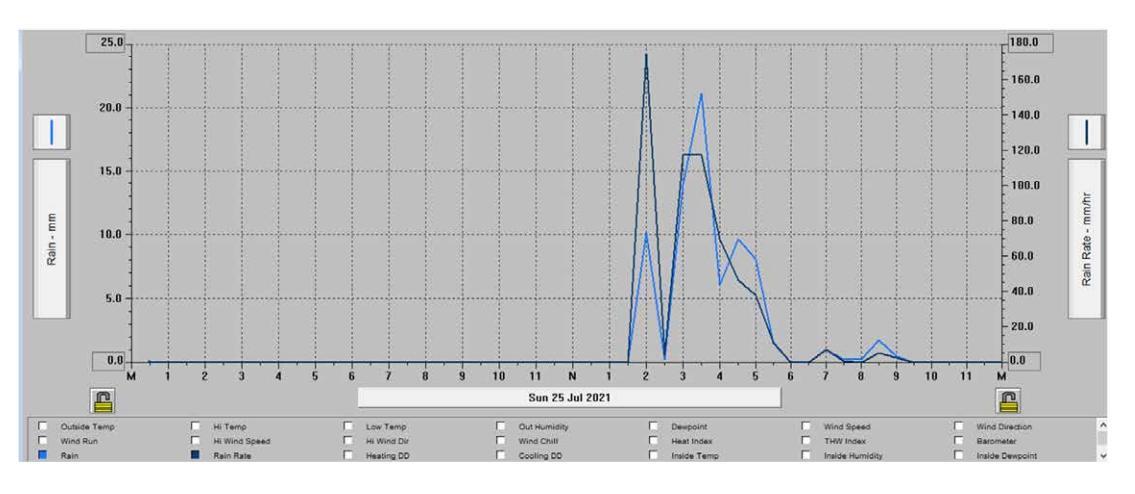
Figure 2 Rainfall chart for 25 July at RLH (times displayed are UTC+1)

Having deployed on routine tasking during the morning, G-LNDN returned to the RLH helipad shortly after 1300 hrs. During the afternoon there was no further tasking for the helicopter, so it remained on the helipad until the incident flight which departed for RAF Northolt shortly after sunset. Between 1300 hrs and 1700 hrs the helipad was subject to significant heavy showers and thunderstorms and, given its forward deployed location, it was not possible to shelter the helicopter during this period (Figure 1). The helipad's automated weather station recorded peak rainfall rates of 175 mm/hr and more than 50 mm total rainfall in the period 1300-2000 hrs (Figure 2), and the wind during this time was between 4 and 10 kt.

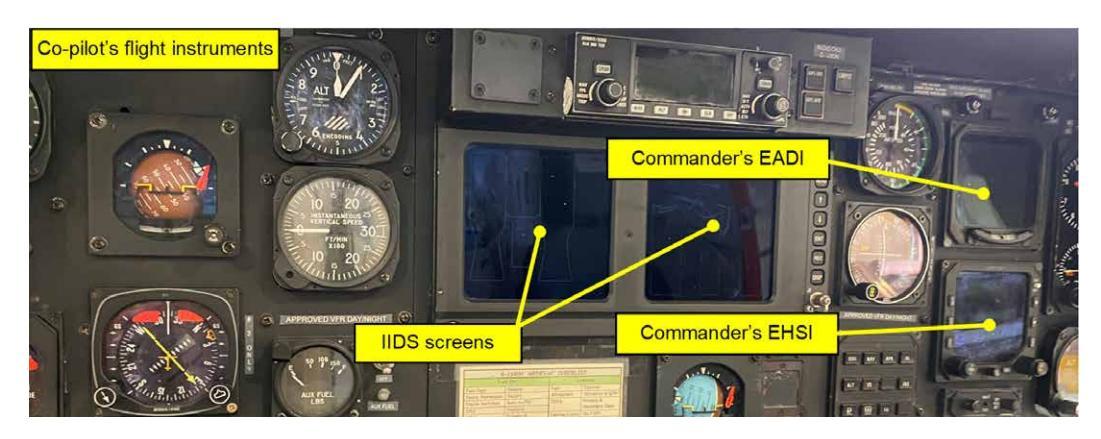
Figure 4 G-LNDN's cockpit instrument displays

Shortly after passing the London Heliport at Battersea the commander's electronic horizontal situation indicator (EHSI) display (Figure 4) blanked. Then, as the helicopter approached the northerly turn at Kew Bridge Visual Reporting Point (VRP), the commander's electronic attitude display indicator (EADI) also began to fail, intermittently blanking and showing spurious caution messages. The co-pilot's electro-mechanical flight instruments were unaffected, and the flight continued northbound from Kew. Shortly after they turned westbound at the Hanger Lane VRP, the pilots were alerted to EEC system fault indications for both engines. Accompanied by an audio tone, a red FAIL warning indication on the helicopter's Integrated Instrument Display System (IIDS) (Figures 4 and 10) was displayed for the right engine's EEC (right EEC) and a yellow, non-critical failure, caution illuminated for the left engine's EEC (left EEC).

The EHSI and EADI both failed during the flight because of a Symbol Generator malfunction. The right EEC FAIL warning indication on the IIDS was a result of the failure of the right EEC. This resulted in the MAN caption not illuminating when the pilot moved the right engine throttle out of NORMAL, because the IIDS only displays the EEC MAN indication when the EEC is transmitting digital data. The left EEC non-critical caution was due to an ARINC communication fault as the left EEC was unable to communicate with the right EEC for torque matching purposes. The left engine's EEC otherwise functioned correctly. Both the right EEC and Symbol Generator were mounted in the aft baggage compartment directly beneath the right engine and showed evidence of having been exposed to water.

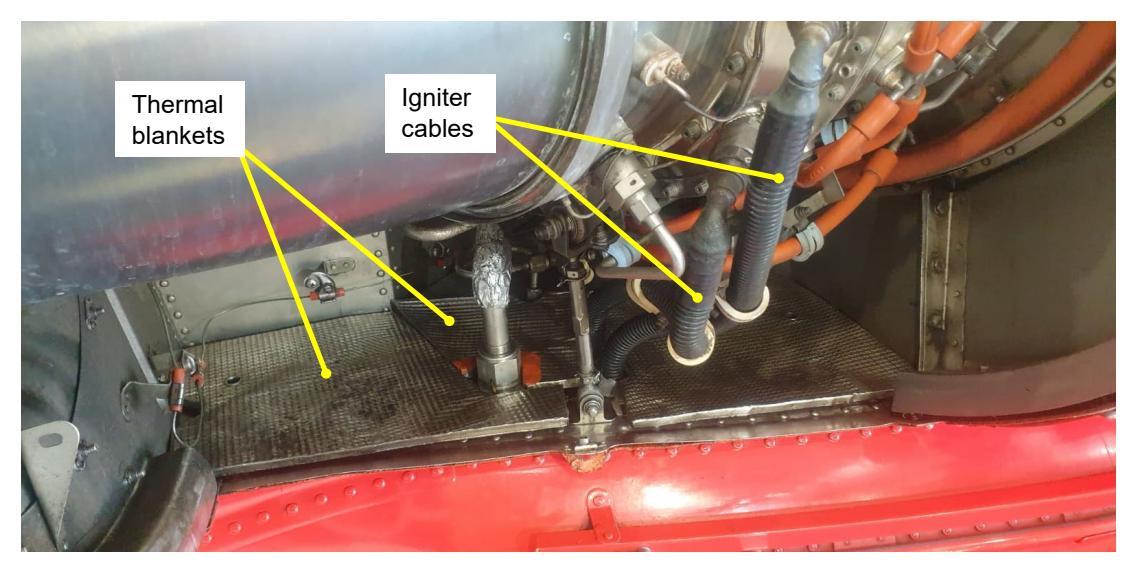
Figure 9 Rear engine compartment (right engine)

compartment is accessed by removing the rear engine cowling. The inlet plenum panel and the engine cowl are secured by screw fastenings and are only accessed during maintenance. The engine cowling has two mesh covered cut-outs, which allow airflow around the engine compartment (Figure 8). The floor of each compartment and the intake plenum has a series of drain holes to allow fluid that may enter the bay to flow out of it. The compartment to the rear of the aft fire wall is serviced by two drain holes. This compartment also has a series of thermal blankets covering the floor to protect the deck from overheating (Figure 9). These are secured in place using hook and loop fastenings. The thermal blankets lie over the drain holes, but do not obstruct them.

G-LNDN had been parked on the helipad at the RLH at the time of heavy rainfall. During this time rainwater entered the right engine bay through the mesh covered cut outs in the engine cowling. The rainwater had then flushed debris in the engine bay toward the rear drain hole, which then partially blocked. Either because of the partial blockage of the drain hole, or through sheer volume of water overwhelming the drains in the engine bay, it started to fill. As the water level reached the igniter lead through-holes, water was able to pass into the rear baggage compartment because inadequate sealing round the igniter leads, which had been applied whilst it was operated by its previous owner, did not prevent water ingress.

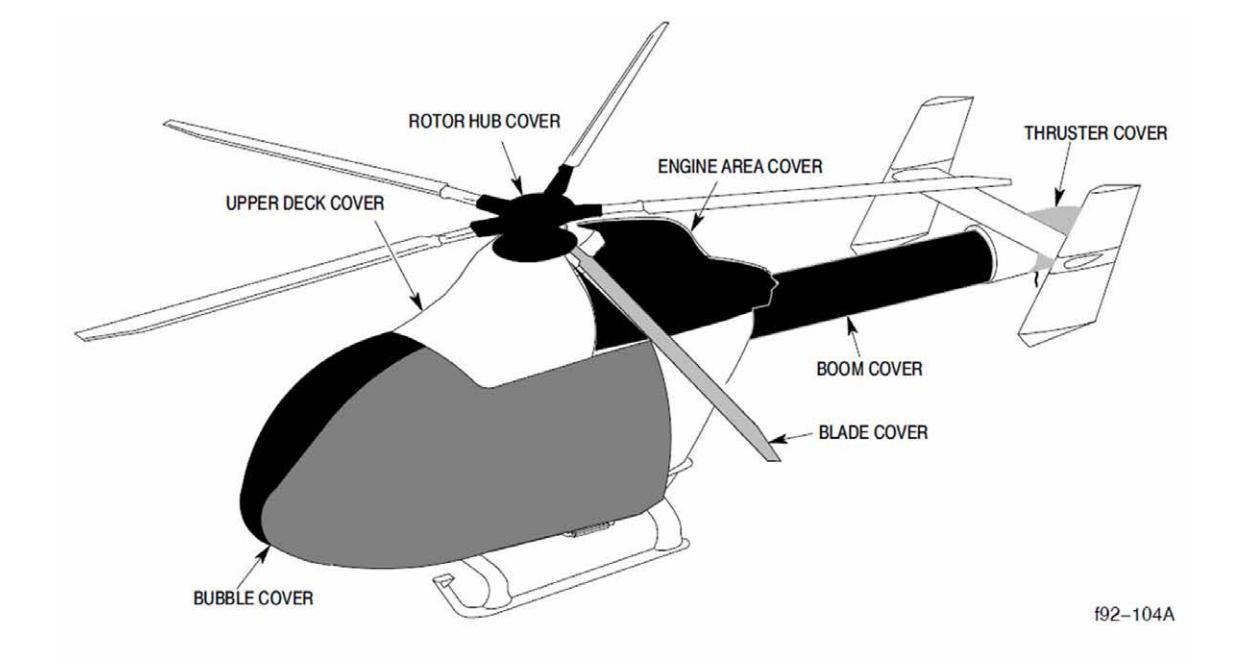
Figure 15 Covers available for the MD 900 series of helicopters

The RFM section 8-3 (pages 4 to 9) provides guidance for parking and storing a helicopter. The section describes the tiedowns and covers available to the operator to protect the helicopter 'from inclement weather conditions and other outside environmental factors that could cause FOD damage while the helicopter is parked, moored, or while in storage.' and highlights in a note that 'The decision to use protective covers and tiedowns is determined by the prevailing weather conditions, length of storage/parking, and location.' This section includes a description of covers for the engine area and upper deck (Figure 15). There was no guidance within either the operator's operations procedures or the RFM to protect the aircraft during heavy rain specifically.

Had engine area or upper deck covers been used to protect the engine bays during the heavy rainfall, the pathway for the rainwater to enter the engine bay would have been blocked. The operator explored the feasibility of using engine cowl covers in addition to the tie downs and engine blanks already required, but this was considered detrimental to the operation of the helicopter when considering its three-minute launch target in its role as an air ambulance. The operator also identified risks of causing damage to the aircraft's antenna and creating possible foreign object debris (FOD) whilst removing the covers that protect the upper surfaces of the fuselage.
