ACCIDENT

Aircraft Type and Registration:	Rogers Sky Prince, G-CJZU	
No & Type of Engines:	1 Continental Motors Corp O-200-A piston engine	
Year of Manufacture:	2009 (Serial no: 00118-1507)	
Date & Time (UTC):	30 June 2021 at 1536 hrs	
Location:	Near Goodwood Aerodrome, West Sussex	
Type of Flight:	Private	
Persons on Board:	Crew - 1	Passengers - 1
Injuries:	Crew - 1 (Fatal)	Passengers - 1 (Fatal)
Nature of Damage:	Aircraft destroyed	
Commander's Licence:	Private Pilot's Licence	
Commander's Age:	65 years	
Commander's Flying Experience:	706 hours (of which 16 were on type) Last 90 days - 89 hours Last 28 days - 19 hours	
Information Source:	AAIB Field Investigation

Synopsis

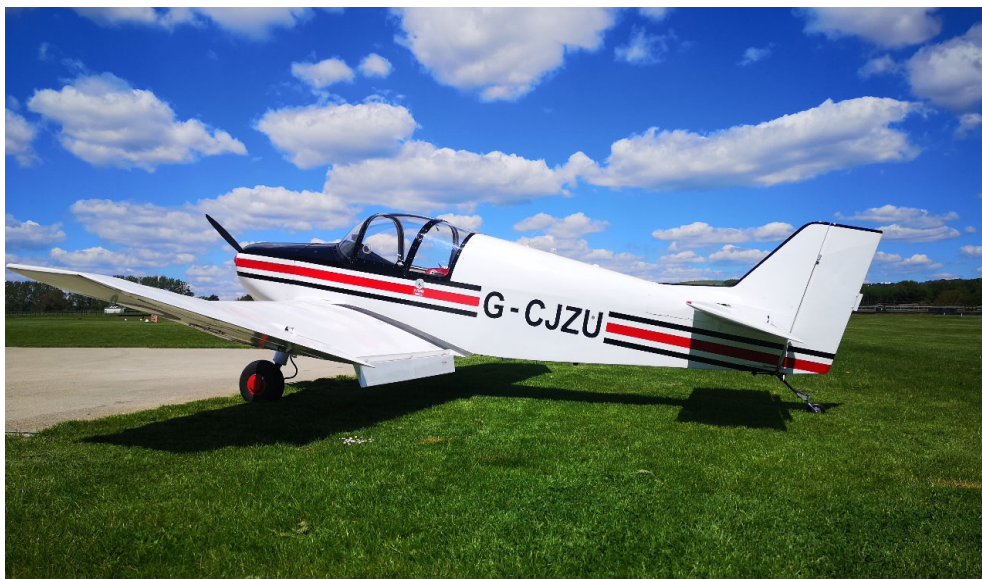
Figure 1

Several electronic devices were recovered from the accident site; however, all were damaged in the post-impact fire and no data could be recovered from them. CCTV footage from the aerodrome captured the aircraft beginning its takeoff roll. Other footage (Figure 1) captured the aircraft airborne, starting just before the intersection of Runways 14/32 and 06/24, through to its descent to the ground. Analysis of the footage suggests that shortly after passing over the runway intersection at about 150 ft aal, the aircraft levelled off for about six seconds before climbing to about 300 ft aal over the next 26 seconds (so averaging about 350 ft/min). The aircraft is then seen to descend and roll left into a steep dive towards the ground. After disappearing from view behind a row of trees, smoke from the post-impact fire can be seen.

Approximate ground track (note rising ground at the top of the chart) and composite image from CCTV showing G-CJZU flightpath (two-second spacing between aircraft)
