# Annual Safety Review 2021

Published 14 June 2022

Air Accidents Investigation Branch  
Farnborough House  
Berkshire Copse Road  
Aldershot  
Hampshire  
GU11 2HH.

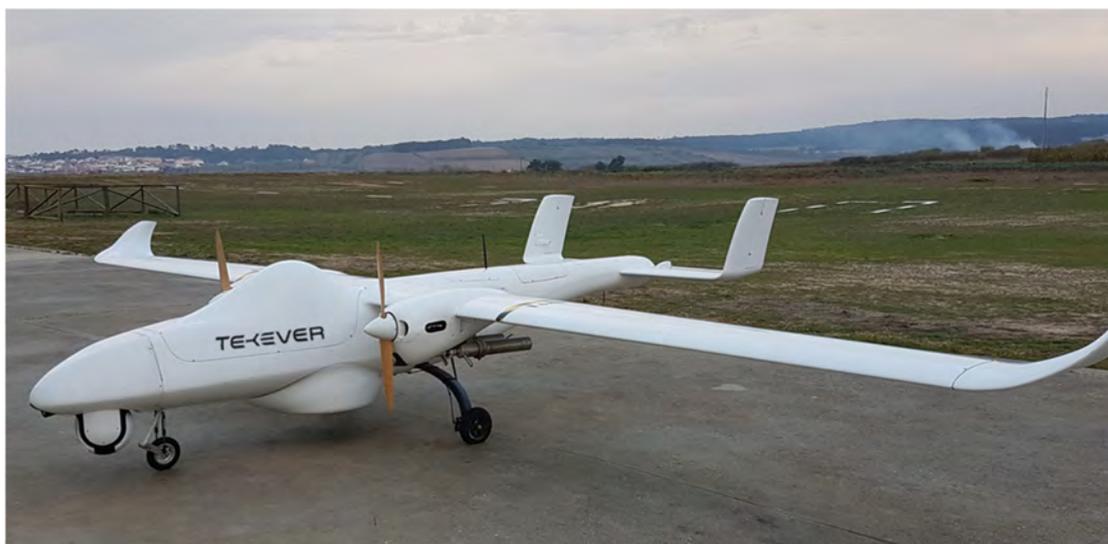
**Figure 1**  
Tekever AR5 Evolution

We have deployed teams to investigate two accidents involving large UAS, a 180 kg Tekever AR5 Evolution Mk 2 (G-TEKV) at Lydd Airport on 29 December 2020 (Figure 1) and a 95 kg Airspeeder at Goodwood Aerodrome on 4 July 2019 (Figure 2).

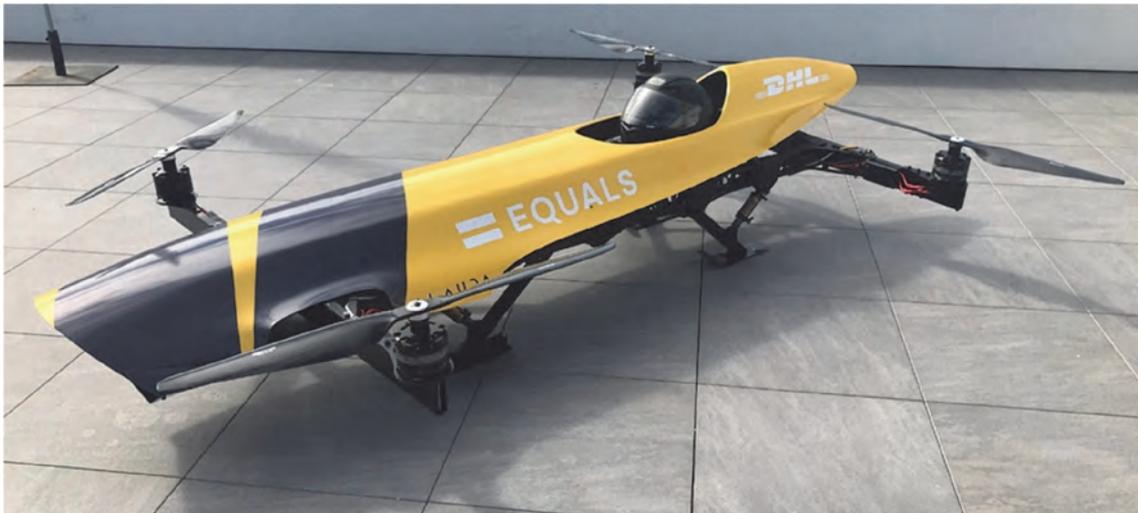
**Figure 2**

The majority of UAS accident investigations are conducted via correspondence but occasionally some get upgraded to field investigations if they are particularly complex or involve safety recommendations. So far, the AAIB has made 21 Safety Recommendations related to UAS, of which 15 concerned the Airspeeder UAS accident (Figure 2). The remaining six were related to four different UAS investigations involving small quadcopter UAS. One of these recommendations was to a manufacturer to provide prompt technical support to Safety Investigation Authorities (SIA). The remaining five were to the CAA and concerned:

Alauda Airspeeder Mk II (exemplar model)

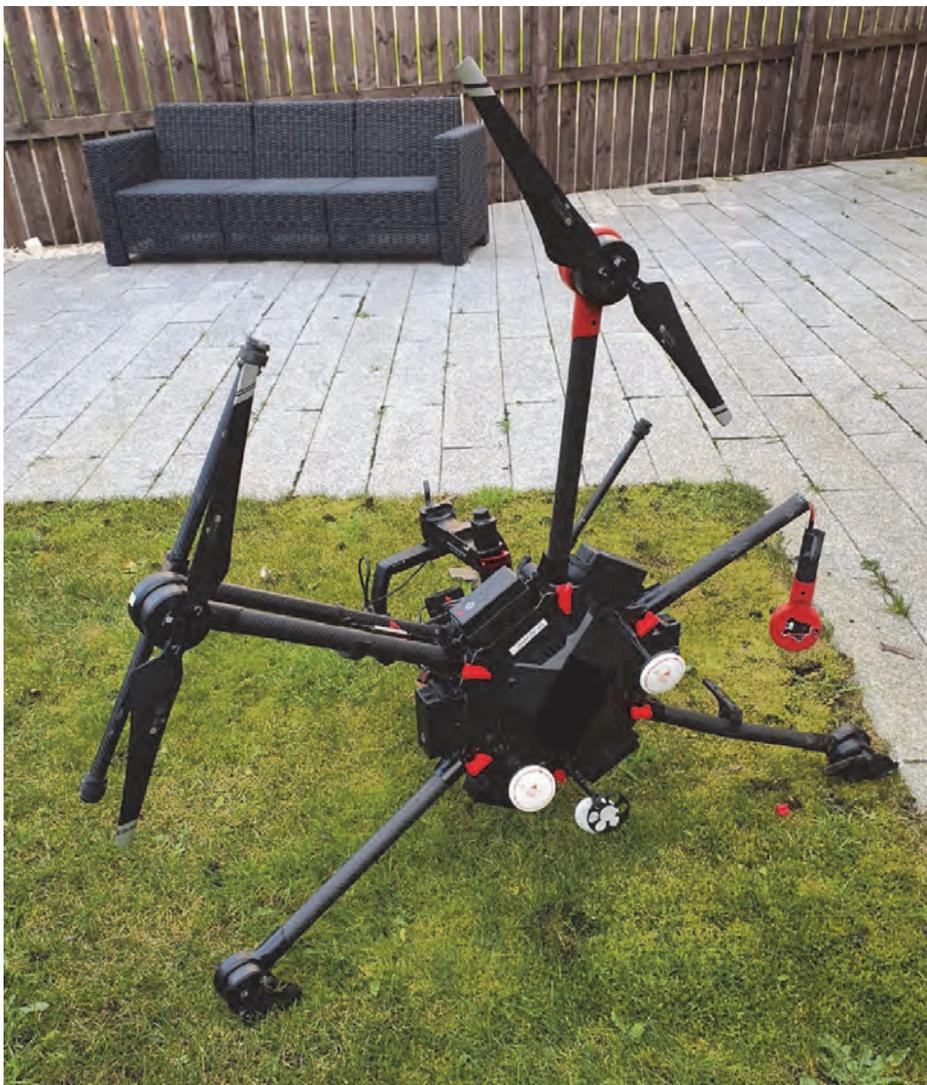
**Figure 4**

- A 1.4 kg UA falling from 8 m could cause a fatal injury
- Quadcopter UA can fall from the sky for many different reasons:
  - Battery failure (hardware or firmware related)
  - Motor failure
  - Speed controller failure (sometimes due to moisture ingress)
  - Propeller failure/detachment

[DJI M600 Pro](#) after falling into a garden

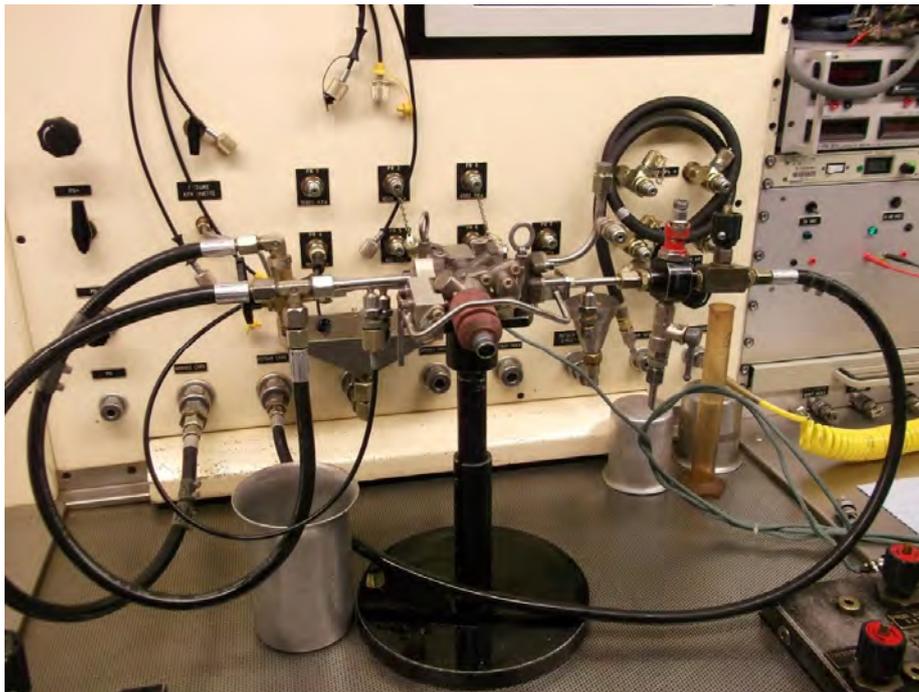
**Figure 2**

Fuel component bench test, an example typical of the work an Acc Rep may be required to oversee

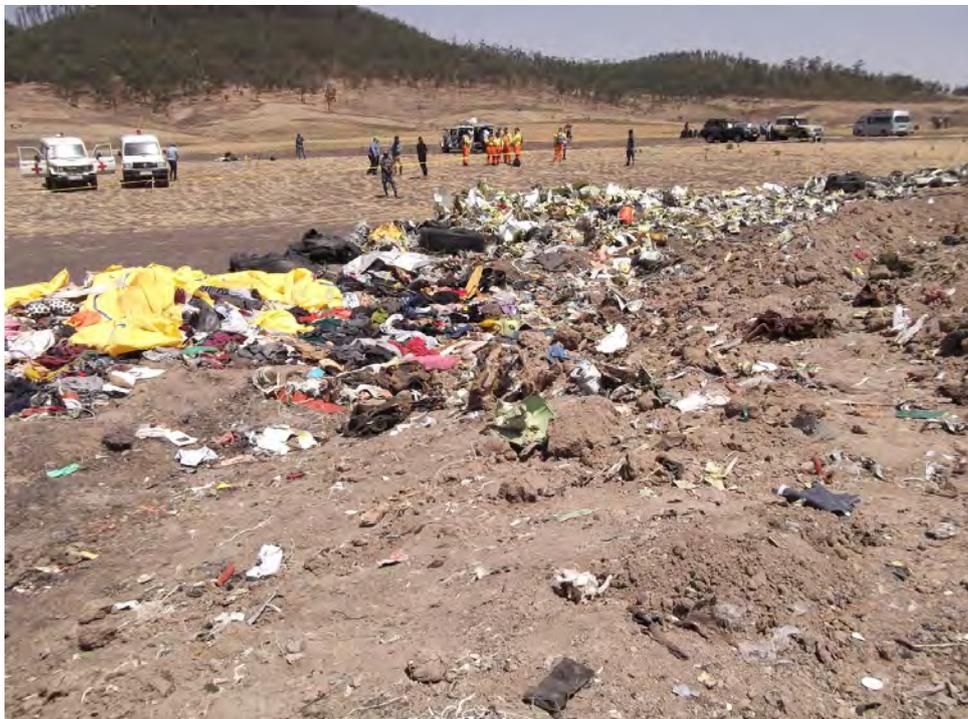
**Figure 4**

A recent example was the accident to the Boeing 737 Max in Ethiopia in 2019. The AAIB sent three inspectors to offer assistance. The team were allowed to visit the accident site to make notes and take photographs in accordance with the protocols. The team assisted the Ethiopian based UK diplomatic staff at the accident site. Information was also provided to the families and to the Coroner as the investigation progressed. Figure 4 shows this in practice and is a general view of the accident site in Ethiopia.

General view of the accident site in Ethiopia

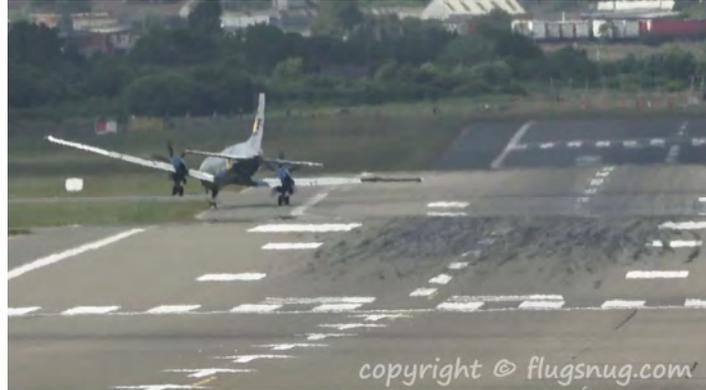
In windy conditions the crew of SE-MAO performed a go-around from their first approach to Runway 33 at Birmingham Airport. On the second approach the aircraft departed the runway to the left after touching down. The crew had not applied or maintained into-wind aileron during the landing or landing roll and, despite the application of full rudder, could not keep the aircraft on the runway. The aircraft was off the paved surface for approximately 450 m. There was no damage to the aircraft or the airfield, and the crew were uninjured.

SE-MAO leaves the paved surface

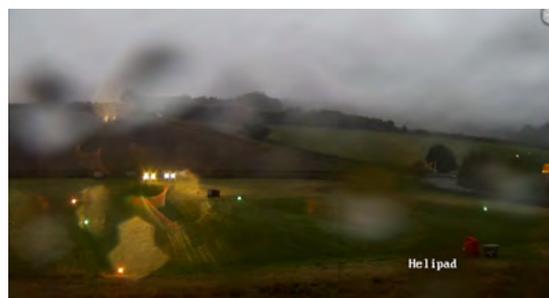
On an approach to a private landing site in conditions of reduced visibility shortly before night, the pilots became uncertain of their position and the helicopter descended to within 28 ft of rising terrain close to a house. During the subsequent emergency climb at low indicated airspeed, engine torque increased to 131% and the pitch attitude of the helicopter was unstable. The helicopter made another approach to the landing site and landed without damage or injury to the occupants.

View of LS to the West at 1720 hrs,  
10 minutes before departure from  
Birmingham  
(used with permission)

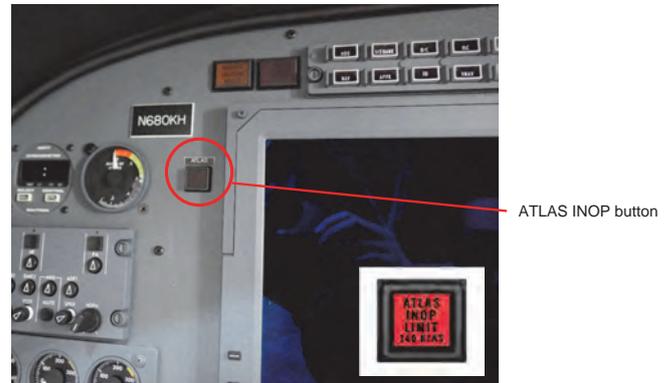
ATLAS INOP button in N680KH,  
inset representation of button when  
illuminated

The pilot was not aware of supplementary procedures associated with the modification. The procedures did not adequately characterise the significance of the system failure, nor address the failure in all anticipated flight conditions. Certification flight tests of the system did not reveal the severity of possible outcomes. The 'Aircraft Safety and Certification Reform Act 2020' underway in the USA will review existing assumptions on pilot recognition and response.

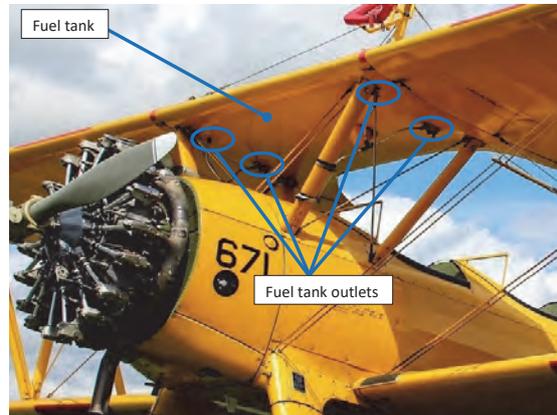
The investigation revealed inconsistencies in fuel planning assumptions, and it is likely that insufficient fuel reserves were onboard for the accident flight.

Fuel tank and fuel pipes from tank of G-CGPY  
(image used with permission)

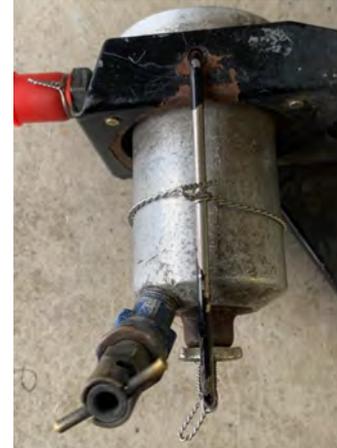
The loss of power resulted from the gascolator drain being inadvertently locked open leading to partial fuel starvation.

Gascolator and drain removed from G-BZDA after the accident

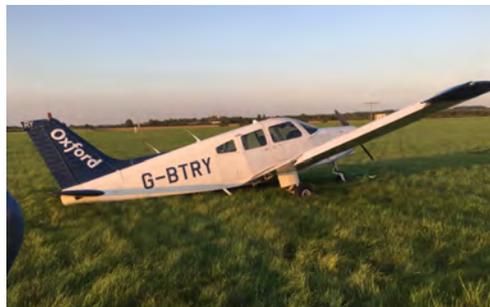
Whilst on final approach to land on Runway 26 at Enstone Airfield the pilot allowed the aircraft to descend too low and the aircraft struck a pile of gravel, causing the left main landing gear to detach from the aircraft. The pilot went around and diverted to Oxford Airport which had better fire and rescue services than Enstone Airfield. The aircraft departed the runway on landing at Oxford Airport, damaging the left wing and tailplane.

G-BTRY after landing at  
Oxford Airport

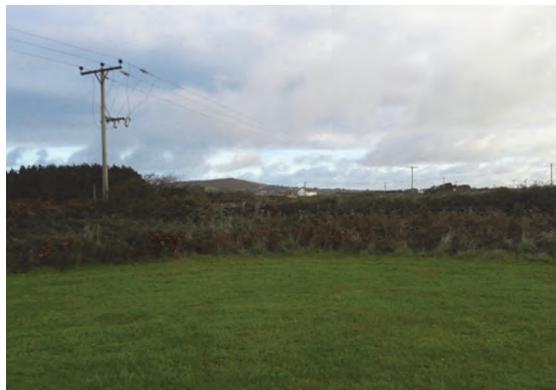
During the latter stages of a practice forced landing (PFL), the right landing gear wheel spat struck the perimeter fence of the airstrip. The aircraft turned sharply right and struck the ground, causing extensive damage. Both those on board were uninjured and were able to exit the aircraft unaided. Safety action was taken to stress the importance of going around should it appear that a PFL would be unsuccessful.

Power cables from approximately where the aircraft came to rest

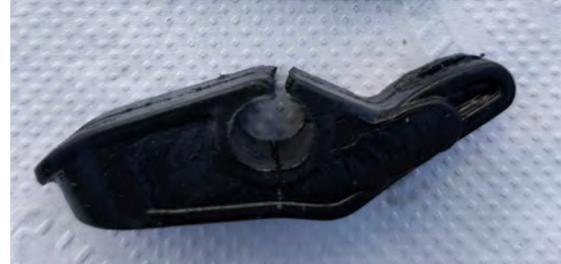
When approaching the airfield to rejoin the circuit, the aircraft's engine began to run rough then lost power completely. During the subsequent forced landing the aircraft came to rest inverted and the pilot sustained minor injuries. A post-accident inspection of the engine revealed a crack on the plastic rocker arm in the fuel pump.

Plastic fuel pump rocker arm

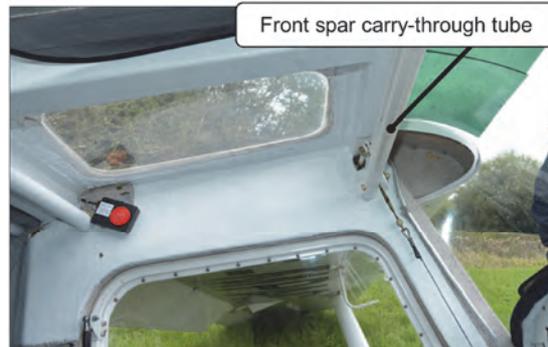
Front spar carry-through tube crossing behind G-MPAC's windscreen (image © Leicestershire Police)

The passenger was uninjured, but the pilot sustained severe injuries having struck his head on a metal bar running across the top of the cockpit. He put the severity of his injuries down to only having a 3-point harness and not bracing for impact. A post-accident field trial by the Light Aircraft Association showed that a slack shoulder strap would allow enough body movement for a seat occupant's head to strike the metal bar during a rapid deceleration.

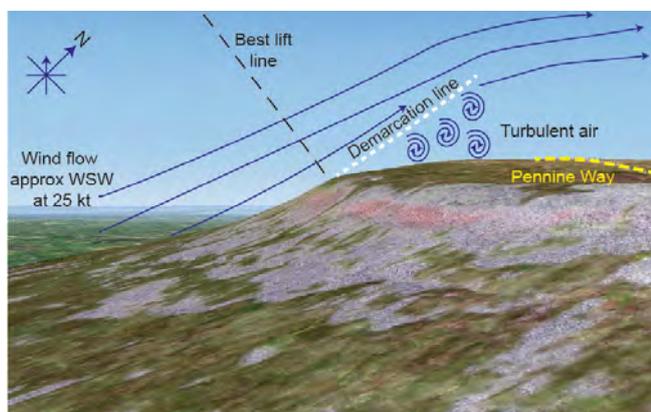
The 15 year old pilot, who was part of a private group visiting a gliding club near Penrith, was flying low behind the ridge at Cross Fell in the Pennines when the tail section of the glider began to oscillate rapidly before breaking away from the glider. The glider pitched nose down and was heavily disrupted when it struck the surface. The pilot was seriously injured. The cause of the failure was flutter, which was driven by the ruddervators and likely occurred when the glider was flying between the Rough Air speed limit and  $V_{NE}$ .

Likely effect of the wind on the summit of Cross Fell where the accident occurred

A number of safety actions have been taken to improve the supervision of young glider pilots, maintenance of training records and the introduction of a national syllabus for hill soaring (ridge flying).

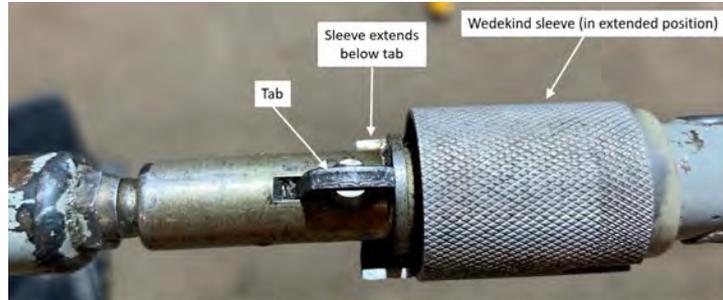
The right aileron L'Hotellier control connection in the fuselage became disconnected in flight, causing the pilot to abandon the glider by parachute. The control connection was equipped with a secondary Wedekind sleeve locking device, and the pilot had conducted a positive control check to his satisfaction prior to the accident flight. The investigation

L'Hotellier control connection with Wedekind sleeve correctly fitted (image courtesy of the BGA)

demonstrated that it is possible to partially assemble this type of control connection such that the connection is not secure, despite appearing to be so during a positive control check.

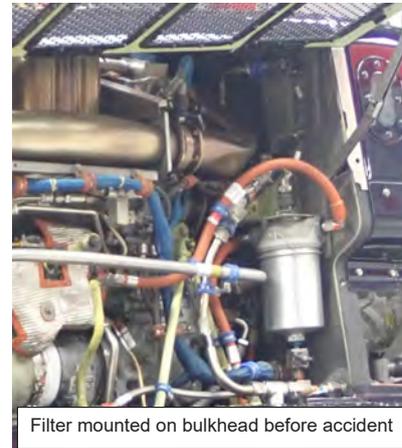
The investigation found that the engine suffered an uncontained failure of the gas producing turbine disc due to insufficient oil reaching the bearings as a result of an oil leak. Due to the extensive damage to the helicopter it was not possible to determine the cause of the oil leak.

Filter mounted on bulkhead before accident

Damage to airframe  
mounted fuel filter

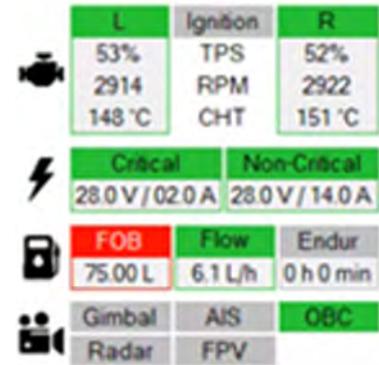
While orbiting south of the runway in preparation for landing, both the unmanned aircraft's engines shut down unexpectedly. The External Pilot on the ground, who was visual with the aircraft, took control and landed it without further incident. The dual engine shutdown was likely to have been caused by an on-aircraft data error. Various safety actions, including improvements to the aircraft's hardware and software, and the Ground Control Station software, have been taken to reduce the risk of a reoccurrence.

<b>L</b>	Ignition	<b>R</b>
	53%	TPS	52%
	2914	RPM	2922
	148 °C	CHT	151 °C

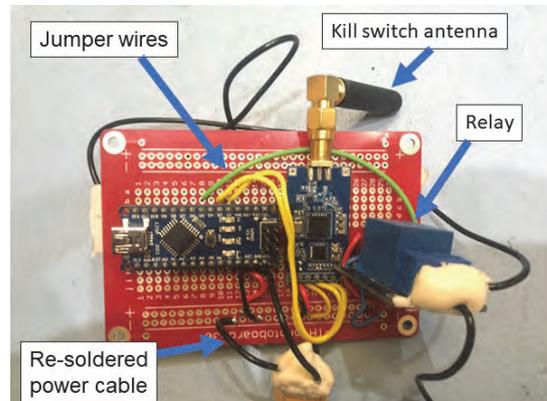
Whilst performing a demonstration flight, the remote pilot lost control of the 95 kg Alauda Airspeeder Mk II scale demonstrator. After the loss of control had been confirmed by the remote pilot, the safety 'kill switch' was operated but had no effect. The Unmanned Aircraft then climbed to approximately 8,000 ft, entering controlled airspace at a holding point for flights arriving at Gatwick Airport, before its battery depleted and it fell to the ground. It crashed in a field of crops approximately 40 m from occupied houses and 700 m outside of its designated operating area. There were no injuries.

Kill switch on-board circuit board

The AAIB found that the Alauda Airspeeder Mk II was not designed, built or tested to any recognisable standards and that its design and build quality were of a poor standard. The operator's Operating Safety Case contained several statements that were shown to be untrue.

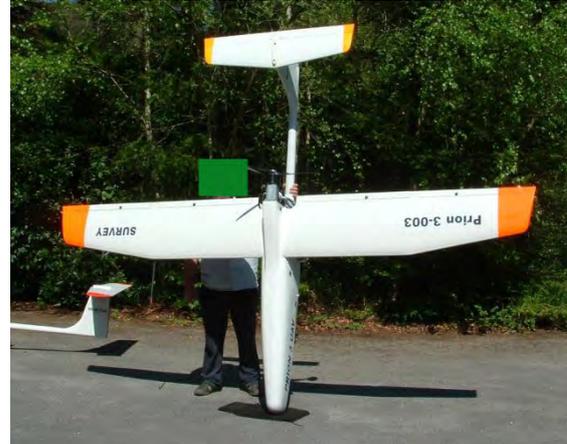
UAVE Prion Mk 3

During a training flight at a height of 400 ft agl the engine lost some power and the aircraft started to descend. The operator sent a command to limit the throttle but this did not resolve the issue. The autopilot was in a mode whereby the throttle was used to control airspeed and elevator used to control altitude. The loss of altitude caused the autopilot to pitch the unmanned aircraft nose-up until it stalled, entered a spin, and then hit the ground.

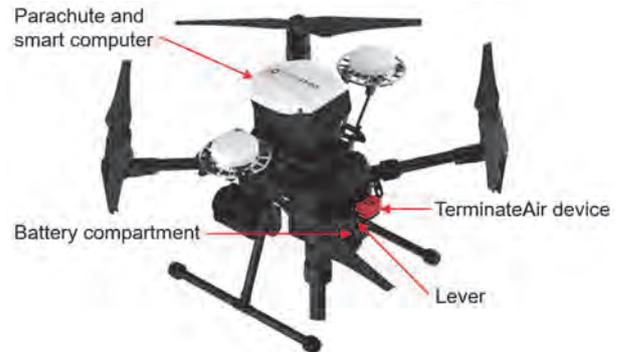
Parazero SafeAir M200 installed on a DJI Matrice 210 RTK unmanned aircraft  
(Source: Parazero)

The DJI Matrice 200 Unmanned Aircraft System (UAS) was being operated on an automated flight plan to conduct an aerial survey. On the fifth flight of the day, while the aircraft was at a height of 100 m, the ballistic parachute recovery system fitted to the aircraft activated. The aircraft descended under the parachute and was subsequently found on the roof of a nearby house.

The investigation was unable to establish the cause of the second accident. There were several warnings in the recorded aircraft's flight log, but analysis of this data did not provide any insight into why the flight was abruptly terminated. However, the parachute manufacturer considered that the second event involved a valid activation of the parachute system in response to a total aircraft power failure.

The parachute system manufacturer is aware of the log alignment issues between its system and the DJI Matrice 200 series of aircraft. As such, the latest parachute system that is being designed for the DJI Matrice 300 series aircraft will communicate directly with the aircraft to cut power to the motors, leaving power on the aircraft to continue logging data, and enable more accurate syncing of the aircraft and parachute system log files.
