**ACCIDENT**

<b>Aircraft Type and Registration:</b>	Piper PA-46-350P (Modified), G-HYZA	
<b>No &amp; Type of Engines:</b>	2 YASA electric motors (common shaft)	
<b>Year of Manufacture:</b>	1997 (Serial no: 4636130)	
<b>Date &amp; Time (UTC):</b>	29 April 2021 at 1425 hrs	
<b>Location:</b>	Near Cranfield Airport, Bedfordshire	
<b>Type of Flight:</b>	Other	
<b>Persons on Board:</b>	Crew - 2	Passengers - None
<b>Injuries:</b>	Crew - None	Passengers - N/A
<b>Nature of Damage:</b>	Left wing detached, landing gear collapsed and nose cowl distortion	
<b>Commander's Licence:</b>	Airline Transport Pilot's Licence	
<b>Commander's Age:</b>	63 years	
<b>Commander's Flying Experience:</b>	34,620 hours (of which 1,588 were on the basic type, 12 were on the modified electric variant) Last 90 days - 59 hours Last 28 days - 19 hours	
<b>Information Source:</b>	AAIB Field Investigation

**Synopsis**

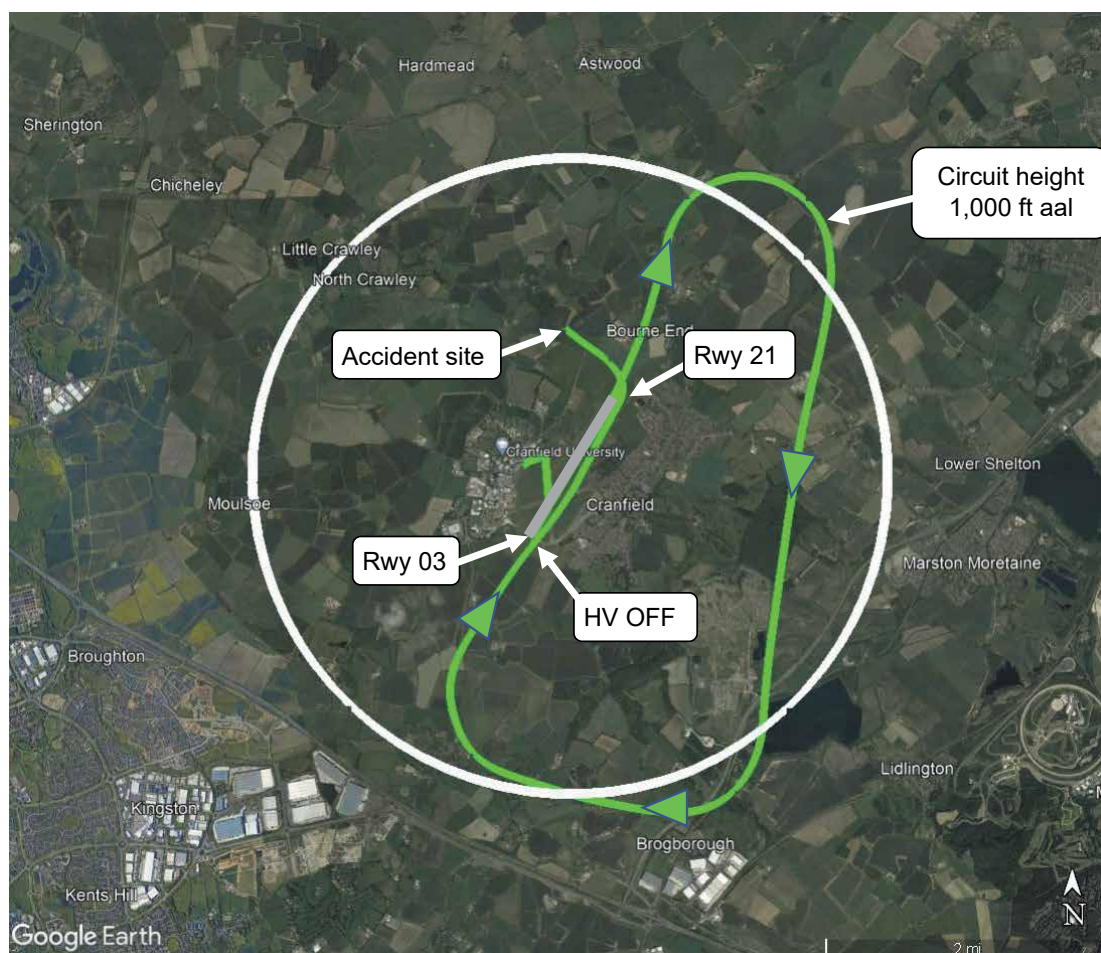
**Figure 1**

G-HYZA track overview (green).  
White circle depicts 2 nm boundary of the flight test area

After takeoff, the aircraft achieved an average vertical speed of approximately 425 ft/min. Circuit altitude of 1,300 ft amsl (approximately 1,000 ft aal<sup>12</sup>) was achieved just under three minutes after takeoff at the start of the downwind leg. Airspeed data was not recorded but the ASI could be read using the cockpit video recording. During the crosswind leg, the aircraft track extended beyond the 2 nm boundary (see Figure 1).

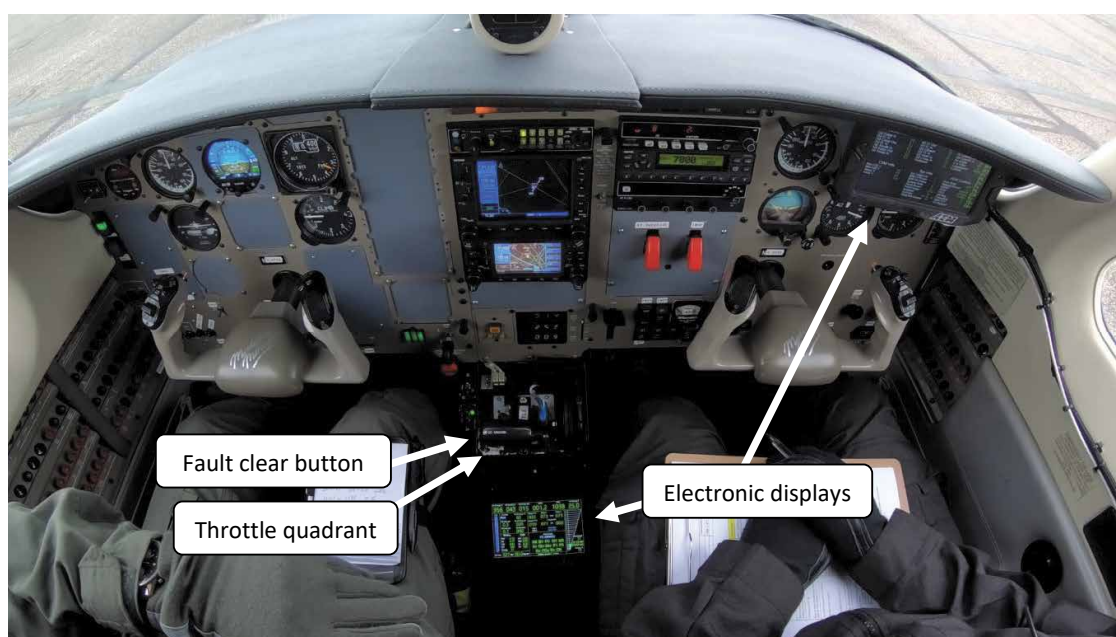
**Figure 4**

Two display screens were fitted to show the power plant and motor parameters, one was located on the cockpit centre console next to the pilot, and the other on the right side of the cockpit next to the observer's seat (Figure 4). The pilot used the display below the throttle quadrant to adjust power and rpm settings throughout the flight. Of note, when the pilot's hand adjusted the power, it could obscure this display.

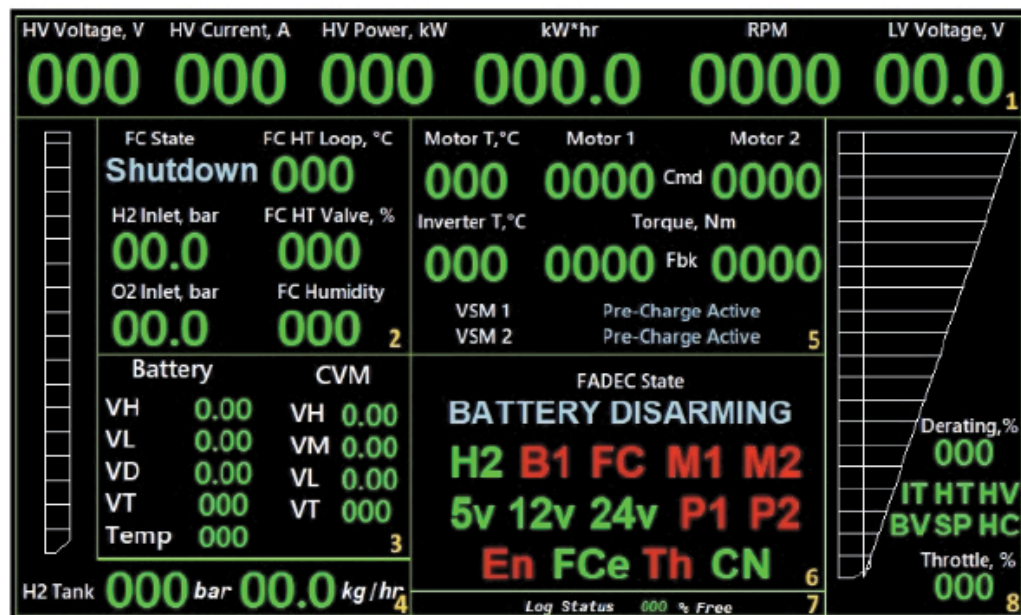
Figure 5

The pilot's display had a viewable area of 175 mm x 110 mm. It showed 28 parameters and 24 status, caution or warning captions in a variety of font sizes down to 4.5 mm (Figure 5).

The certification basis<sup>8</sup> of the PA-46 contains requirements for the design of electronic displays that represent good practice within aviation. As an E Conditions aircraft, G-HYZA was not required to comply with these standards; however, CAP1220 refers to guidance in CAP659<sup>9</sup> 'A guide to Approval, Construction and Operation of Amateur Built Aircraft'. To assist those undertaking projects, Appendix 1 of this document sets out the design criteria for different types and weights of aircraft. The weight of G-HYZA would place it under Certification Standard (CS) 23, which includes a section on instruments and displays.
