Fatal man overboard from the single-handed creel fishing vessel, *Saint Peter* (LH22) east of Torness Point, Scotland on 2 May 2021

SUMMARY

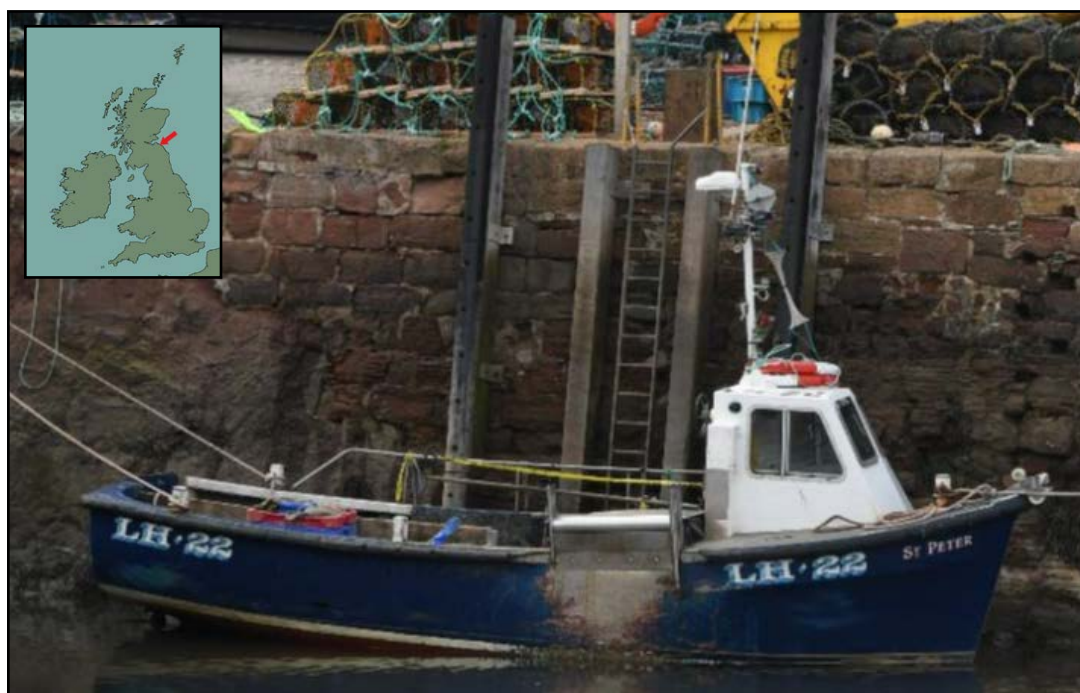
Figure 1: *Saint Peter*

On the morning of 2 May 2021, the owner/skipper (the skipper) of the single-handed creel fishing vessel, *Saint Peter*, also known as *St. Peter* (Figure 1), was shooting creels in the North Sea, 1.2 nautical miles (nm) east of Torness Point, Scotland. At about 0830, the skipper accidentally entered the water, probably as a result of being caught in the back rope while shooting, and was kept afloat by a personal flotation device (PFD). There was no easy means for the skipper to reboard *Saint Peter* and he had no equipment to send a distress signal from the water; his body was recovered later that afternoon by a coastguard helicopter.

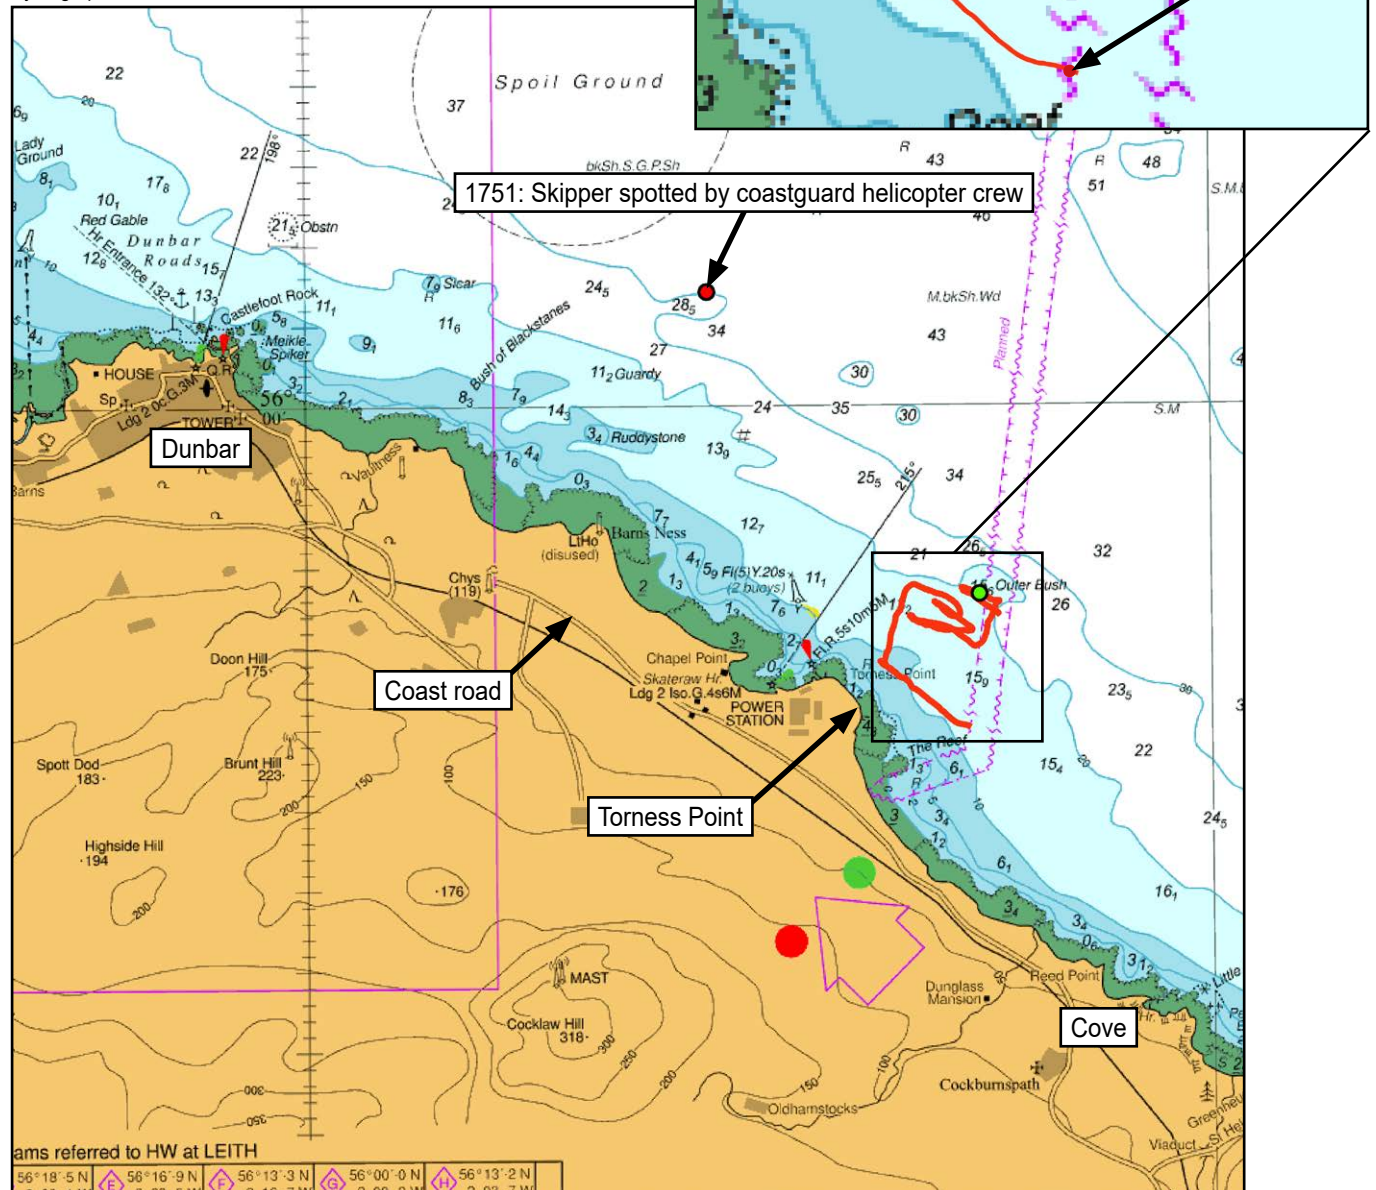
Figure 2: Location of the accident on 2 May 2021 and (inset) track of *Saint Peter* taken from chart plotter

At about 0800, crew working on a nearby fishing vessel observed the skipper working on *Saint Peter's* aft deck at an estimated position 2nm north of Torness Point (**Figure 2**). At 0820, *Saint Peter's* chart plotter recorded the vessel travelling at 5.7kts, 1.2nm north-east of Torness Point, then slowing to 0.8kts, before briefly increasing speed to 3.7kts. At 0830, the vessel stopped (**Figure 2**).

At 1751, the crew of the coastguard helicopter spotted *Saint Peter's* skipper, floating on his back and wearing a fully inflated PFD, about 3nm north of Torness power station (**Figure 2**). The winchman recovered the skipper to the helicopter and its crew cut away his PFD so that emergency first aid could be carried out during the flight to the Royal Infirmary of Edinburgh, but the skipper was unresponsive. At the same time, the ALB crew returned to *Saint Peter*, cut away the anchor line and towed the vessel to Dunbar.
