Report on the investigation of  
the foundering of the whelk potter

***Nicola Faith (BS58)***

resulting in three fatalities  
in Colwyn Bay, North Wales

REPORT NO 8/2022

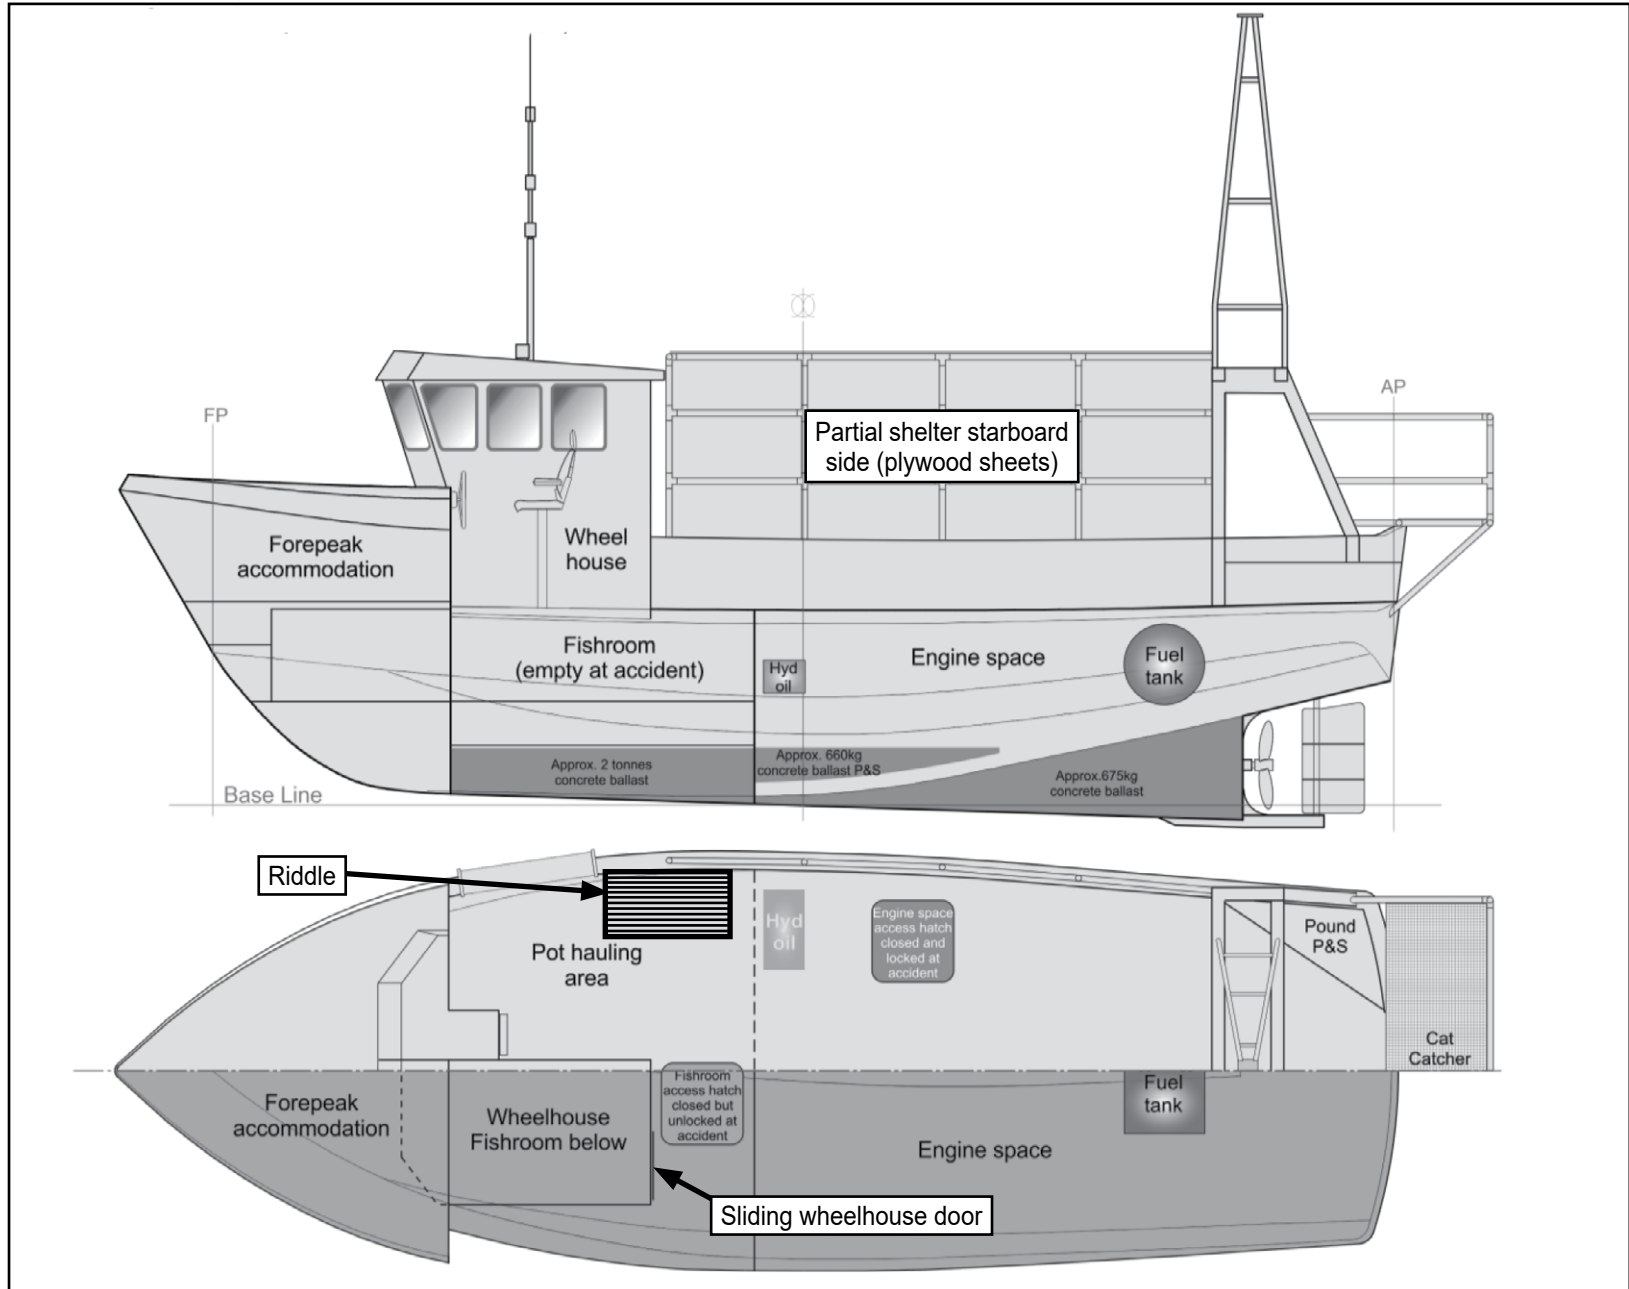
Figure 17: Naval architect's drawing of *Nicola Faith*

Before the modifications, when the original wheelhouse door on the centreline of *Nicola Faith* was in use, down-flooding into *Nicola Faith's* forward spaces would occur at a 90° angle of heel or list. The minimum down-flooding angle when heeled to port reduced to 29° when the new plastic sliding door was fitted in the aft bulkhead of the wheelhouse (**Figure 17**).
