AAIB Bulletin

7/2022

Published 14 July 2022

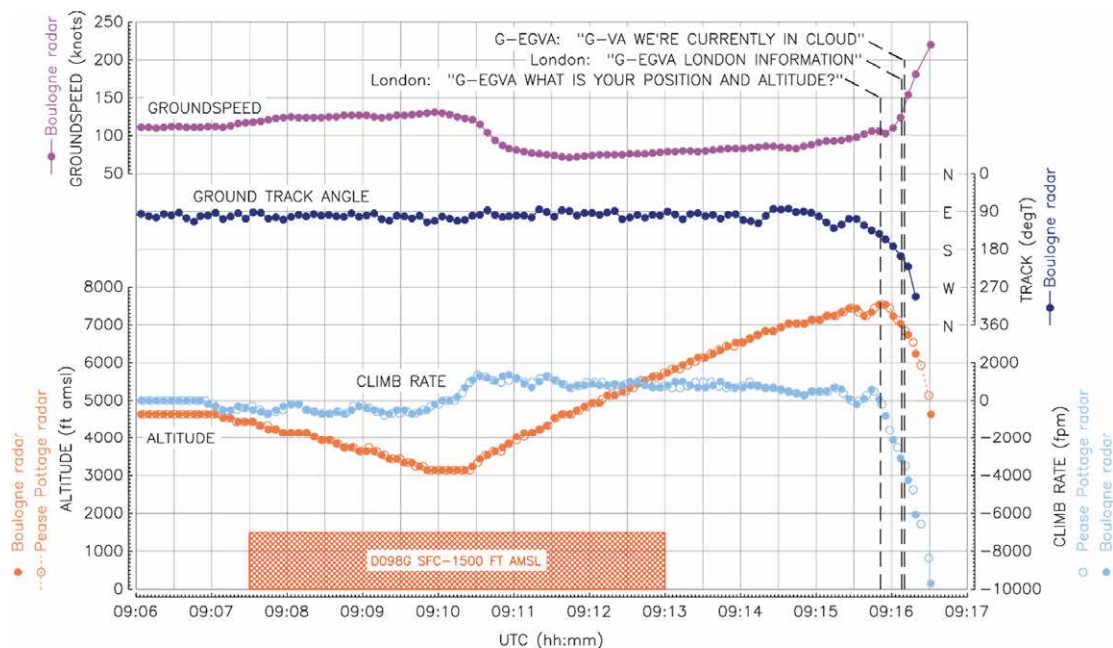
Figure 8 is a plot of the altitude and radar-derived data for G-EGVA starting just before the descent from the cruise altitude. The plot shows that the aircraft descended to about 3,000 ft at approximately 500 fpm, where it remained for 30 seconds before climbing to over 7,000 ft at about 1,000 fpm, while maintaining an easterly track. Over the next 50 seconds the aircraft climbed 400 ft, descended 200 ft, and then climbed 300 ft, and at the same time

turned right, left, and right again through a total of 50°. The aircraft then continued to turn to the right in a descent. Radar contact was lost 40 seconds later as the aircraft descended through 4,600 ft with a calculated descent rate of just under 10,000 fpm. The last recorded position was 50°34'23.49" N 001°04'11.23" E at 0916:31 hrs.

Figure 8 also shows when the last radio transmissions between London Information and G-EGVA were made. G-EGVA was descending through 7,000 ft at about 3,000 fpm and accelerating during its final transmission.

Altitude and radar-derived data for G-EGVA

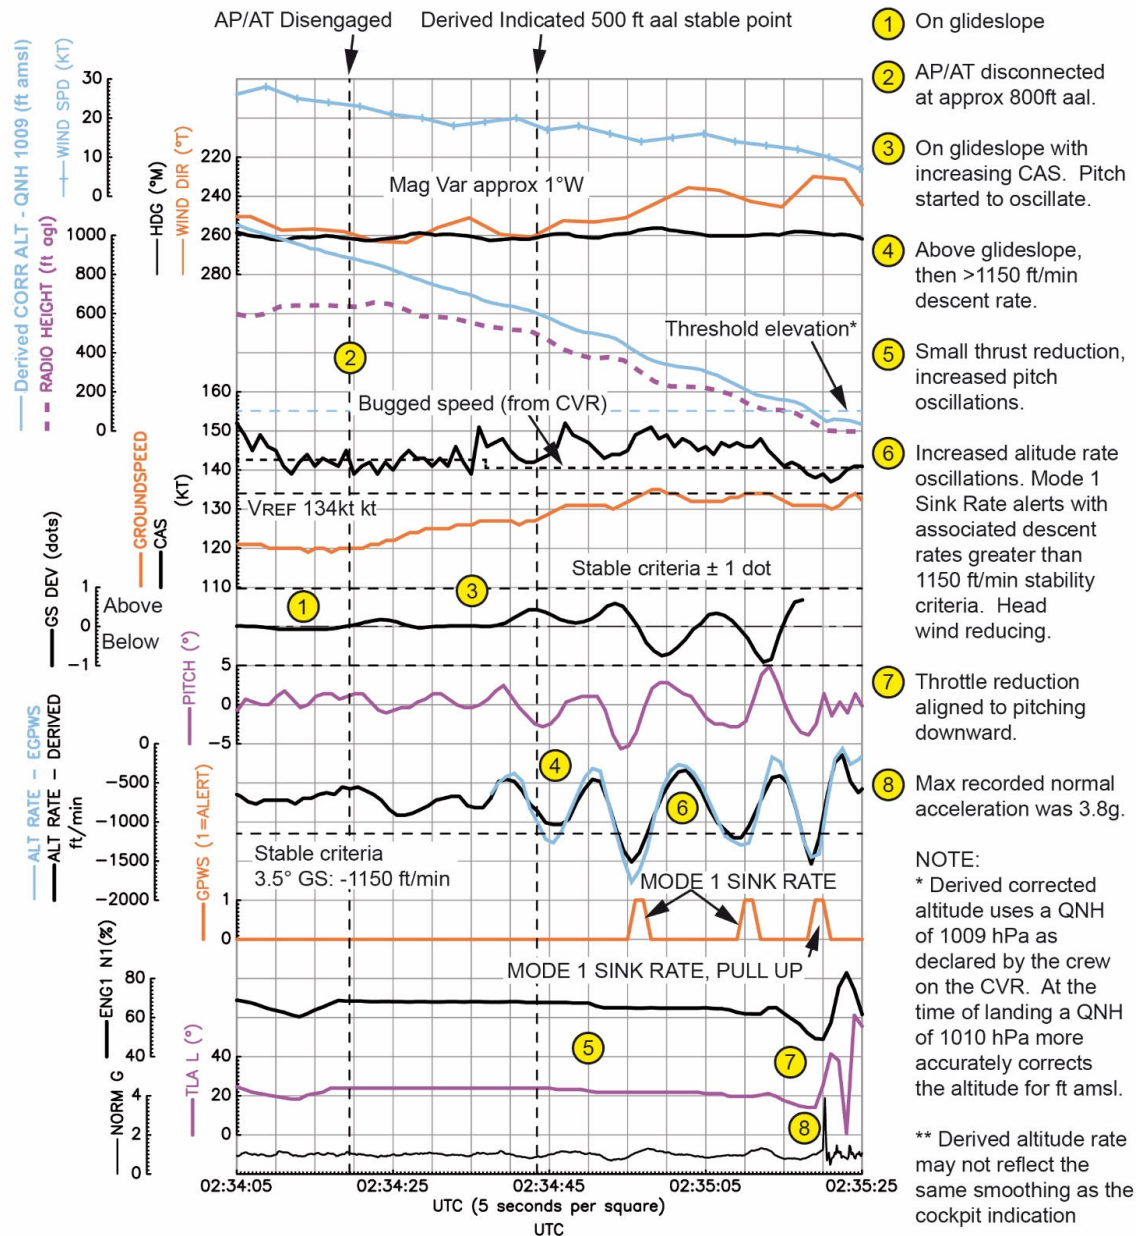
Figure 4

The data indicates that the aircraft did not stall. The maximum vertical acceleration recorded by the FDR on touchdown was 3.8g, at this point there was 3° of left roll. However, FDR sample rates and sensor locations are not ideally placed to determine peak forces on touch down. Altitude rate parameters are smoothed and so lag the aircraft dynamic behaviour. The descent rate values were decreasing on touchdown, but more detailed aircraft modelling was required to better understand the descent rate at touchdown. The airframe manufacturer assessment of the data indicates a calculated descent rate of approximately 24 ft/second. This is consistent with the trends of the combined recordings of the left and right radio heights.

After landing, the aircraft maintained a left roll attitude taxiing to the stand, varying between 1.5° and 4.5°. The right trailing edge flap angle had reduced from 40° to 37° on landing, but later in the landing roll this returned to 40°, matching the recorded left flap angle again. The master caution was triggered as the groundspeed reduced through approximately 20 kt. The FDR recorded low pressure states for the hydraulic A and B systems associated with engine 1 and 2 respectively and hydraulic B electrical systems during the taxi to stand.

Pertinent parameters from the FDR and TAWS recordings

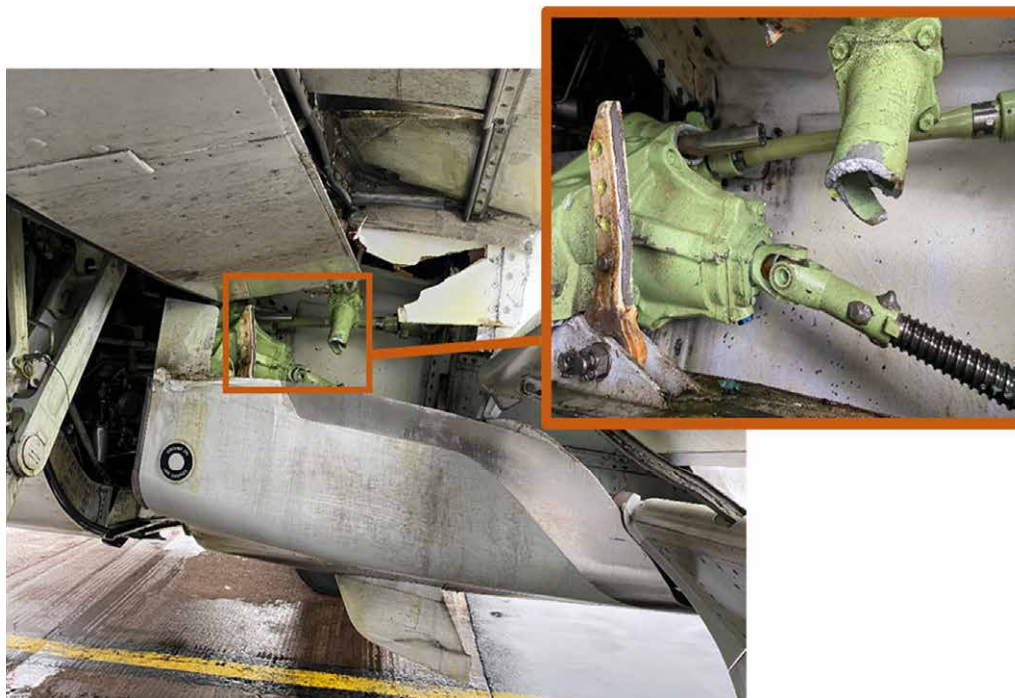
Figure 7

There was no obvious tyre damage and the main landing gear drag strut bolts were intact. The engine cowlings were undamaged, so it was apparent that the engines had not touched the runway during the landing. The flap drive mechanism was damaged, and the left-wing inboard driveshaft was bent; the left inboard gearbox casing and its mountings were broken (Figure 7).

View looking inboard under the left-wing. Broken flap gearbox is highlighted

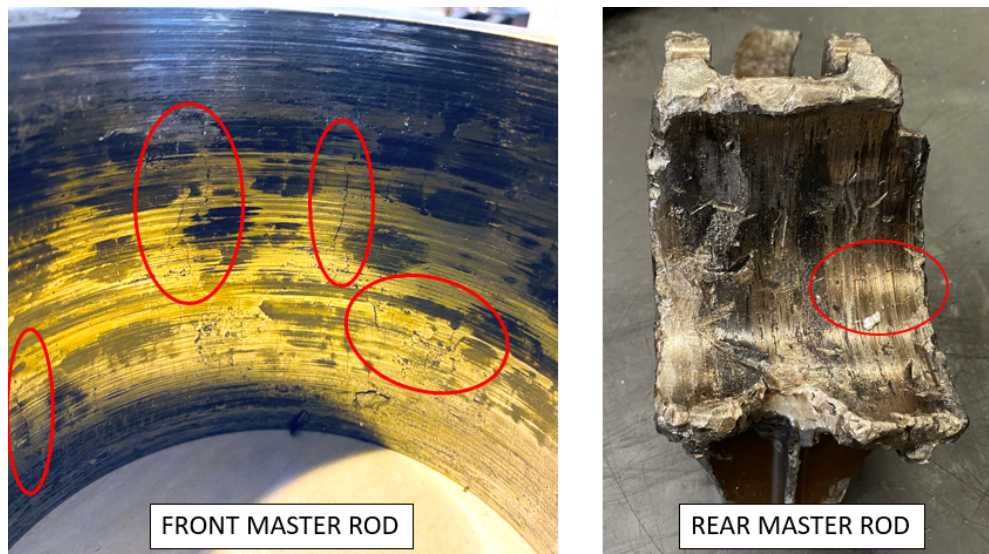
**Figure 10**

The fractured sections of the master rod big end showed evidence of overheating and a large number of cracks were present on the face of the master rod big end bore (Figure 10). The front master rod bore exhibited similar cracking. Examination of the cracks in the rear master rod bore showed that they were intergranular, following grain boundaries, and were coated with tin. Metallurgical assessment of the cracks noted that they were likely caused by liquid metal embrittlement (LME) of the master rod steel material with molten tin from the crankpin sleeve bearing. Three conditions are required for rapid crack propagation in steel due to LME with tin; the steel must be in a state of tension, with the steel surface free of oxidation and the liquid tin must intimately wet the steel surface. All three conditions were present in the master rod big end bores during the engine failure.

Cracks (circled) in the front and rear master rod big end bores

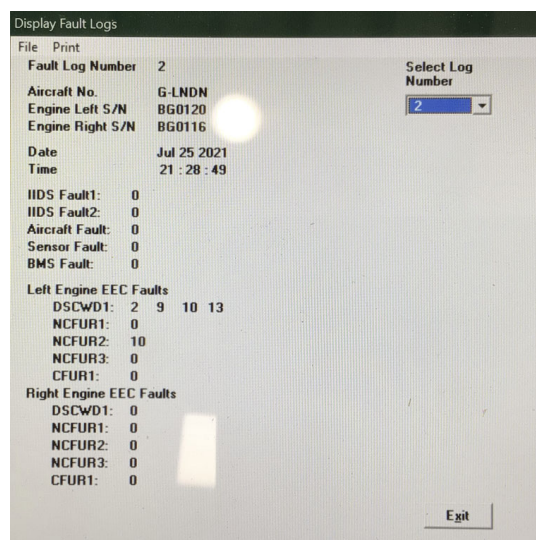
The helicopter's IIDS was interrogated on the aircraft and subsequently downloaded. A fault message (Figure 6) relating to a loss of digital communications between the left and right EECs was recorded at 2028:49 hrs UTC (2128:49 hrs local time is displayed on the IIDS), which correlated with the pilots' account of when they had been alerted to the EEC system faults. Further information on this fault is included in the aircraft information section.

Figure 6
IIDS recorded fault message

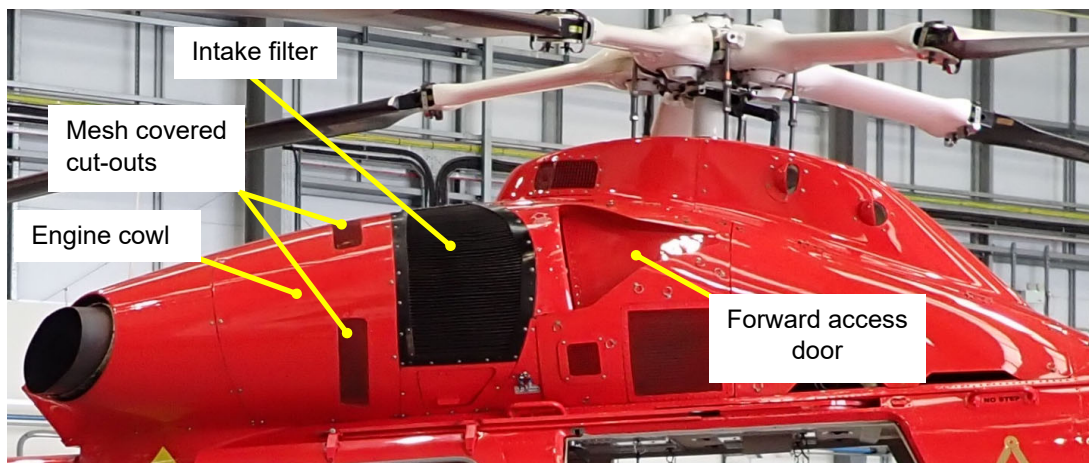
Figure 8

Right engine access doors and cowling

G-LNDN had been parked on the helipad at the RLH at the time of heavy rainfall. During this time rainwater entered the right engine bay through the mesh covered cut outs in the engine cowling. The rainwater had then flushed debris in the engine bay toward the rear drain hole, which then partially blocked. Either because of the partial blockage of the drain hole, or through sheer volume of water overwhelming the drains in the engine bay, it started to fill. As the water level reached the igniter lead through-holes, water was able to pass into the rear baggage compartment because inadequate sealing round the igniter leads, which had been applied whilst it was operated by its previous owner, did not prevent water ingress.

Had engine area or upper deck covers been used to protect the engine bays during the heavy rainfall, the pathway for the rainwater to enter the engine bay would have been blocked. The operator explored the feasibility of using engine cowl covers in addition to the tie downs and engine blanks already required, but this was considered detrimental to the operation of the helicopter when considering its three-minute launch target in its role as an air ambulance. The operator also identified risks of causing damage to the aircraft's antenna and creating possible foreign object debris (FOD) whilst removing the covers that protect the upper surfaces of the fuselage.

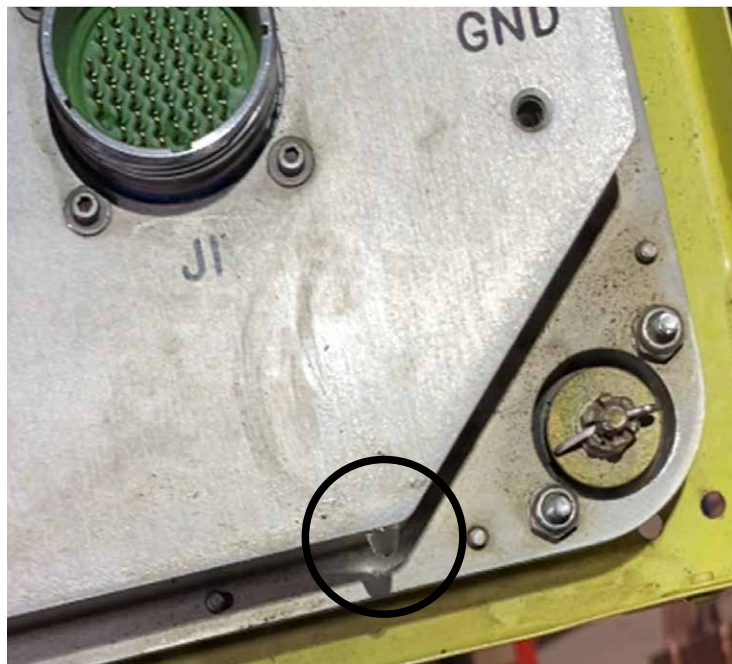
Figure 12

The right EEC, which is positioned inboard of the Symbol Generator, showed evidence of having been in contact with water. The unit is mounted horizontally in the helicopter and accessed by removing the rear mounts and then lowering it, hinging around the forward mounts. As the unit was lowered, water was seen dripping from the ambient pressure tapping on the rear of the unit (Figure 12). Water was also found accumulated within the JI connector when it was disconnected.

Right engine EEC showing water dripping from ambient pressure tapping

Assessment of the right EEC and its DCU found that, even after drying, the EEC would not power up. The DCU download did not show any information about the EEC failure but did record engine control being moved into manual. There were no further events logged on the DCU. It was considered most likely that exposure to water caused a short circuit on the power board causing the EEC to fail permanently.

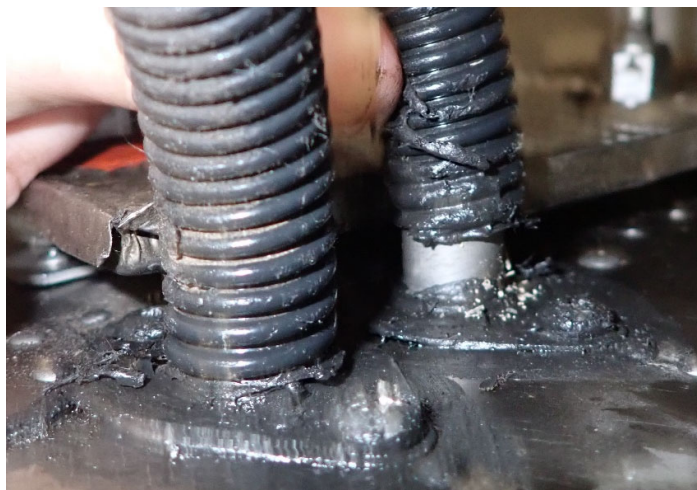
Figure 14

The amount of sealant around the right engine igniter cables as they passed through the deck was minimal. The outer sheaths between the deck and the engine could be moved away from the deck with little force (Figure 14). A liquid solvent degreaser was sprayed on the area where the igniter cable passed through the deck. A stream of solvent was immediately observed flowing into the rear baggage compartment from around the igniter cables. This fluid flowed directly onto the right EEC. A similar assessment of the left engine igniter cables was carried out. This found that the sealant was well applied around the igniter leads and no leaks were observed when solvent was sprayed at the interface. As the right engine had not been removed whilst it had been in operation in the UK, the sealant around the igniter leads is likely to have been applied when it was being operated by its previous operator.

Right engine igniter cable sheath easily moved away from deck

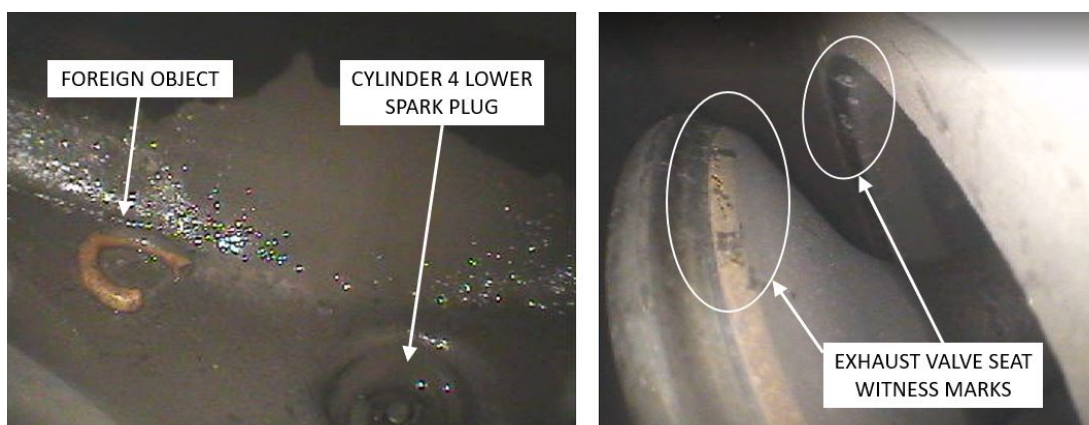
Figure 7

The engine basic compression test was repeated once the aircraft wreckage was recovered to the AAIB, but this time a normal degree of compression was noted on all four cylinders. Borescope inspection of cylinder No 4 revealed that a C-shaped foreign object was present in the cylinder (Figure 7). Witness marks were present on the exhaust valve seat faces caused by contact of a hard foreign object, which would have prevented the exhaust valve from closing correctly. It was considered likely that the C-shaped foreign object had been trapped beneath the exhaust valve when the engine was examined at the accident site, but that it had come loose during transportation to the AAIB.

Borescope images inside cylinder No 4

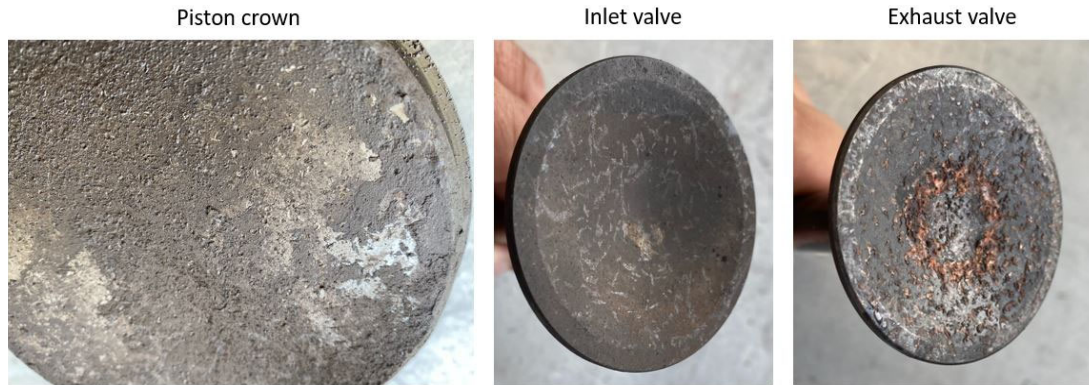
Figure 8

The No 4 cylinder was removed from the engine and the piston crown, inlet and exhaust valve surfaces were examined. Numerous hard-body impact marks were present on the piston crown, and the faces of the inlet and exhaust valves also showed impact marks where combustion residues had been removed from the valve faces (Figure 8). No such impact marks or foreign objects were observed in Nos 1, 2 or 3 cylinders.

Impact marks on cylinder No 4 piston crown, inlet and exhaust valves

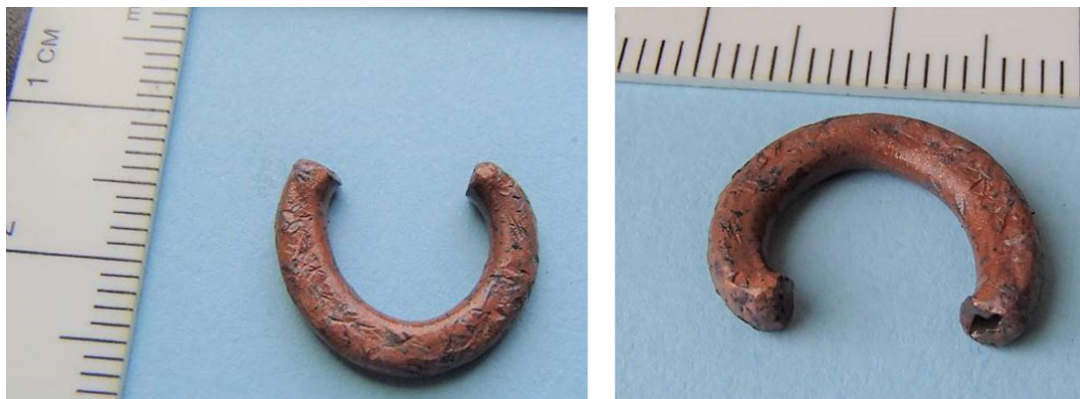
Figure 9

The aircraft's exhaust muffler was cut open, but no additional foreign objects were identified within. The C-shaped foreign object was of tubular cross section which had been flattened due to impacts on the tube's outer diameter (Figure 9).

Foreign object recovered from No 4 cylinder

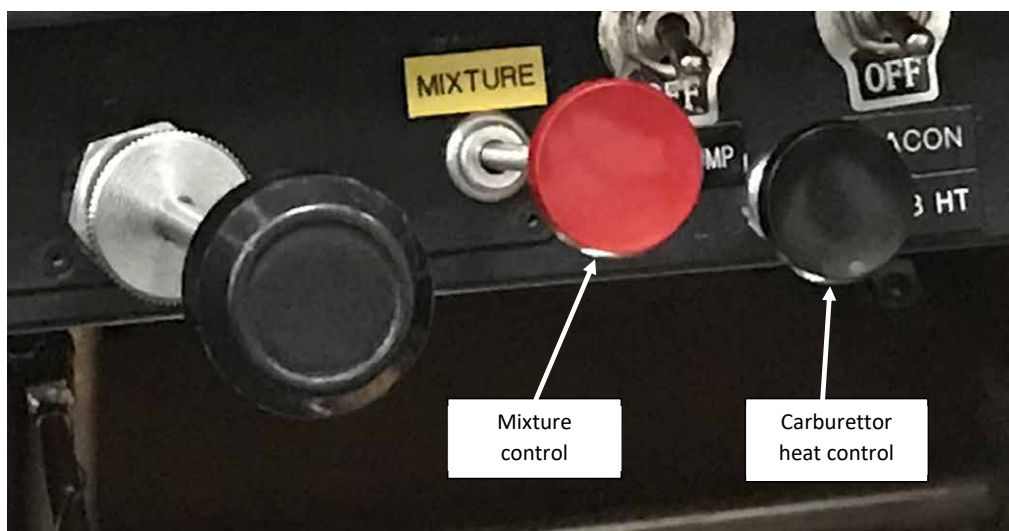
Figure 3

The aircraft engine mixture control was a pull/push lever with a red round knob fitted on the end. This mixture control was the same shape and had very similar dimensions as the engine carburettor heat control lever which was fitted next to it. The only difference between the two levers was the colour of the knob fitted to the end. The controls are shown in Figure 3.

Cockpit controls (used with permission)

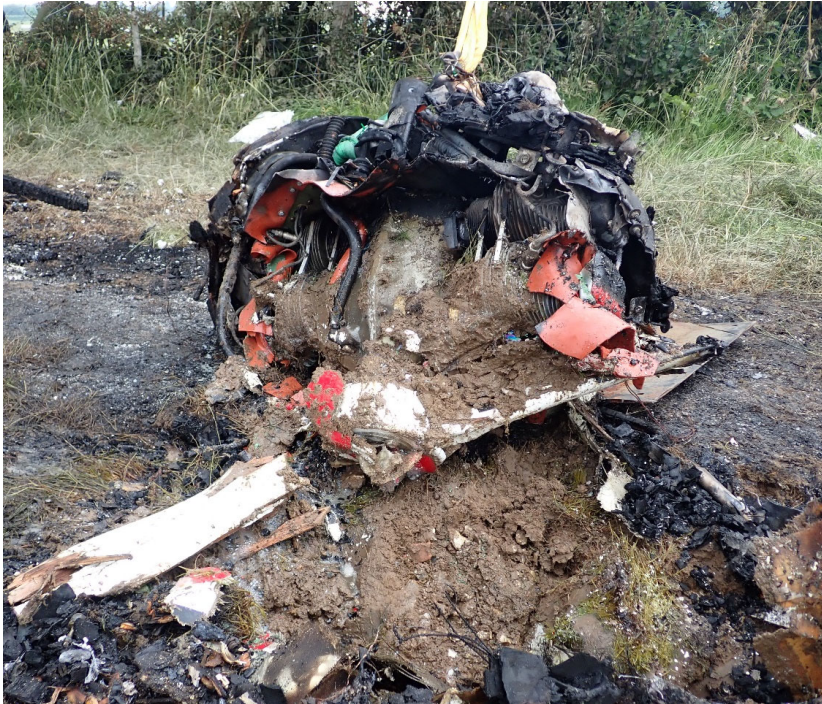
Figure 5

The engine, whilst having suffered some impact damage was relatively intact. The carburettor had been almost completely sheared off its attachment and the fuel inlet hose connector had been destroyed by the impact. The propeller had been fragmented on impact, but the propeller hub and part of the blade were still connected to the engine (Figure 5).

Engine recovered at accident site

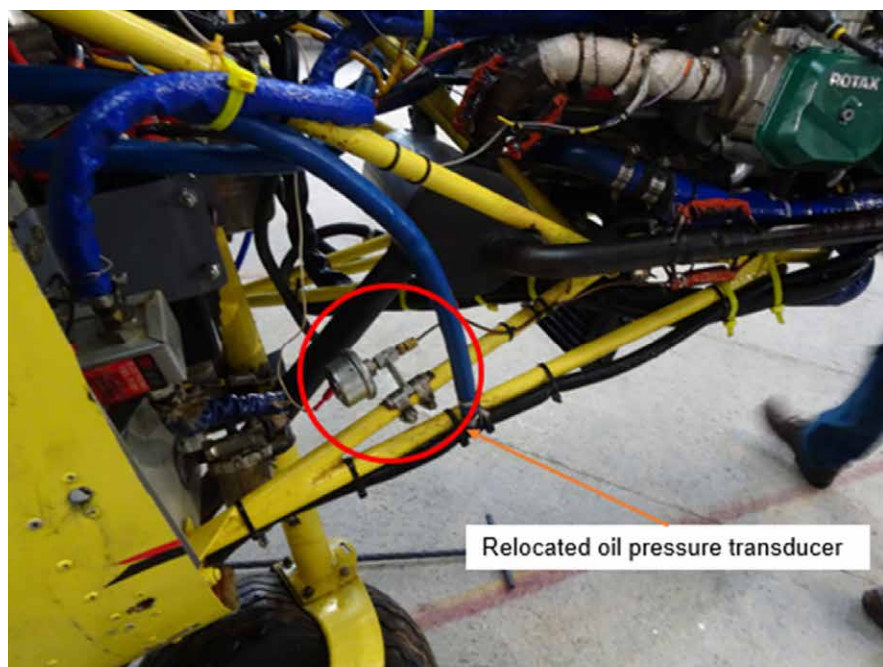
Figure 1

Inspection of the engine found that a brass pipe connecting the oil pressure transducer to the engine had failed causing loss of oil from the engine. Normally the oil pressure transducer is mounted directly on to the front right hand side of the crankcase. At some point in the aircraft's history the oil pressure transducer had been relocated from the standard position to the engine frame (Figure 1).

Image showing relocated position of the oil pressure transducer
