**ACCIDENT**

<b>Aircraft Type and Registration:</b>	Rotorway Executive 162F, G-JDHN	
<b>No &amp; Type of Engines:</b>	1 Rotorway RI 162F piston engine	
<b>Year of Manufacture:</b>	1998 (Serial no: 6324)	
<b>Date &amp; Time (UTC):</b>	2 April 2021 at 1500 hrs	
<b>Location:</b>	Near Ledbury, Herefordshire	
<b>Type of Flight:</b>	Private	
<b>Persons on Board:</b>	Crew - 1	Passengers - 1
<b>Injuries:</b>	Crew - 1 (Minor)	Passengers - 1 (Minor)
<b>Nature of Damage:</b>	Helicopter damaged beyond repair	
<b>Commander's Licence:</b>	Private Pilot's Licence	
<b>Commander's Age:</b>	54 years	
<b>Commander's Flying Experience:</b>	Approximately 300 hours (of which 80 were on type) Last 90 days - not declared Last 28 days - not declared	
<b>Information Source:</b>	AAIB Field Investigation

**Synopsis**

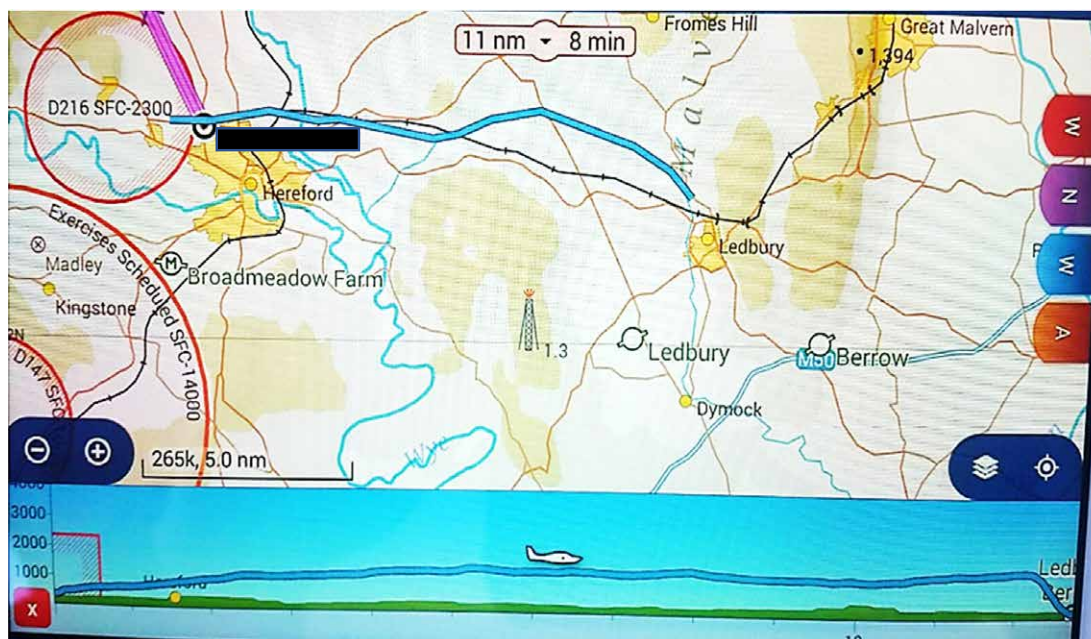
**Figure 1**

G-JDHN's recorded track from SkyDemon application  
(used with permission)

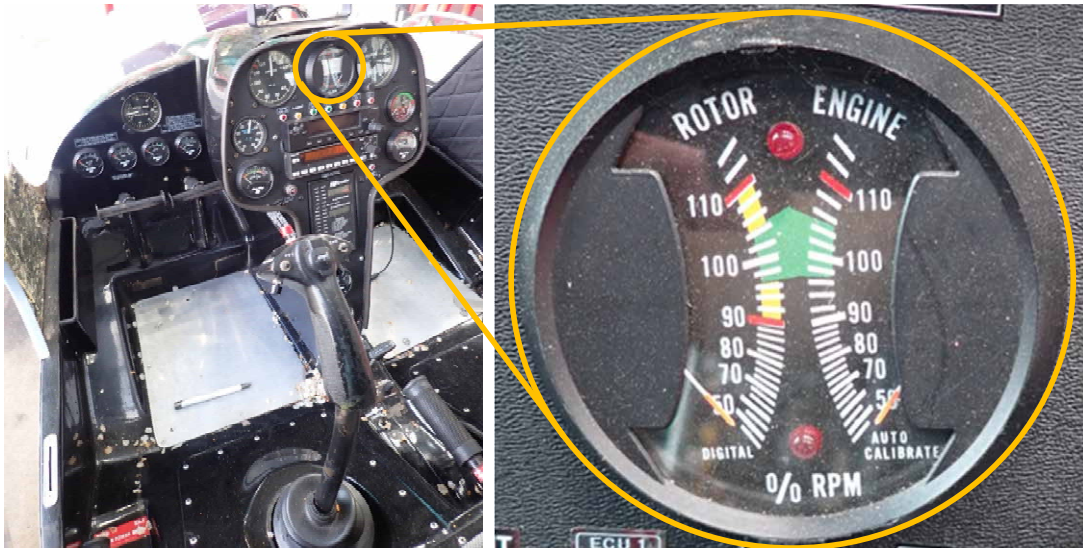
**Figure 4**

G-JDHN cockpit layout (left) and rotor / engine combined rpm gauge (right)

The throttle is operated by a twist grip on the collective lever to the left of the pilot's seat. There is no mechanical or electronic automated control of the throttle when moving the collective lever and so the pilot must manually account for any collective movements with a change in throttle position to maintain the engine speed in the green arc.

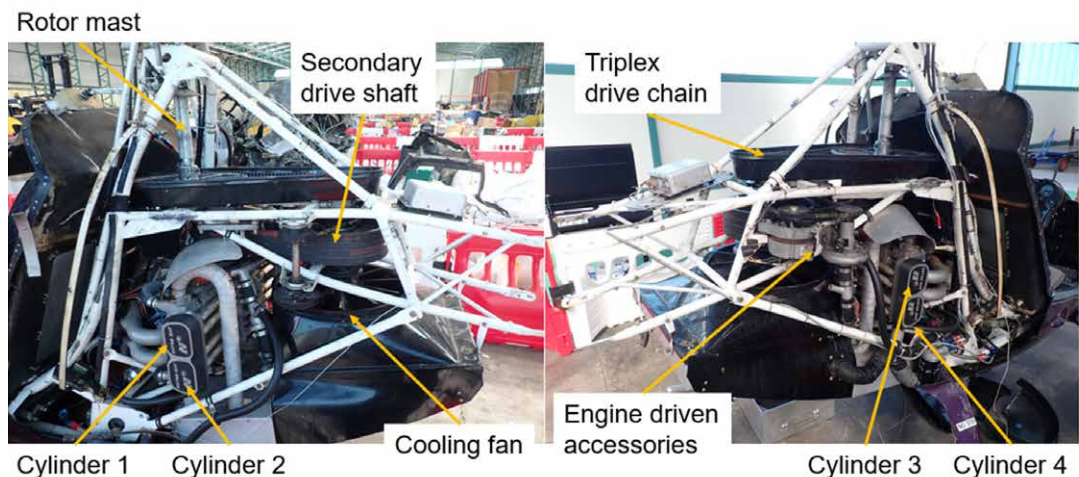
**Figure 5**

The flat-four engine (Figure 5) was designed and built specifically for the 162F helicopter and is installed with the crank shaft oriented vertically. The engine has two valves per cylinder and is water cooled. Fuel metering and timing is controlled by a primary DECU which uses various sensors to ensure optimal running. A secondary DECU, using pre-programmed default values instead of sensor data, is installed in case of a failure of the primary DECU. The drive from the crankshaft is transferred to a secondary drive shaft by four V belts in parallel, with a movable spring-loaded third pulley wheel which is operated as a clutch during start up. The pulley wheel tensions the drive belts by an over centre linkage operated by the pilot pushing on a steel T-handle lever in the cabin bulkhead (Figure 6). Drive to the main rotor head from the secondary shaft is via a triplex drive chain whilst external engine accessories, such as alternator, cooling fan and water pump, are driven from separate V belts. The exhaust pipe from the four cylinders has a single silencer and tail pipe suspended beneath the tail boom.

G-JDHN engine layout. Helicopter left side (left) and right side (right)

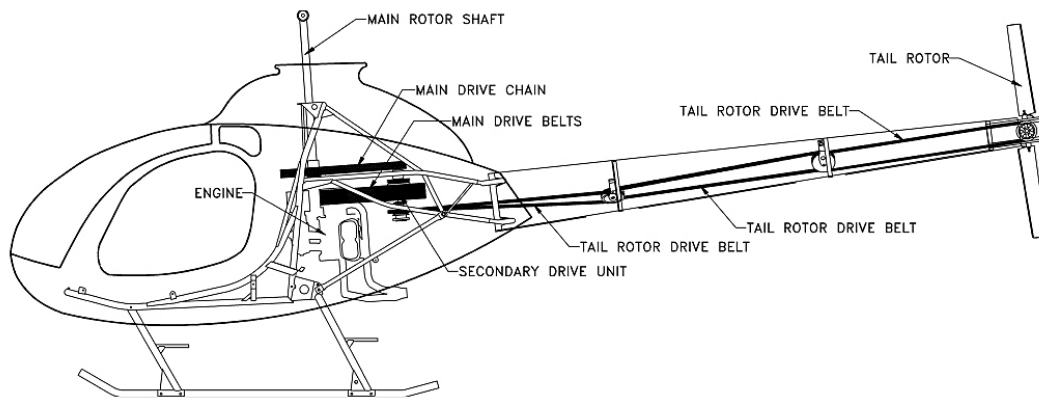
**Figure 7**

Drive to the tail rotor is via three V drive belts in series from the secondary drive shaft (Figure 7). The secondary drive shaft is vertical, but the tail rotor drive shaft is horizontal, so there are two intermediate pulleys aligned 30° from the previous pulley thereby rotating the drive. All three belts in the system are tensioned by adjusting the position of the last pulley, and the belt tension is checked by the pilot as part of the pre-flight inspection using a special tool to verify 1 3/8" deflection with 10 lb of force applied.

The tail drive belts on G-JDHN were replaced during annual maintenance in February 2020, and they were inspected and had their tension checked in February 2021 with no defects found. The belts had accumulated 43.8 hours of operation by the time of the accident flight, well within the replacement requirement of 250 hours or two years.

G-JDHN Rotor drive system
