Rail Accident Report

**Near miss between a rail grinding train and
an empty passenger train at Sileby Junction,
Leicestershire
5 May 2021**

Report 06/2022
July 2022

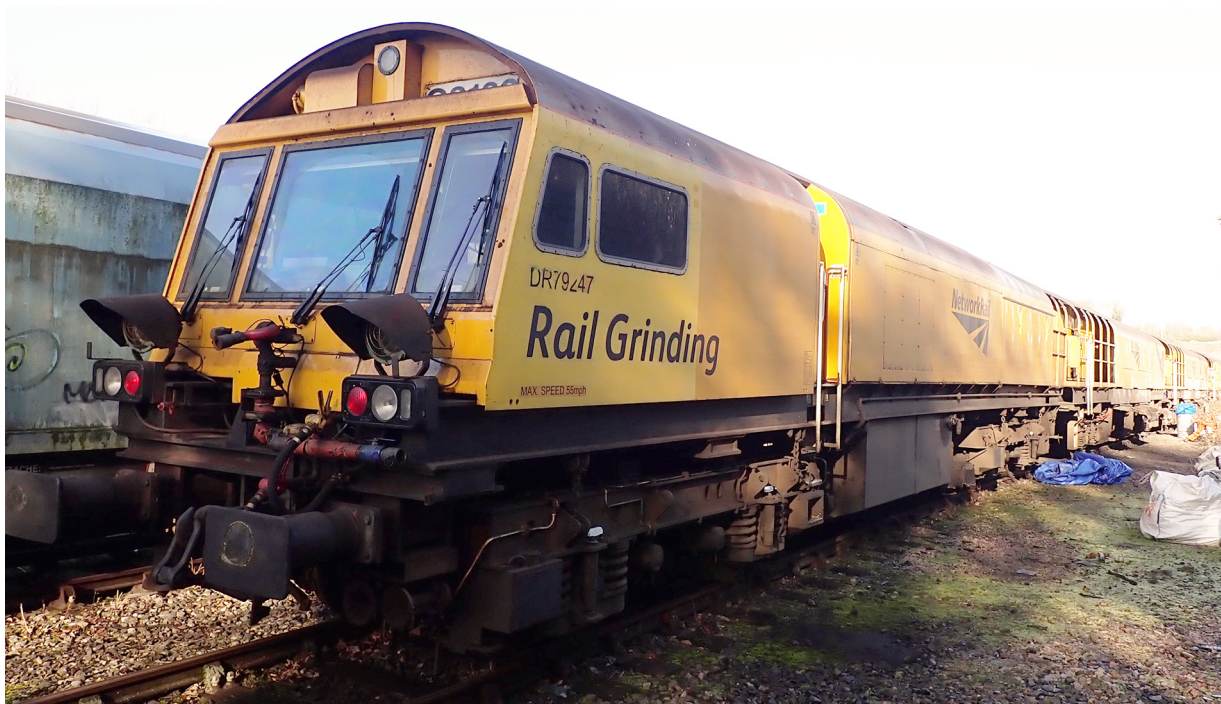
- 14 Train 6Z08 was formed of rail grinding machine C2101, one of a fleet of three such machines operated by Loram which are used to reprofile the railhead, eliminating surface cracks and thereby increasing the lifespan of the rail. C2101 consists of five vehicles, including driving cabs at each end (figure 4). Its maximum permissible speed while travelling outside possessions is 55 mph (89 km/h).

Figure 4: Rail grinding train similar to C2101
