AAIB Bulletin

1/2022

Airbus Helicopters AS355 F1	G-BOSN	02-Mar-21	11
-----------------------------	--------	-----------	----

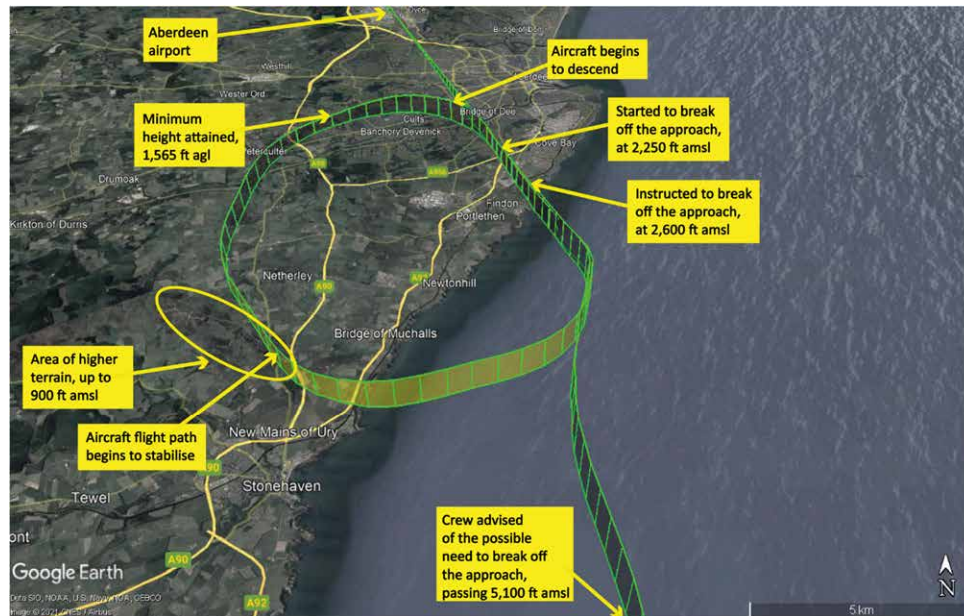
Figure 1

G-FDZF's flightpath into Aberdeen and the unintended descent

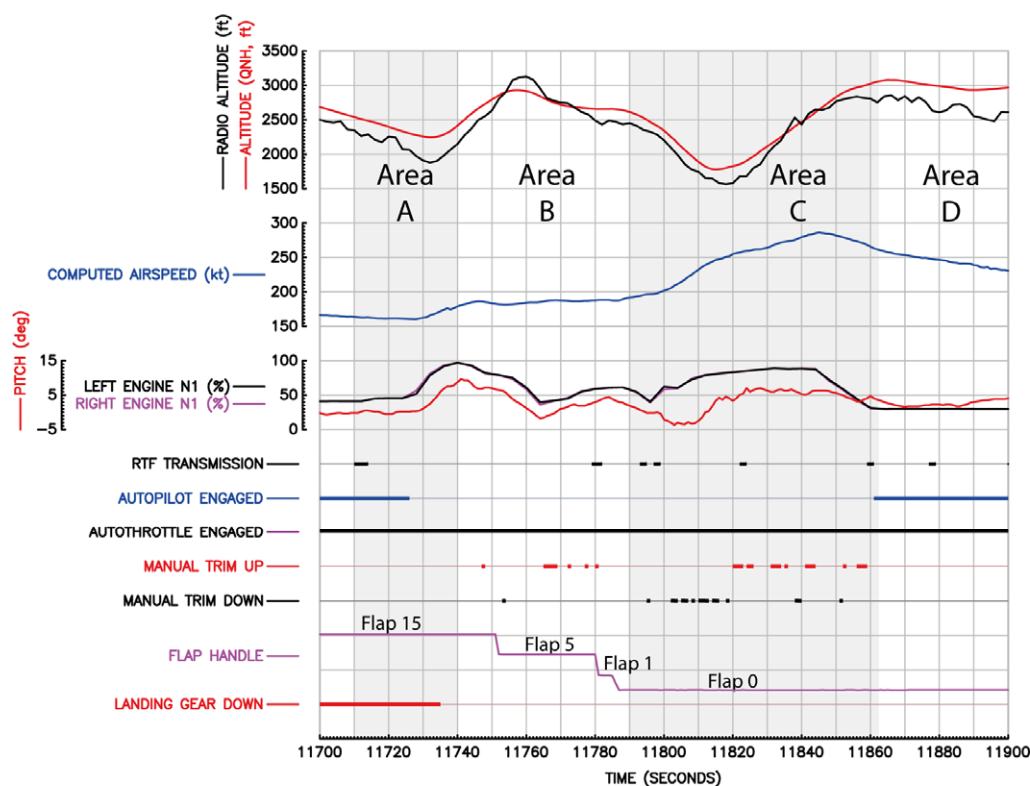
Figure 2

Flight data for the approach and subsequent unintended descent

Area A shows the flightpath from when the crew responded to the ATC instruction to break off the approach and shows the disconnection of the autopilot as the TO/GA mode was activated. It shows that the landing gear was retracted, the thrust increased towards the full go around N1 limit and the aircraft's pitch attitude increased as the aircraft climbed. Note the strong correlation between the changes in the pitch of the aircraft and engine power setting. No manual pitch trim inputs were observed in the data.

Area B shows that as the aircraft approached the selected altitude of 3,000 ft, the pitch of the aircraft decreased and the autothrottle reduced the engine power setting in anticipation of the level-off being commanded by the flight director. As the aircraft reached this point, the flaps were retracted from flap 15 to flap 5 and the aircraft then descended having failed to meet the criteria for the flight director to transition to ALT HOLD. The flaps were then further retracted from flap 5 to flap 1 and from flap 1 to flap 0 during the descent."

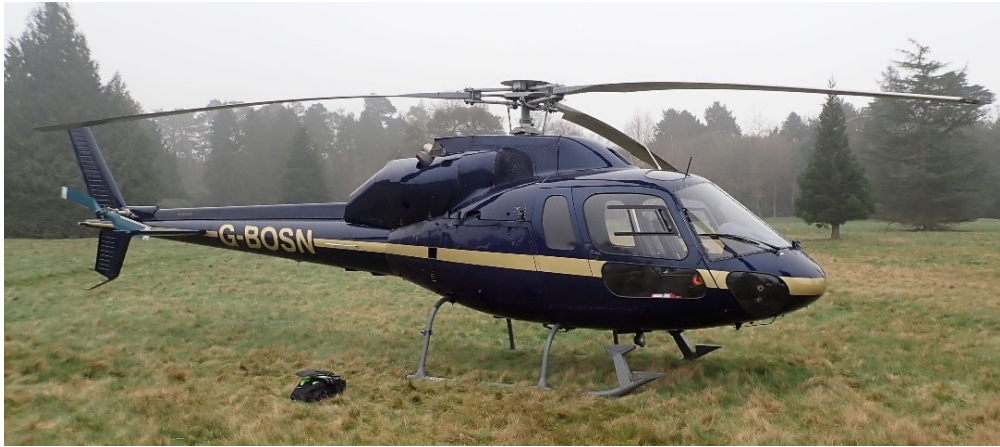
The helicopter, having made a precautionary landing, was positioned on its skids in the grounds to the south of Hedsor House (Figure 1). Apart from paint blistering of some of the right engine cowls (Figure 2) and melting of the cowl latches, the external appearance of the helicopter was unremarkable.

Figure 1
G-BOSN after landing

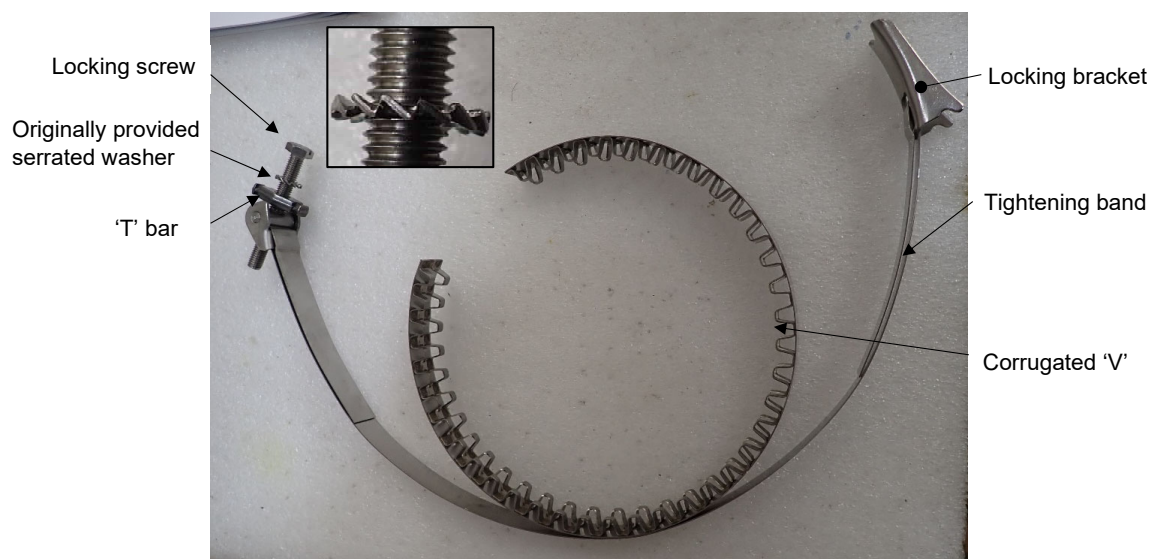
Figure 7

The clamp failure was attributed to a combination of an incorrect locking washer being fitted during maintenance and elevated engine vibration which caused the clamp to loosen. A crack then propagated in low-load high-cycle fatigue until final rupture of the clamp.

As supplied V-band clamp, inset showing serrated washer that must be removed prior to installation on the helicopter

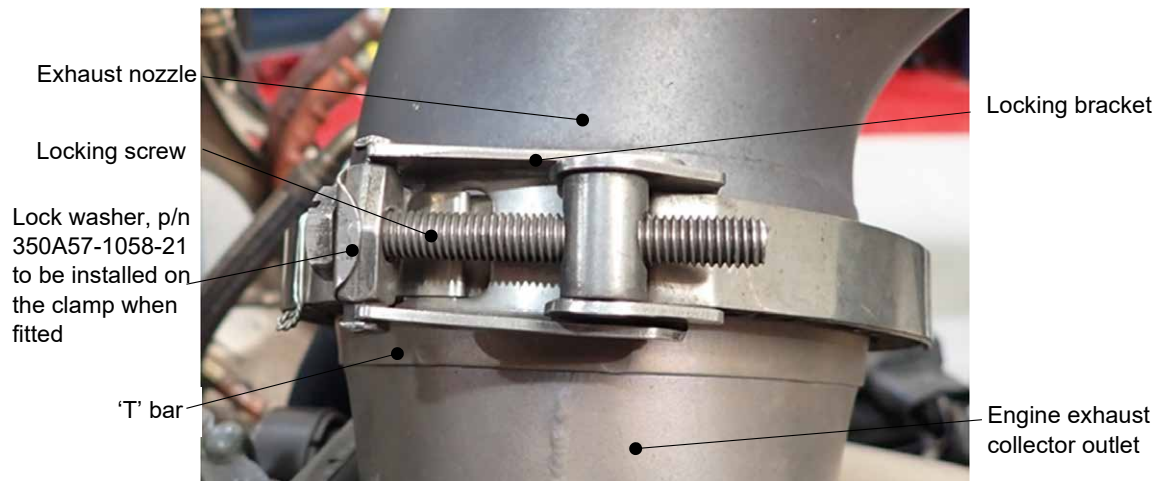
Figure 8

Exhaust nozzle clamp correctly installed

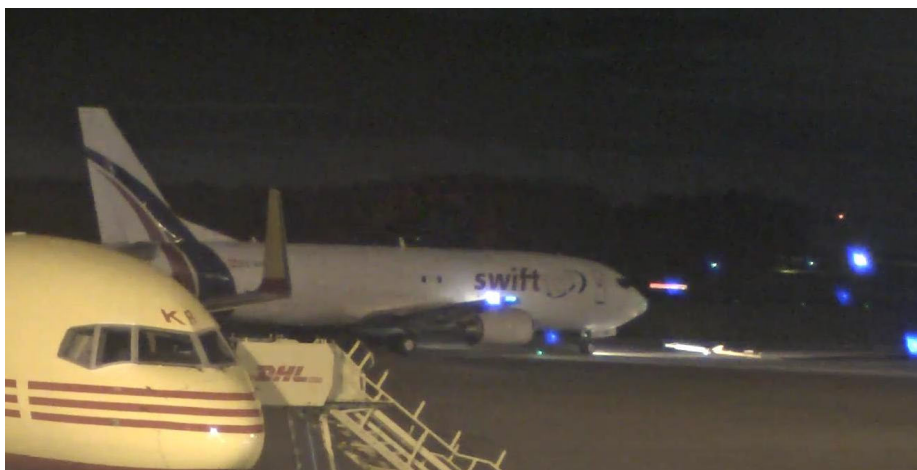
Figure 1

The crew received clearance from ATC to taxi towards Runway 27. Soon after the aircraft started to move, the co-pilot felt something similar to the toe brakes being applied momentarily. Upon asking the commander if he had checked the brakes, the commander said he had not. They did not see the towbar under the aircraft's nose prior to commencing the taxi, Figure 1.

EC-MIE and towbar just prior to taxiing

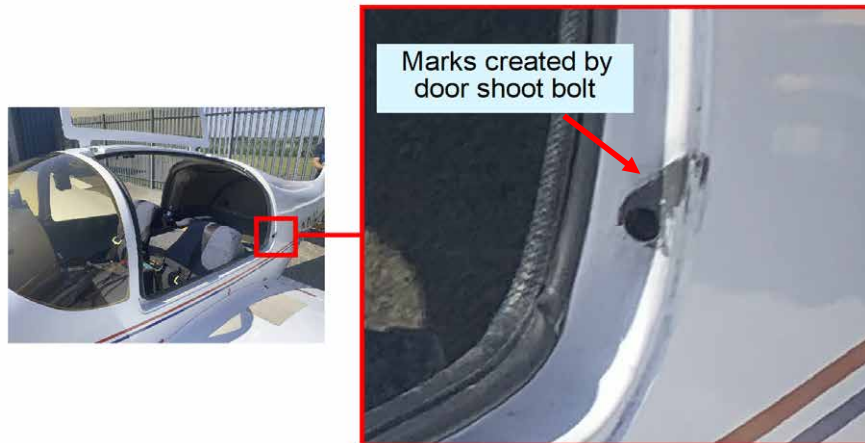
Figure 7

There was no evidence of significant damage to either the left door's front or rear shoot bolt guides, the surrounding door frame or fuselage. However, there was superficial damage to the paintwork adjacent to both the left door's front and rear guides (Figure 6 and Figure 7). The damage was similar and was consistent with having been caused by the tapered shoot bolt coming into contact with the fuselage skin and the door frame. Possible causes for this included:

Rear shoot bolt guide

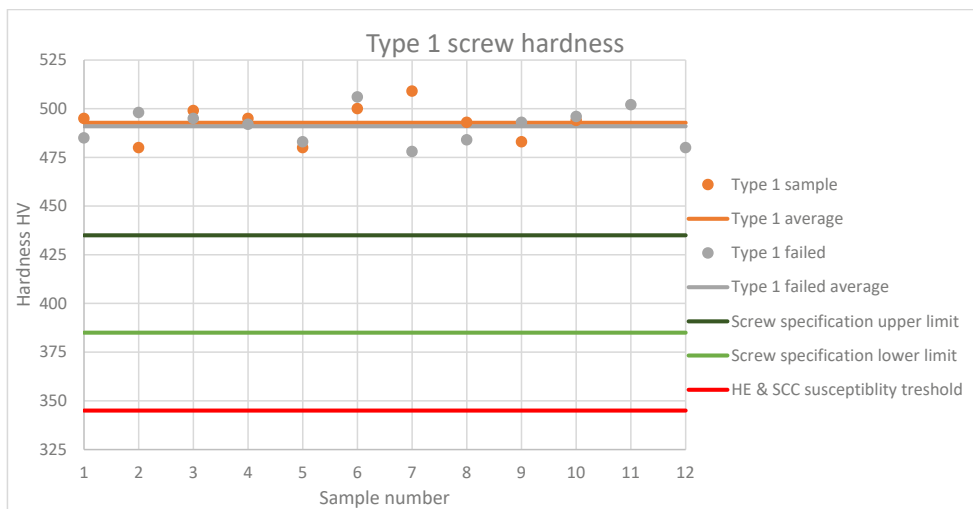
Graph 1

All the sample screws and the failed type 1 screw were very similar in hardness and exceeded the specification value. The difference between the average hardness of the sample screws and the failed screw was 2 HV.

Hardness testing of type 1 screw samples
