AAIB Bulletin

12/2021

Aircraft Type and Registration:	Cessna FRA150L, Aerobat, G-CIIR	
No & Type of Engines:	1 Rolls-Royce Continental O-240-A piston engine	
Year of Manufacture:	1973 (Serial no: 187)	
Date & Time (UTC):	11 October 2020 at 1342 hrs	
Location:	Troutbeck Airfield, Cumbria	
Type of Flight:	Private	
Persons on Board:	Crew - 1	Passengers - None
Injuries:	Crew - 1 (Fatal)	Passengers - N/A
Nature of Damage:	Destroyed	
Commander's Licence:	Private Pilot's Licence	
Commander's Age:	44 years	
Commander's Flying Experience:	69 hours (of which 52 were on type) Last 90 days - 3 hours Last 28 days - 2 hours	
Information Source:	Field Investigation

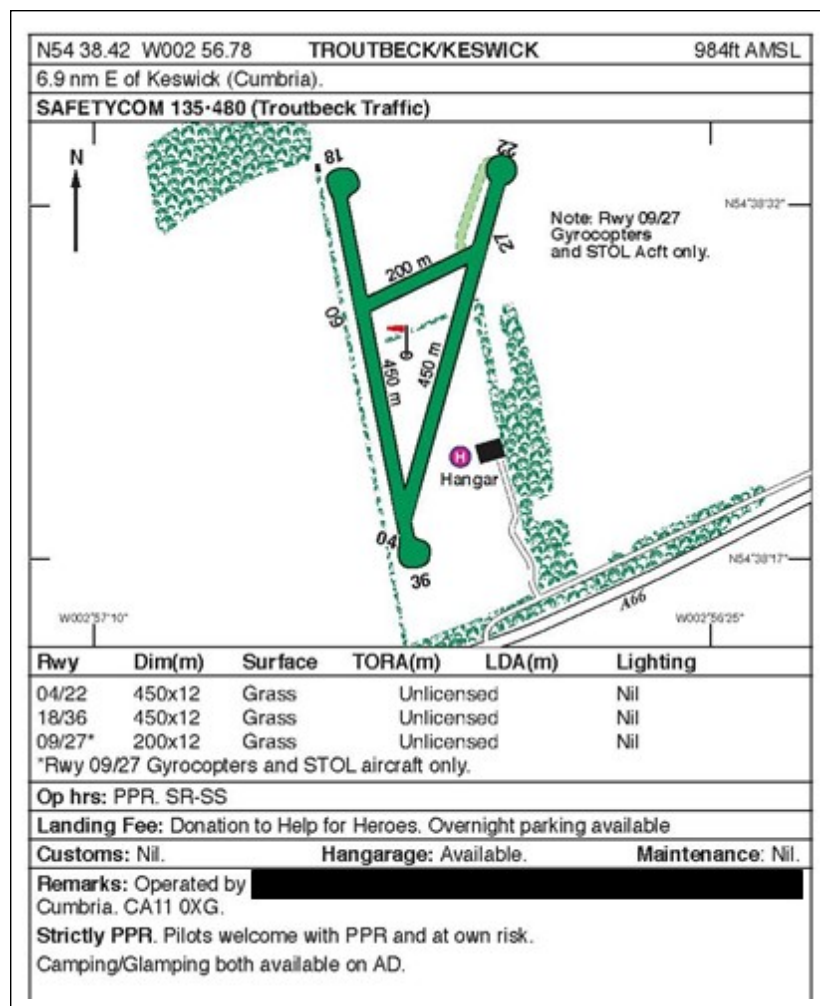
Figure 1

Plate of Troutbeck Airfield - © Pooleys

Troutbeck Airfield has three grass runways orientated 18/36, 04/22 and 09/27 (Figure 1). Runway 36 is a 450 m grass runway. The runway has a positive gradient of about 3.3% from the threshold of Runway 36 to just after the intersection with Runway 04. Thereafter, it has a negative gradient. The elevation is approximately the same at the threshold of Runway 36 and Runway 18. Runway 36 is approximately 320 m long from the intersection of Runway 04.

As stated in Figure 1, Troutbeck airfield is '*Strictly PPR*' and the SafetyCom frequency (134.480 MHz) is to be used for RTF communications.

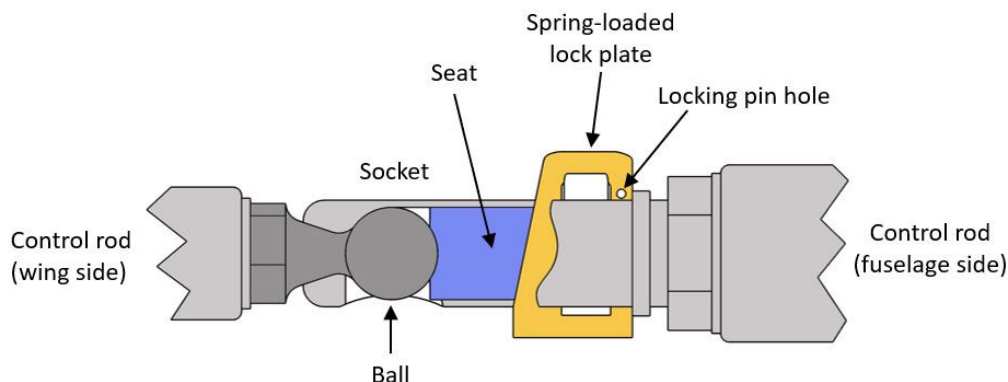
Figure 3

The aileron and airbrake control connections in the fuselage were of the L'Hotellier type, in which a ball on the wing pushrod end engages with a socket in the L'Hotellier fitting at the end of the fuselage pushrod (Figure 3). A spring-loaded lock plate is pressed downwards during assembly of the connection, which allows a seat to move away from the socket such that the ball may enter the socket. The ball is locked into the socket when the lock plate moves to its upward position, under spring loading, allowing the seat to contact the ball.

L'Hotellier control connection components

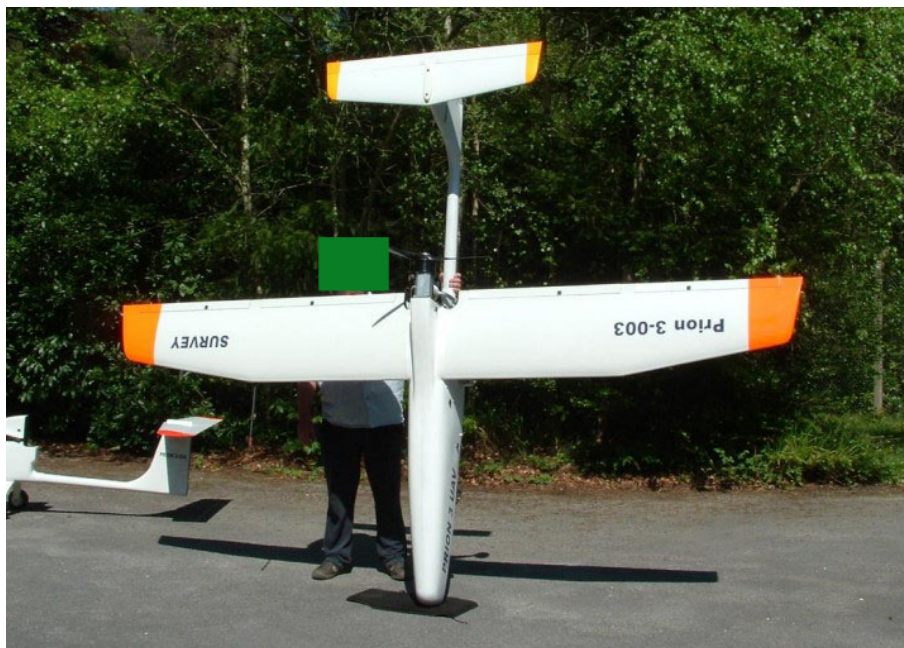
Figure 1

The UAVE Prion Mk3 is a fixed-wing unmanned aircraft with a 3.8 m wingspan and a 45 kg maximum takeoff mass (Figure 1). It was being operated by the aircraft manufacturer on a training flight in a protected area of Salisbury Plain. The flight crew consisted of a Remote Pilot Station Operator (RPSO), a Safety Pilot and a Flight Operation Manager. The flight was conducted within Visual Line of Sight rules and the Safety Pilot was the PIC. The RPSO was sat inside a van equipped with a control station, while the Safety Pilot stood outside the van with a remote controller, in a position to be able to monitor both the aircraft and the displays inside the van. The Safety Pilot is able to take manual control within five seconds or less.

UAVE Prion Mk 3
