SERIOUS INCIDENT

Aircraft Type and Registration:	Grob G115B, G-BYDB	
No & Type of Engines:	1 Lycoming O-320-D3G piston engine	
Year of Manufacture:	1988 (Serial no: 8025)	
Date & Time (UTC):	17 April 2022 at 1450 hrs	
Location:	Clacton Airfield, Essex	
Type of Flight:	Private	
Persons on Board:	Crew - 1	Passengers - None
Injuries:	Crew - None	Passengers - N/A
Nature of Damage:	Damage to the leading edge of the wing and shock loading of the engine	
Commander's Licence:	Private Pilot's Licence	
Commander's Age:	52 years	
Commander's Flying Experience:	189 hours (of which 10 were on type) Last 90 days - 4 hours Last 28 days - 2 hours	
Information Source:	Aircraft Accident Report Form submitted by the pilot

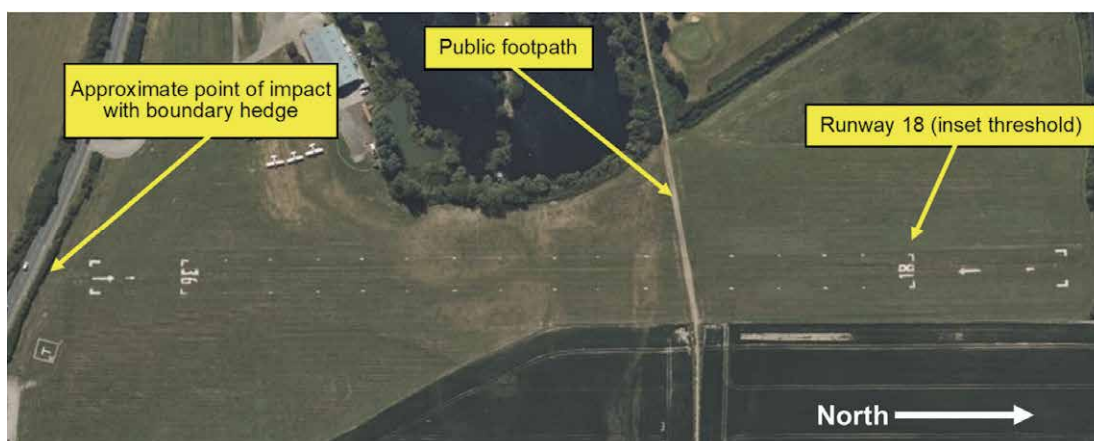
Figure 1

This serious incident occurred on a cross-country flight from Fowlmere Airfield to Clacton Airfield (Clacton) in Essex. On the day of the incident, Clacton was using Runway 18 (Figure 1), which the pilot had previously landed on in a Cessna 172. On that earlier occasion he was advised, "if you do not land before the footpath, perform a go-around".

Overview of Runway 18/36 at Clacton Airport
(Imagery ©2022 Bluesky.CNES / Airbus, Getmapping plc, Infoterra Ltd & Bluesky.Landsat / Copernicus, Maxar Technologies, Map data 2022)
