Maritime &
Coastguard
Agency

SS Richard Montgomery: Survey Report 2021

June 2022

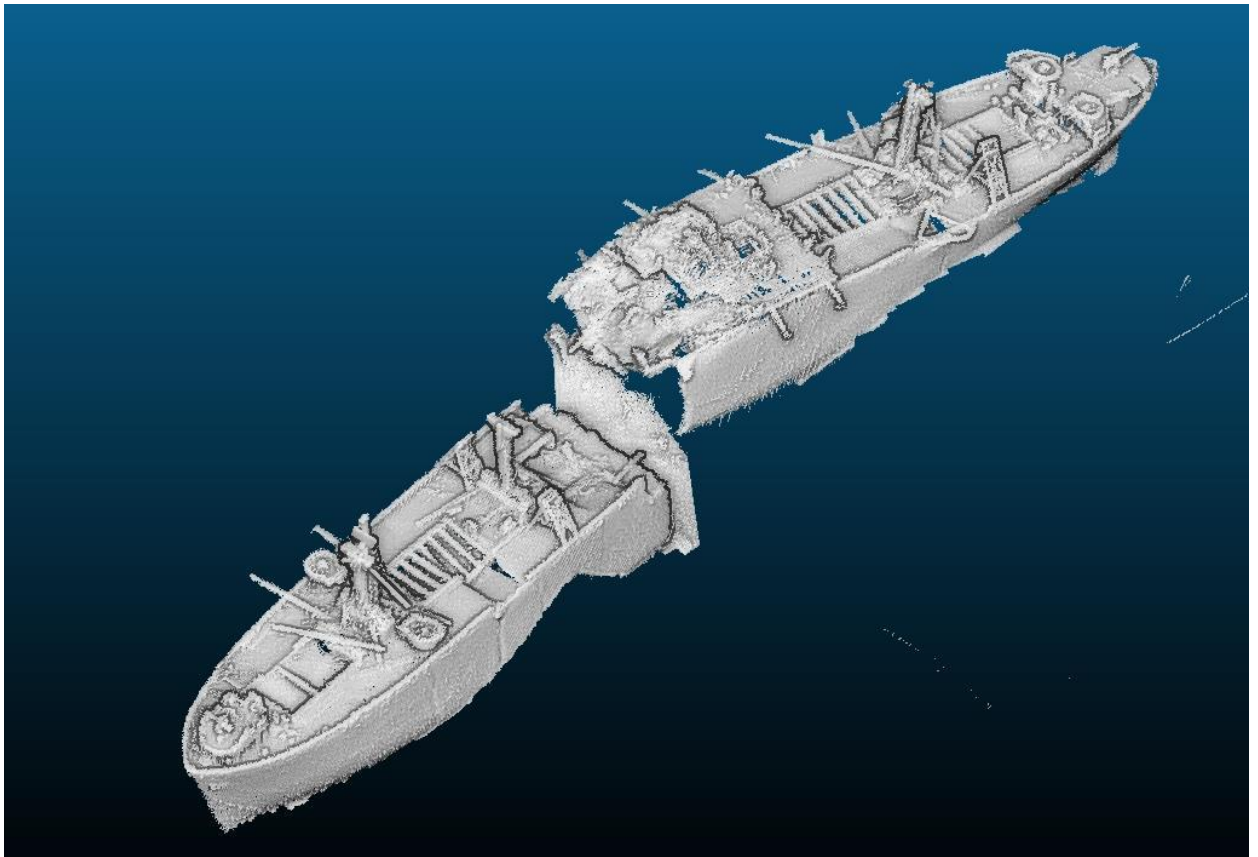
Figure 5 SSRM overview from the north west.

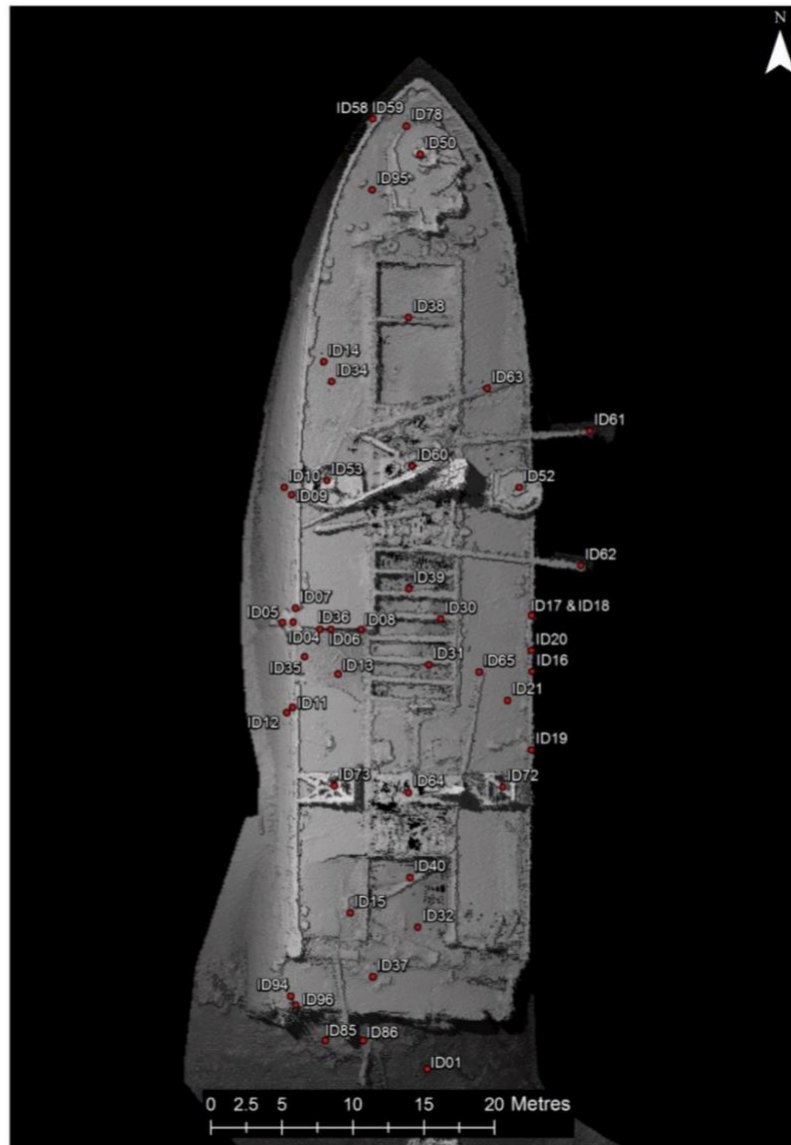
- 4.2.1** Over the whole of the wreck, 96 specific features have been used in successive surveys as comparison points for quantifying change and deterioration. The location of these features is given in Figure 13.
- 4.2.2** In addition to the 96 features the six Key Areas that have been highlighted in previous surveys as areas of significant structural change are monitored in each survey (Figure 13).

Figure 13 ID features on Forward section

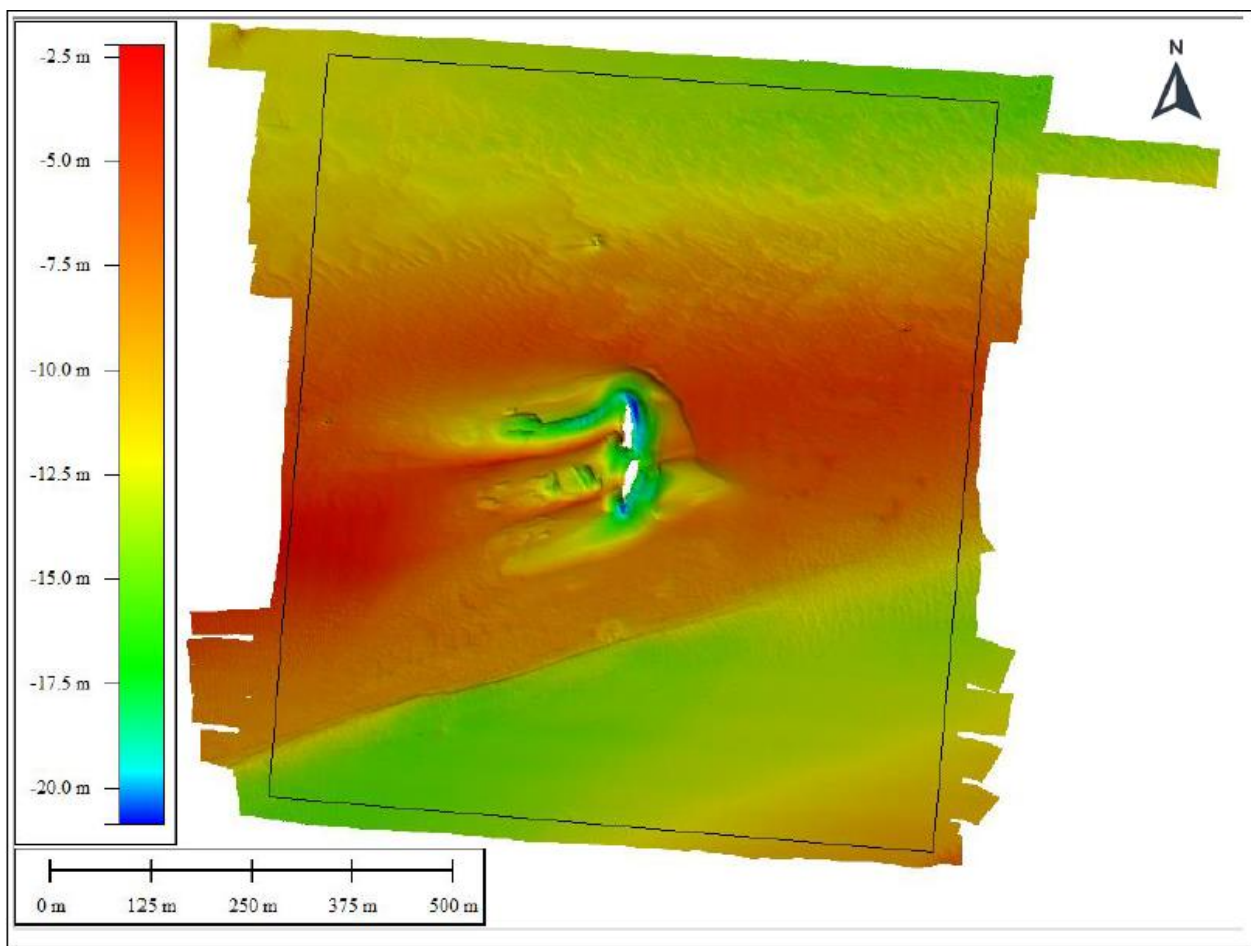
5.1.1 The seabed survey fully covered the area of the survey identified below in Figure 35.

Figure 35 – Shaded relief plan of seabed survey area

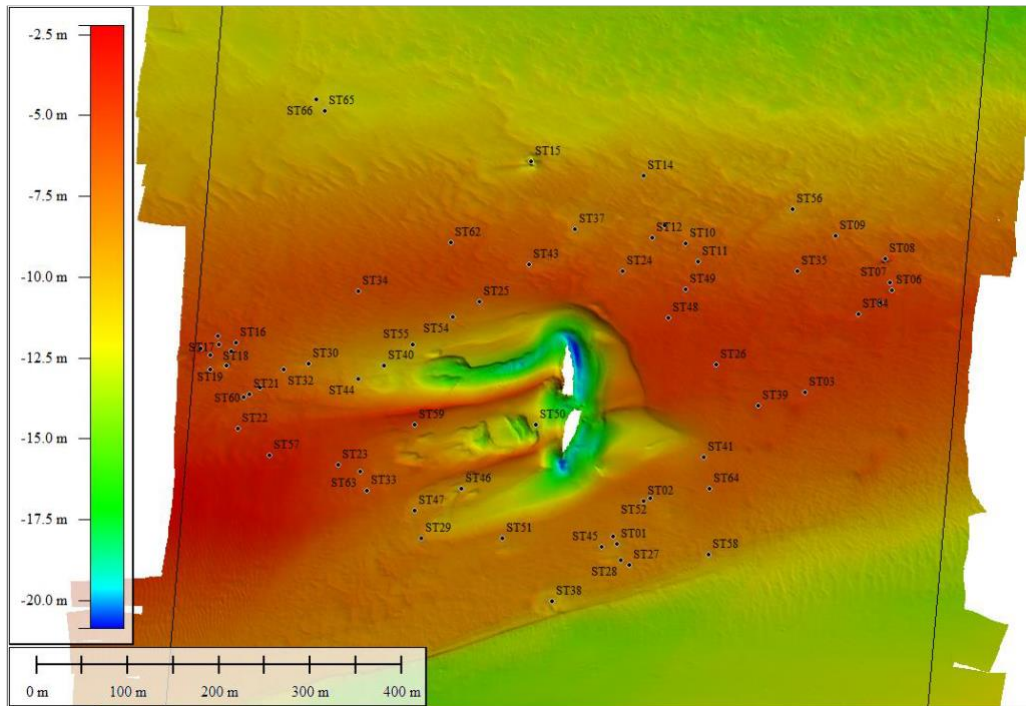
5.1.3 The 66 seabed contacts from 2017 were compared against this year's bathymetry. Analysis of the 2021 dataset has added a further 2 targets to the contact list, while 7 items from the 2017 contact list are not apparent on the 2021 data. The seabed contacts, especially the smaller or lower lying ones, are subject to a pattern of being buried and uncovered by moving sediments. As a result, their presence or not in any year's data set is largely a function of the movement of sediment around and over them.

Figure 37 – Seabed reference points
