Defence
Safety Authority

Service Inquiry

Loss of Hawk T Mk1 XX189
from 736 Naval Air Squadron,
RNAS Culdrose

SERVICE INQUIRY INVESTIGATION INTO THE LOSS OF HAWK T MK1 AIRCRAFT XX189 FROM 736 NAVAL AIR SQUADRON, RNAS CULDROSE, ON 25 MARCH 21

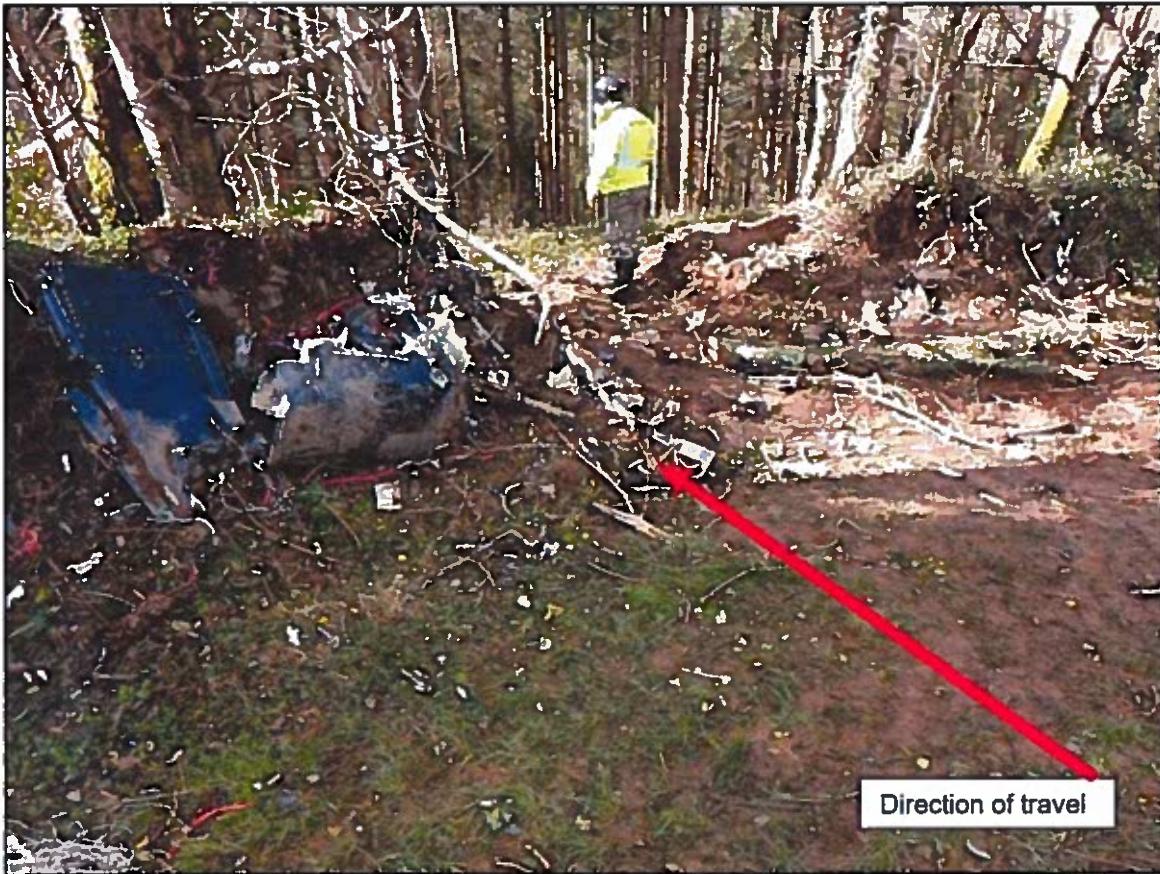
1.3.39. **Accident site laydown and location.** The aircraft crashed just west of Caervallack Farm (Grid Reference SW245725), hitting a tree in the hedgerow between two fields. The aircraft impacted the ground in the corner of the field, demolishing part of a Cornish Hedge²⁷ (Figure 1.3.5) between the field and a wooded slope leading down to a stream. The bulk of the wreckage came to rest on the wooded slope above the stream (Figure 1.3.6). The stream fed Mawgan Creek that, in turn, fed the Helford River, a site of special scientific interest and a Marine Conservation Zone. The two ejection seats landed approximately 1km further north-east: one in a field by Mudgeon Farm, and the other in a nearby hedgerow ditch. One of the crew's parachutes was snagged in a row of trees east of the seats. Plexiglass, from the shattered canopy following miniature detonation cord initiation, was found in the farmer's fields by the ejection seats.

Figure 1.3.5 - The Cornish hedge at the top of the slope.

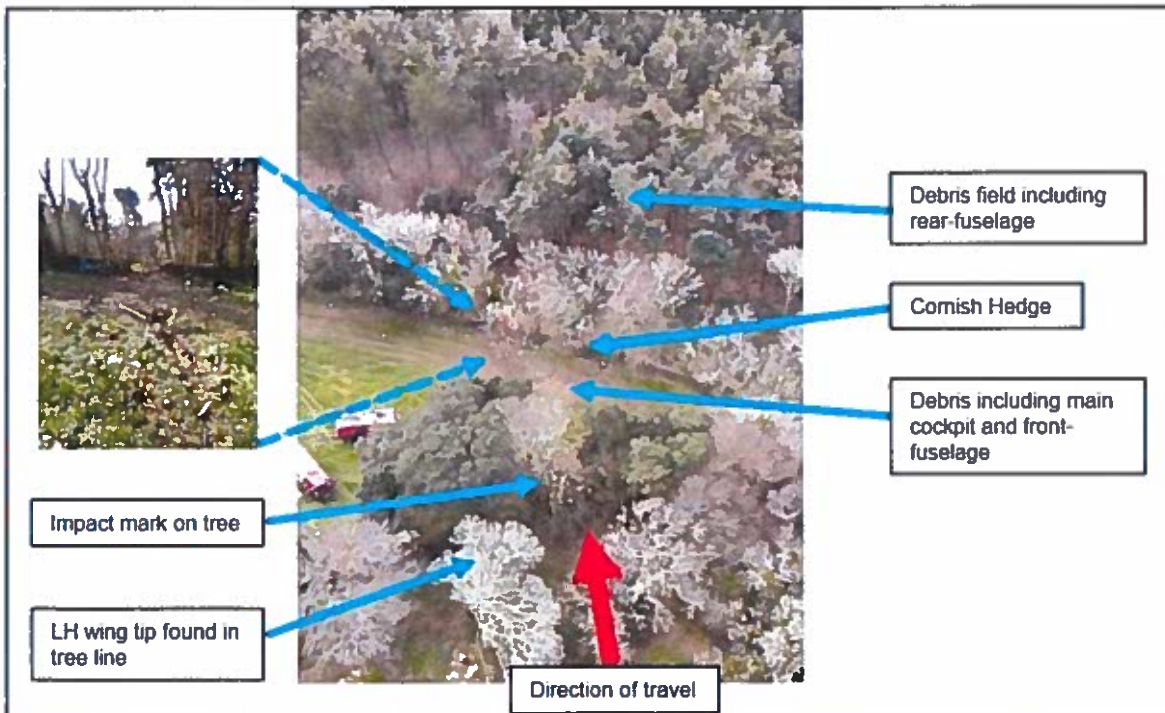
Figure 1.3.6 - Drone captured photo of the impact area.

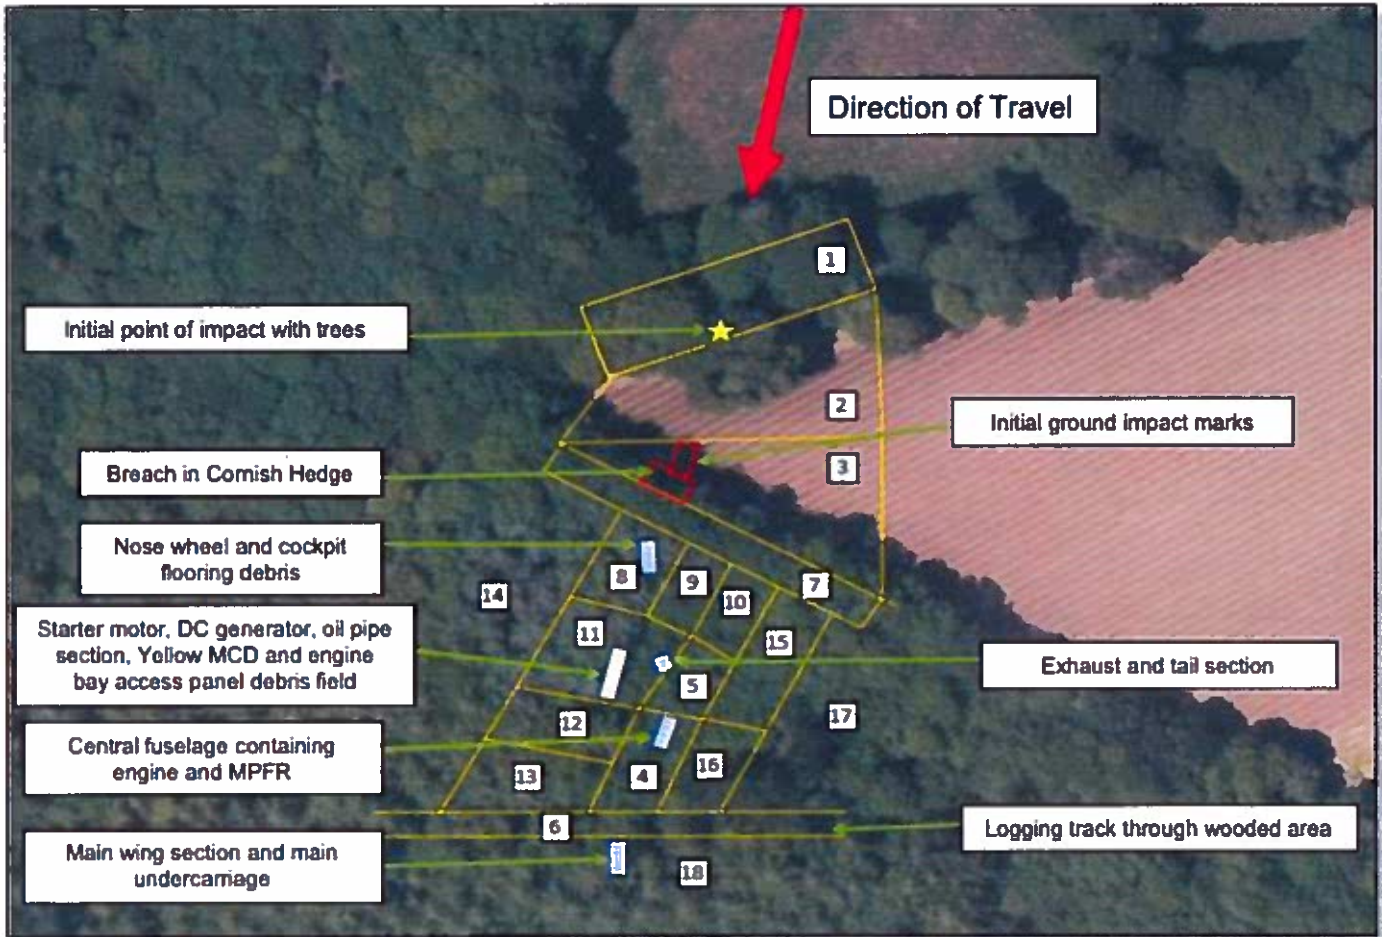
Figure 1.4.8 - Wreckage plot of the crash site.

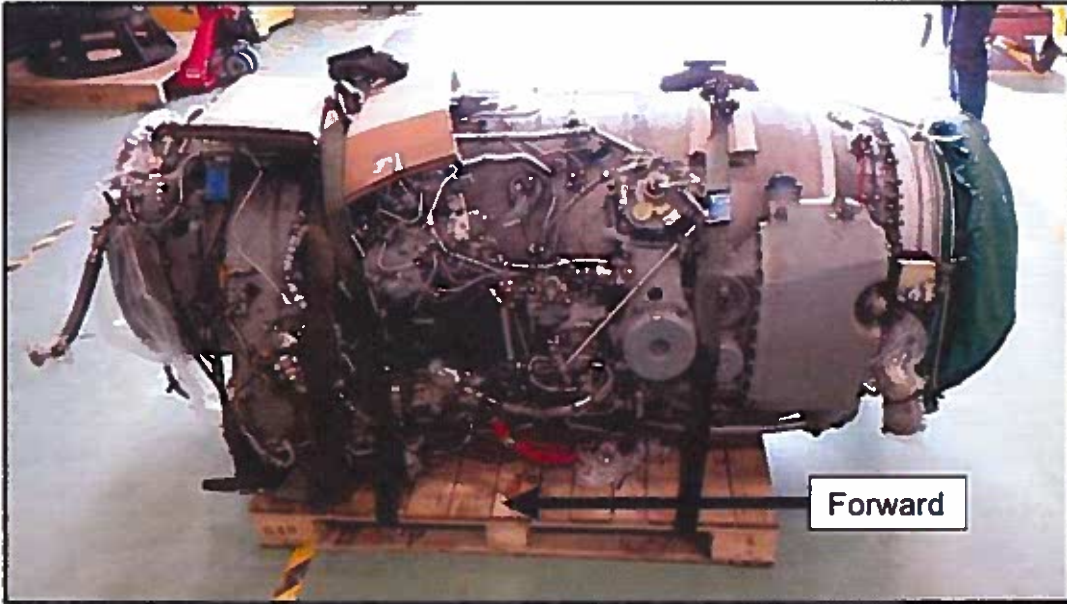
1.4.68. The engine and all ancillary components were recovered from the crash site, systematically stripped, and inspected by R-R to ascertain the root cause of the engine failure (Figure 1.4.12). The engine was disassembled into its constituent modules (Figure 1.4.13) by R-R under the observation of DAIB investigators.

Figure 1.4.12 - View of the bottom of XX189's Adour Mk151 engine (Serial 5100) as delivered to R-R ASI workshop.

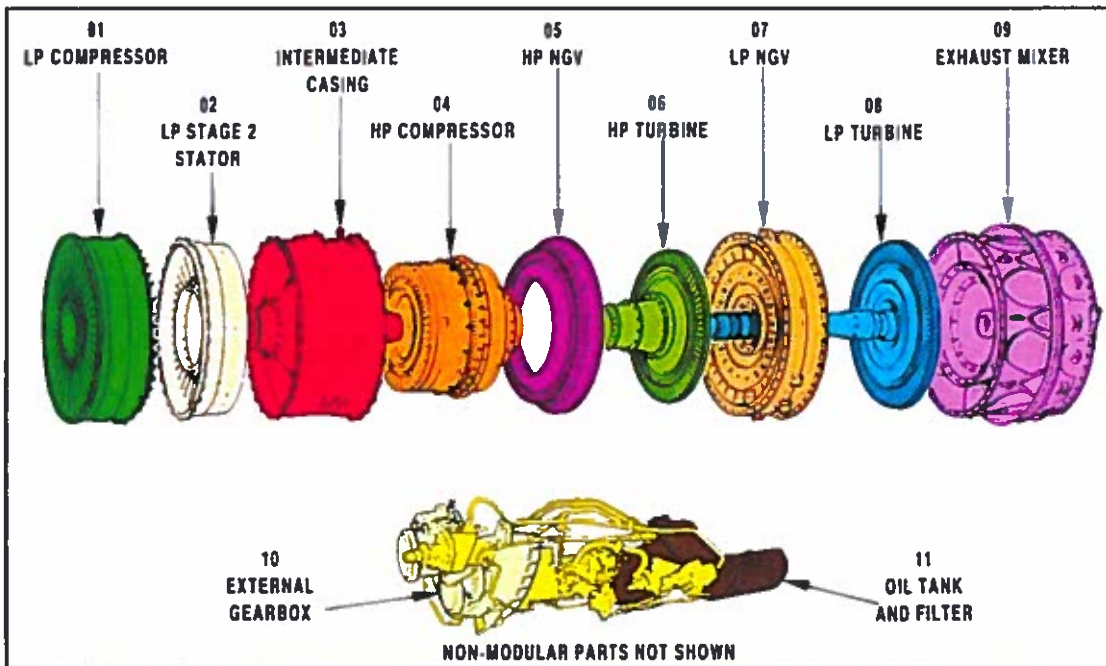
Figure 1.4.13 - Break down of engine modules.

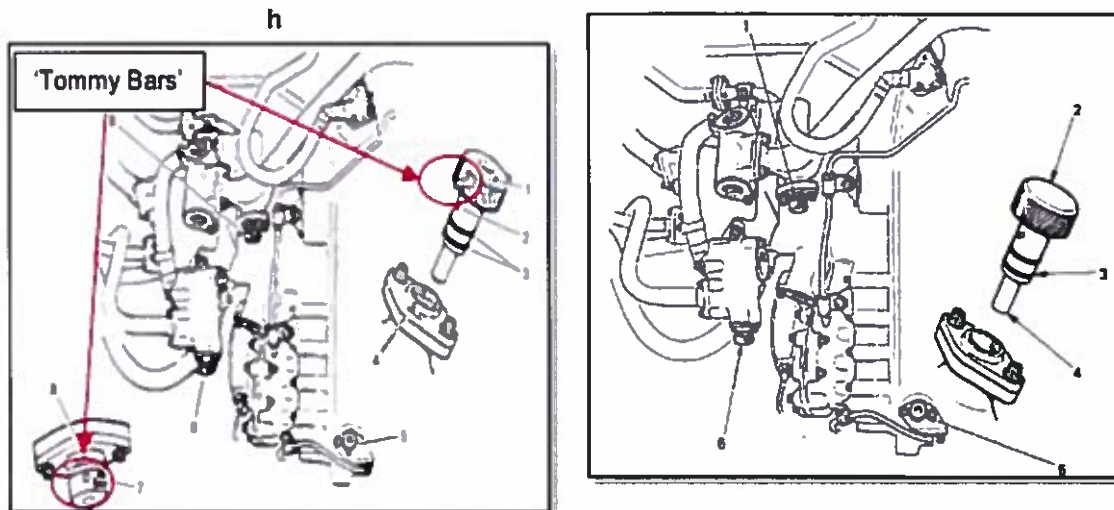
Figure 1.4.32 - MCDs with 'Tommy Bars' from the AMM (left) compared to Adour 151 MCDs without 'Tommy Bars' from the R-R Engine Test Servicing Manual (right).

1.4.149. **Recommendation.** The Hawk Type Airworthiness Authority should review the Air System Document Set in order to ensure they correctly reflect the configuration of the aircraft.

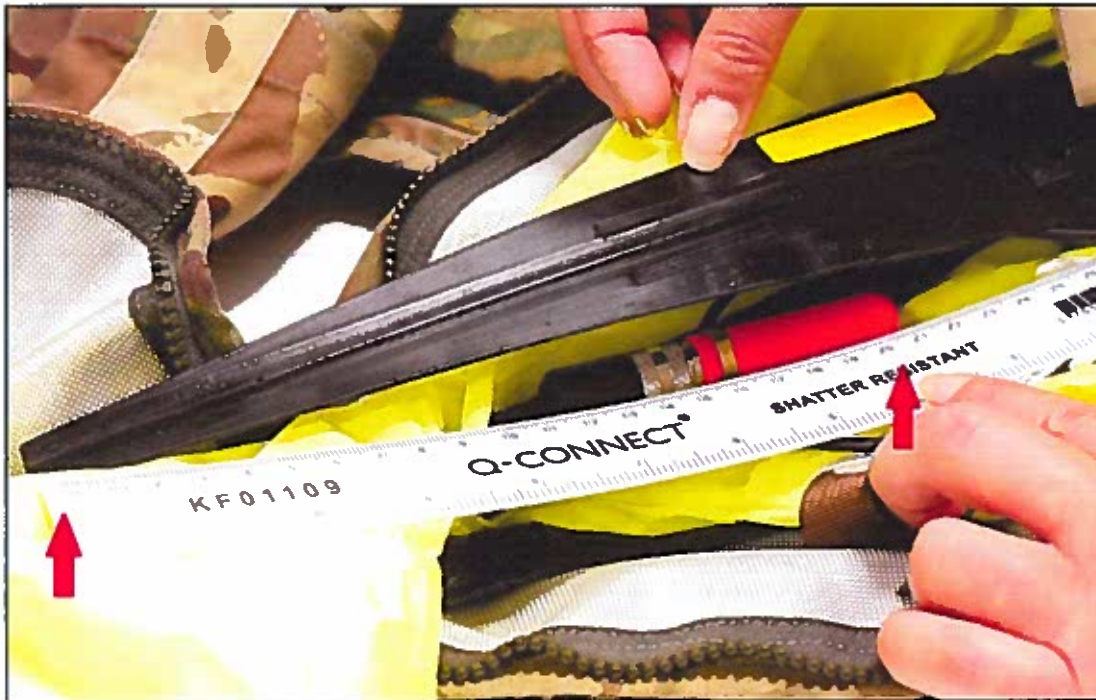
Figure 1.4.44 - Position measurements for the EPLB antenna on a reference LSJ.

1.4.196. There had been no previously reported failures relating to the position of the EPLB antenna alone, however, the Panel determined that when combined with other factors (below) the positioning was highly likely to be an issue. The Panel concluded that the positioning of the EPLB antenna was a factor in the incident. The Panel finds that the positioning of the EPLB antenna was a **Causal Factor** in the failure of the LSJ.

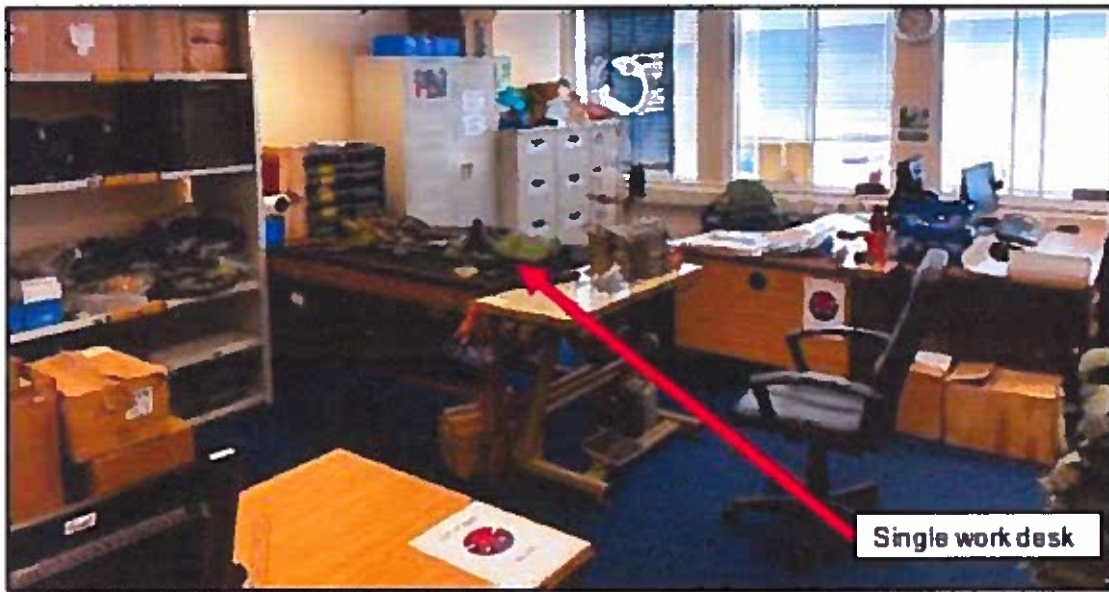
1.4.201. **Maintenance area.** As highlighted in Figure 1.4.46, the SES office / maintenance area was small, full of equipment and only contained one work desk where routine maintenance, unscheduled repairs and modifications could be carried out.

Figure 1.4.46 - 736 SES Office and maintenance area – View 2.

1.4.202. The limited space was barely big enough to place a fully inflated LSJ and did not provide room for other personnel to work concurrently.

1.4.203. Requirements for SES work areas were laid down in DAP 108A-0007-1. The SES on 736 NAS fell short of the requirement when referencing the guide detailing the planning, organisation, and maintenance of the section. Had this DAP been complied with during the move to Bravo site, the SES would have likely been provided with adequate facilities in which they could conduct routine business with sufficient space and storage. The Panel concluded that the area allocated was inadequate. The Panel finds that the inadequate area allocated to conduct safety critical functions was an **Other Factor**.

1.4.204. **Recommendation. The RNAS Culdrose Delivery Duty Holder should review the working environment within the 736 Naval Air Squadron Survival Equipment Section against the requirements of Digital Air Publication 108A-0007-1 in order to ensure compliance.**

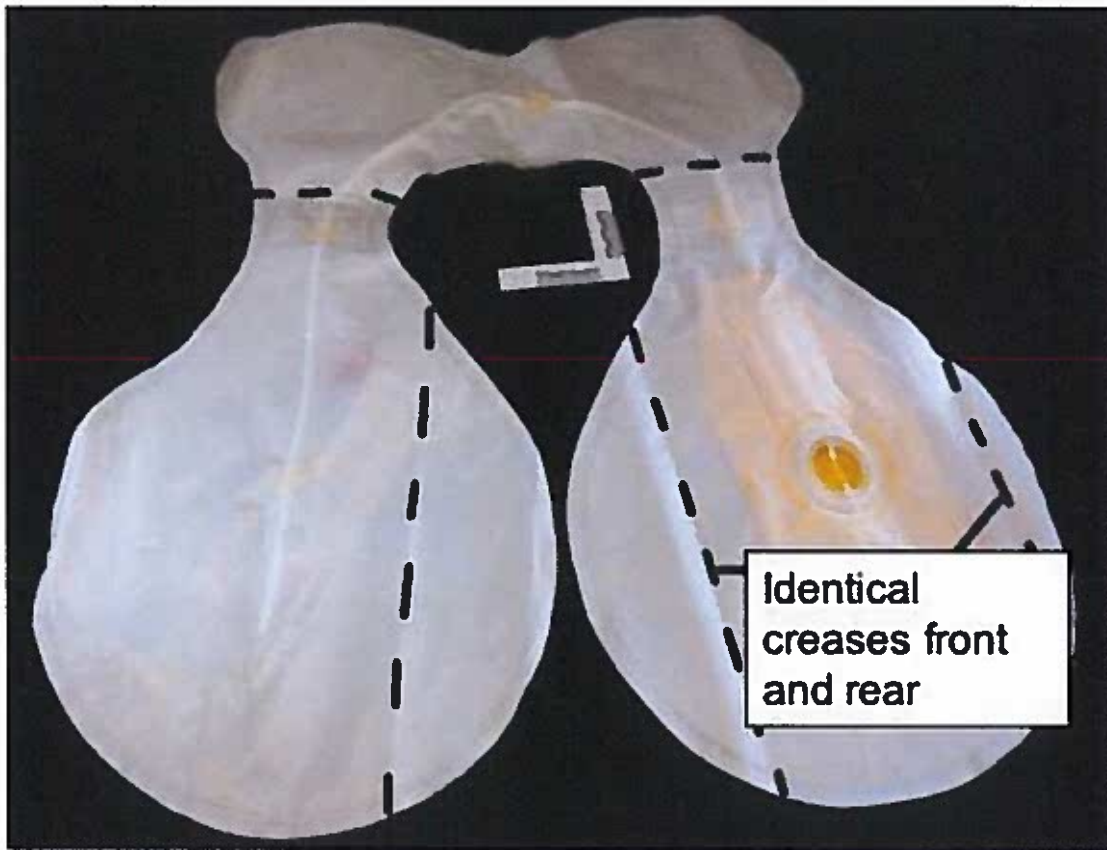
1.4.214. The visual examination of the failed stole had revealed differences in the creasing of the material between the front and rear fabric surfaces. The reference stoles were examined to determine the level of the creasing observed. This 'baseline' of creasing was used as the datum to assess the failed stole (Figure 1.4.50 and Figure 1.4.51).

Figure 1.4.51 - Creases on the never installed stole.

1.4.215. Similar differential creasing to that found on the failed stole was observed on the front and rear surfaces on the installed stoles. The never

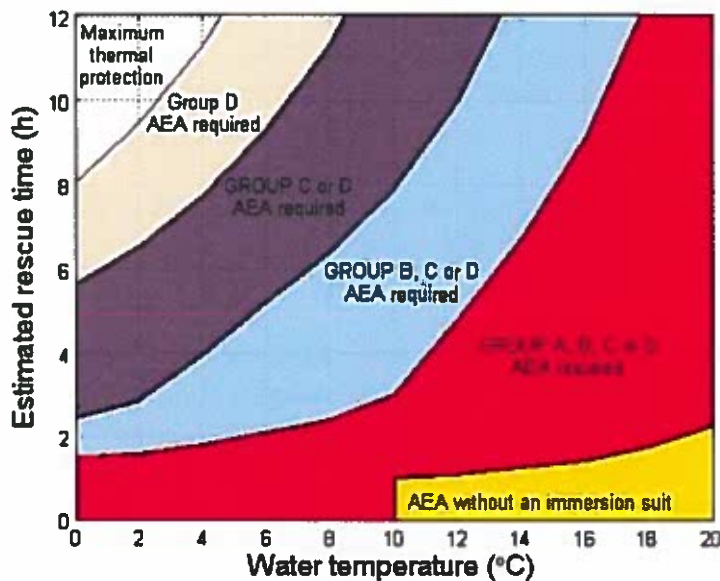
Figure 1.4.55 - Sea Temp vs Estimated rescue time highlighting groups of AEA required.

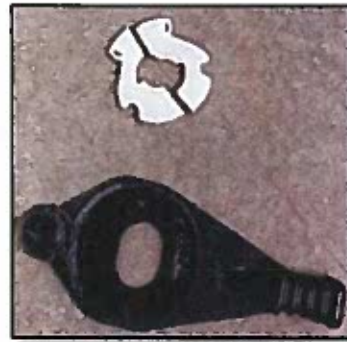
Figure 1.4.59 - Visor locking cam.

1.4.236. Examination of the maintenance record documents indicated that at the last maintenance the visor locking mechanism was functioning correctly. It was likely that the damage to the mechanism occurred during the windblast phase of the ejection when the forces generated were sufficient to overcome the locking mechanism and fracture the locking cam.

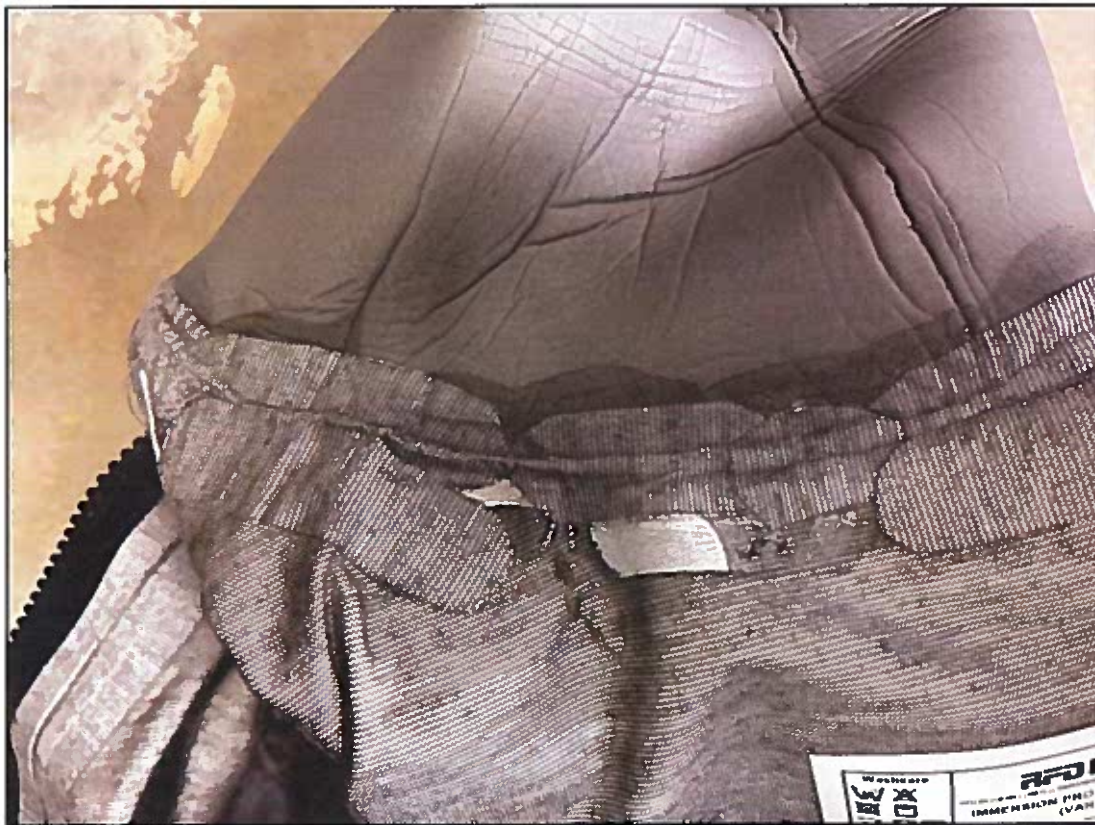
Figure 1.4.60 – Neck seal of the IPG worn by the Passenger.

1.4.242. As the potential loss of seam integrity could have allowed water to enter the IPG had the aircrew ejected over water, a further in-pool assessment was conducted. The aim of this test was to determine the extent of any water leakage. A suitably sized individual donned the Passenger's IPG together with undergarments (Future Aircrew Clothing System (FACS) base layer), socks, Mk42M single stole LSJ and anti-g trousers. The subject was pre-weighed wearing just the aircrew undergarments and socks. The fully clothed subject inflated the LSJ then entered the water and floated for 10
