Rail Accident Investigation Branch

Rail Accident Report

Buffer stop collision at Kirkby, Merseyside 13 March 2021

Report 07/2022
August 2022

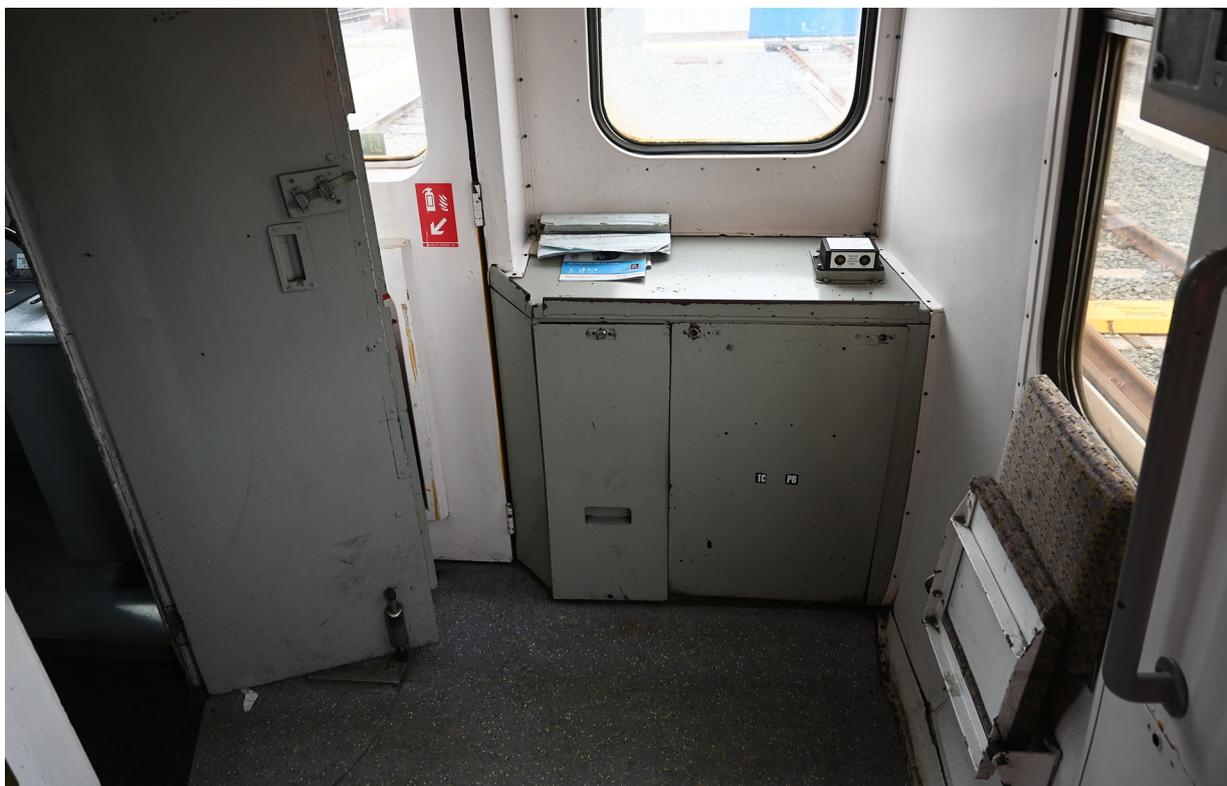
Figure 5: Photograph showing gangway area of a class 507 train

- 15 The train was fitted with an on-train data recorder (OTDR) and internal CCTV cameras. It was not fitted with forward-facing CCTV.
- 16 Class 507 trains are fitted with a gangway at each cab end which is not accessed by the public, except in emergencies. As a result of this, the driving cab is located in a separated cubicle on the left-hand side in the direction of travel (figure 5). Access to and from the cubicle is through a door which opens up into the gangway space and can be held open by a floor bolt. On the right-hand side of the gangway area, under the front window is a small cabinet which holds the tripcock⁴ equipment (figure 5). Between the tripcock cabinet and the cubicle, along the centreline of the train, is the gangway door which allows for emergency egress within tunnels.

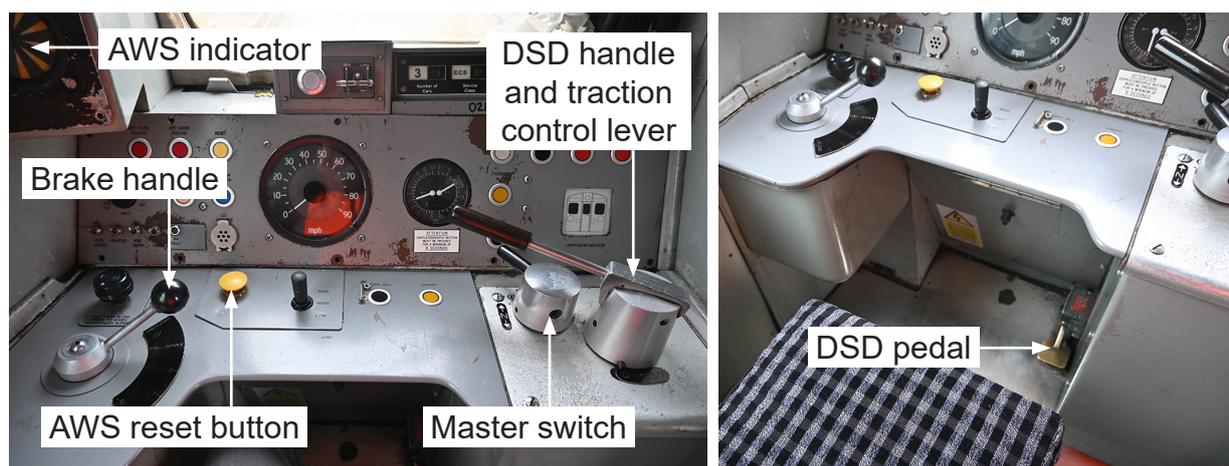
Figure 6: Photograph of the driving cab of a class 507, showing the position of the DSD and AWS controls

- 18 The DSD system on the class 507 is intended to apply the emergency brakes should the driver become incapacitated. The driver must maintain downward pressure on either a foot pedal (located under the driver's right foot) or the traction control lever (figure 6). On the class 507, an emergency brake demand is triggered should both controls be released for more than 2.5 seconds. There is no requirement for the driver to release and reapply the DSD controls at set time intervals, which is a feature of more modern DSD systems. The DSD on the class 507 would not necessarily detect if a driver ceases to be vigilant in circumstances where pressure is still maintained on the relevant controls.

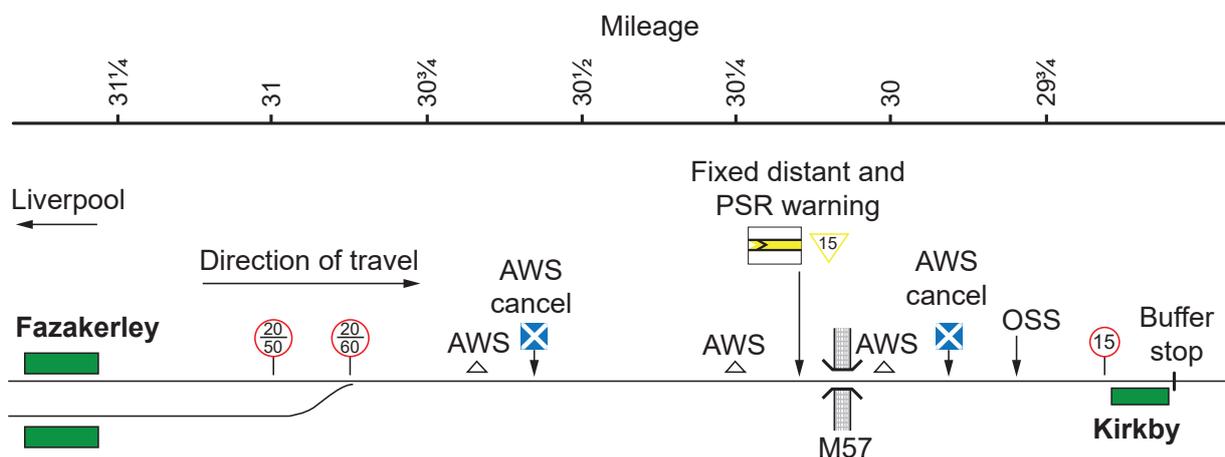
Figure 7: Schematic showing the track layout and associated infrastructure between Fazakerley and Kirkby

36 The train departed on time from Fazakerley at 18:49:45 hrs.⁷ The driver accelerated through the points and onto the single line (figure 7). Once the train reached 50 mph (80 km/h), the driver stopped applying power, allowing the train to coast. After passing the points, the permissible speed increased to 60 mph (97 km/h). The driver did not increase the train's speed further after the train passed into this higher permitted speed.

- 37 As the train coasted through the single-line section, it passed over three AWS magnets (as shown in figure 7) at the following times, all of which were recorded by the OTDR as sounding a warning horn in the cab:

- 18:50:52 hrs – AWS warning at an unsuppressed⁸ AWS magnet for signal ML308, a signal for trains travelling in the opposite direction.
 - 18:51:22 hrs – AWS warning at an AWS magnet alerting the driver to a fixed distant signal (a retroreflective sign showing an image of a cautionary yellow semaphore signal, see figure 8a), and a sign warning of the upcoming permanent speed restriction (PSR) at Kirkby station.

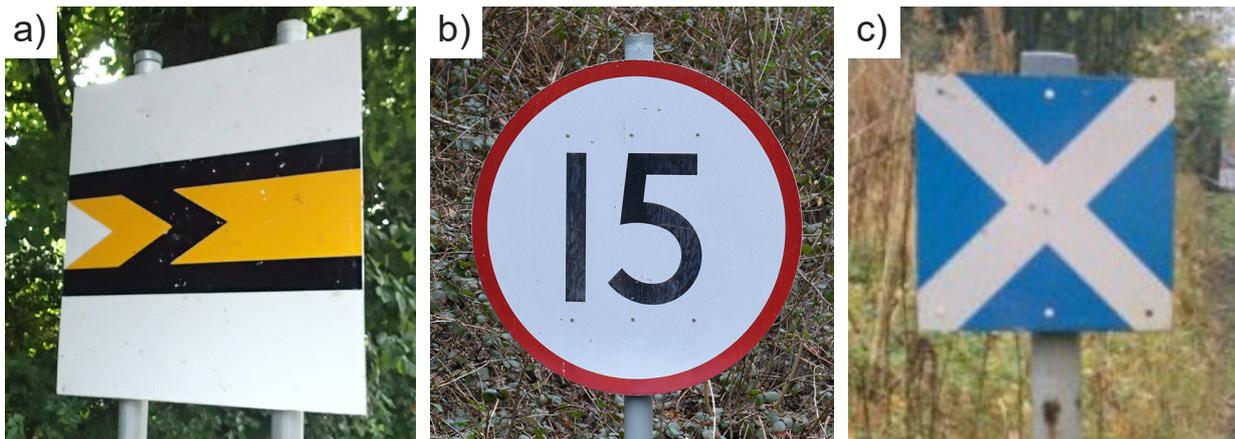
Figure 8: Photographs showing examples of a) a fixed distant signal, b) a 15 mph permanent speed restriction sign and c) an AWS cancel sign

⁸ On lines signalled in both directions, trains will pass over AWS magnets intended for trains travelling in the opposite direction. These can either be suppressed, where a second magnetic field masks the AWS magnet from the train, or unsuppressed, where the train receives a warning as normal but the driver is informed by a lineside sign (figure 8c) that the warning does not apply to them.
