AAIB Bulletin

9/2022

SERIOUS INCIDENT

Aircraft Type and Registration:	Airbus A350-1041, G-XWBC	
No & Type of Engines:	2 Rolls-Royce Trent XWB-97 turbofan engines	
Year of Manufacture:	2019 (Serial no: 362)	
Date & Time (UTC):	2 January 2022 at 1430 hrs	
Location:	London Heathrow Airport	
Type of Flight:	Commercial Air Transport (Passenger)	
Persons on Board:	Crew - 12	Passengers - 326
Injuries:	Crew - None	Passengers - None
Nature of Damage:	Damage to aircraft skin, toilet waste panel and tailstrike sensor	
Commander's Licence:	Airline Transport Pilot's Licence	
Commander's Age:	49 years	
Commander's Flying Experience:	17,305 hours (of which 652 were on type) Last 90 days - 141 hours Last 28 days - 48 hours	
Information Source:	AAIB Field Investigation

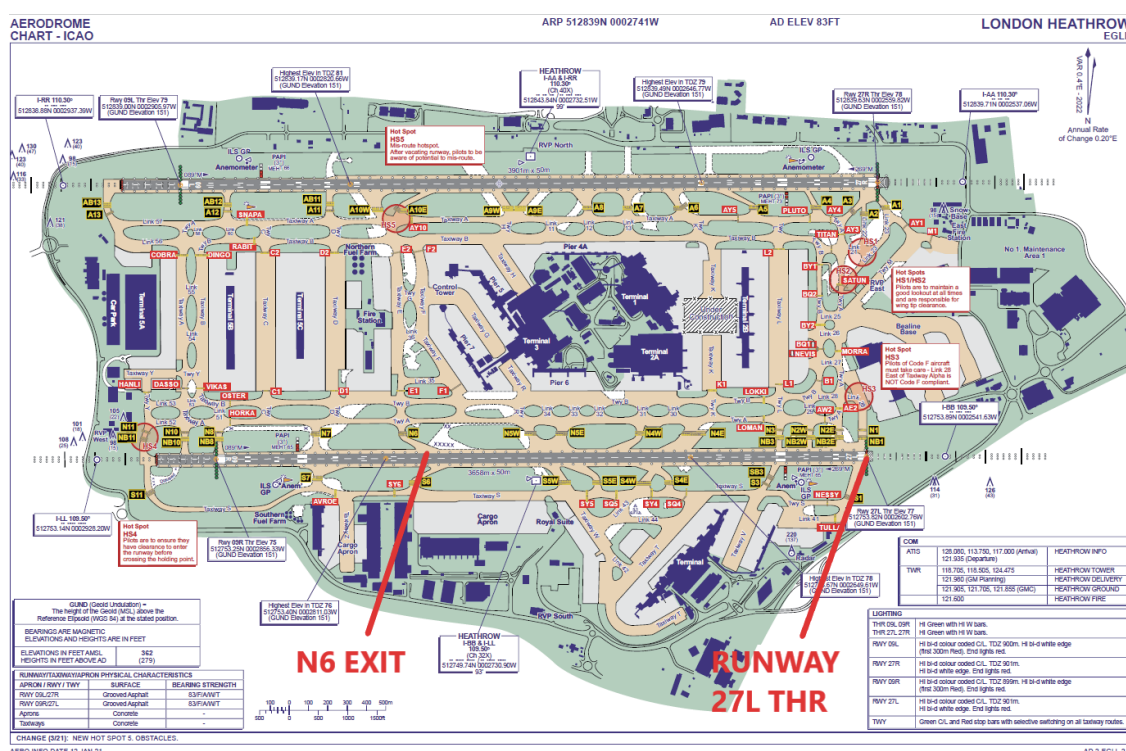
wind was within limits¹ for the co-pilot to act as PF for the landing and that was accepted as the plan. Due to the blustery conditions the crew calculated the landing performance for both Flap 3 and Flap Full. Both are approved landing configurations, but Flap 3 is preferable in gusty conditions. The runway surface was wet and so, in accordance with the operator’s SOPs, the crew assumed medium to poor braking action and no reverse thrust for landing distance calculations. The aircraft is equipped with a Brake to Vacate (BTV) autobrake system, which allows the crew to select a desired exit from the runway and then automatically varies the braking force to achieve that exit. In this case the crew selected the N6 exit (Figure 1) from Runway 27L.

Figure 1
London Heathrow Airport Chart

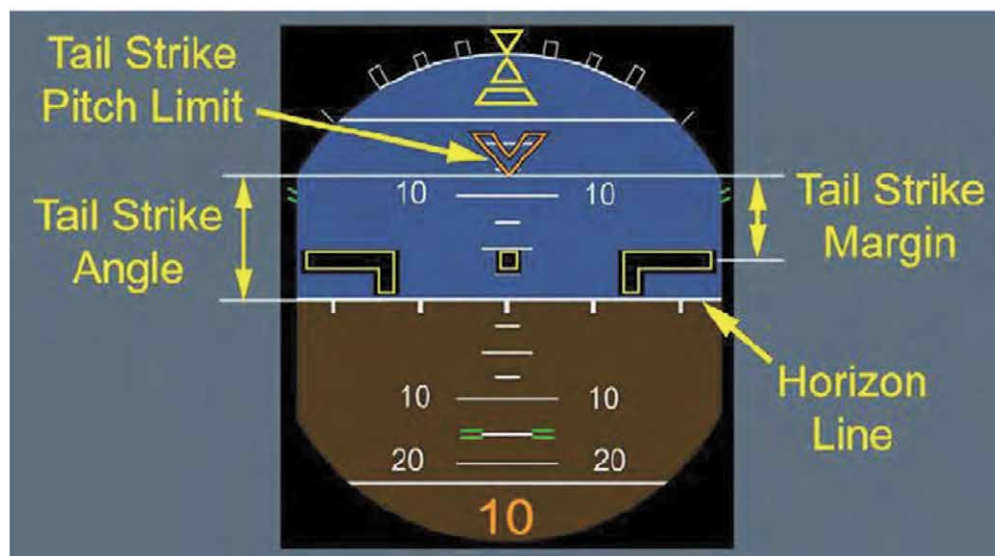
Figure 4
PFD Tailstrike Pitch Limit

The tailstrike pitch limit in the Primary Flight Display (PFD) (Figure 4) is displayed at fixed pitch value, which corresponds to the pitch limit on the ground with the main landing gear compressed plus an additional margin. The illustration from the Flight Crew Training Manual

(FCTM) shows the pitch limit for an A350-900. The incident aircraft was an A350-1000, which is longer, and therefore the PFD indication would be positioned at 8.6° nose-up. The indication disappears when the groundspeed falls below 50 kt, or 4 seconds after a go-around is initiated.

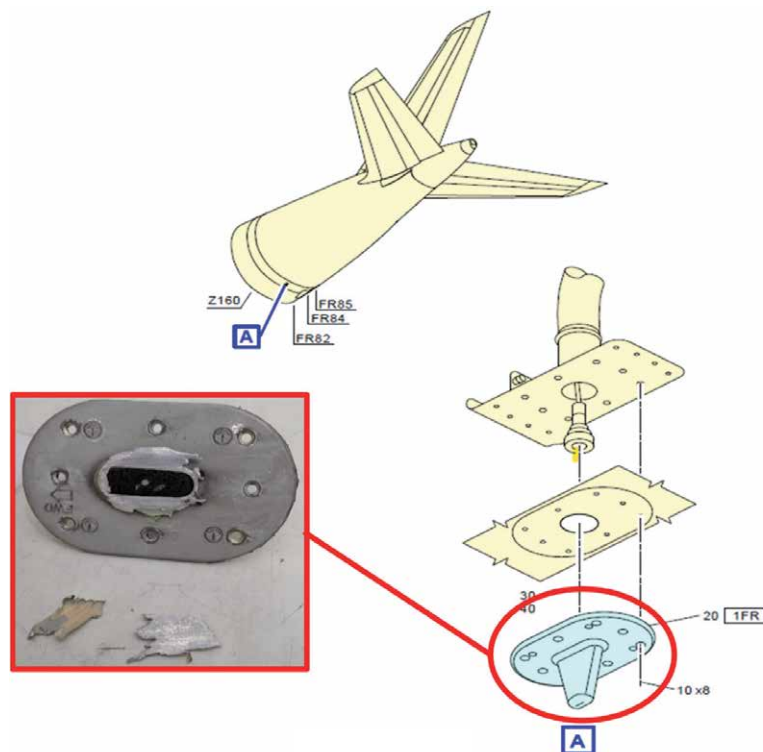
Figure 7

The primary component of the tailstrike indicator system is the tailstrike sensor which is designed to fracture when the aircraft's tail hits the ground. There are two wires inside the sensor (Figure 7) to allow for a fault condition should one of the wires become open circuit. In this state no tailstrike alert is displayed and the fault is added to the post flight report by the Centralised Maintenance System and included in a maintenance check.

Tail strike sensor location

When a tailstrike does occur, the two wires in the sensor are damaged and become open circuit from their normally grounded (GND) state. The change of signal state is detected by the Common Remote Data Concentrators which change the format of the data and transmits it to the Flight Warning System (FWS) via the Avionics Full Duplex Switched Ethernet (AFDX). The FWS shows a warning on the ECAM Warning Display providing the aircraft is in the appropriate flight phase, landing or taking off. A single chime is also produced from the flight deck loudspeakers. On the cockpit glare shield and panels 411VU and 412VU, MASTER CAUT push buttons are also illuminated (Figure 8). Other than an ECAM message, the system warnings are inhibited when TOGA is selected during landing.

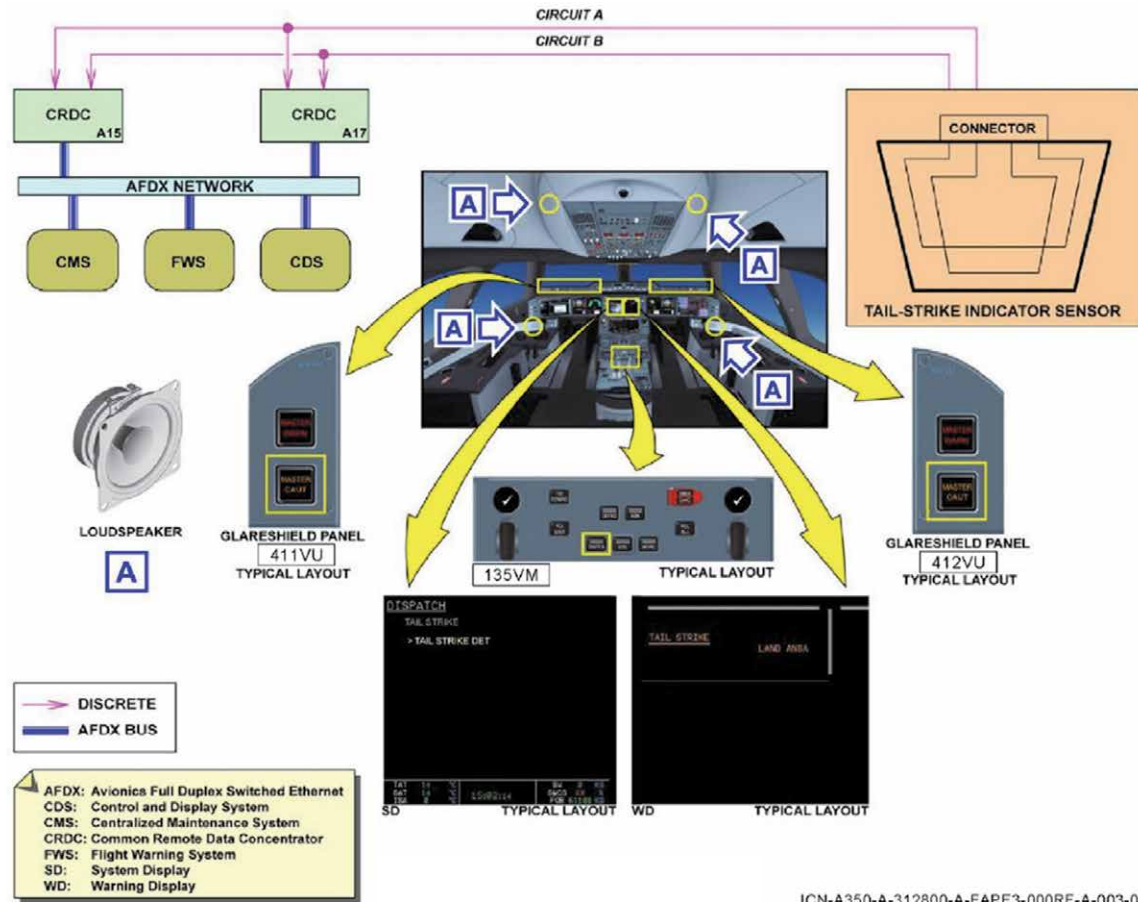
Figure 8

Tail strike system diagram

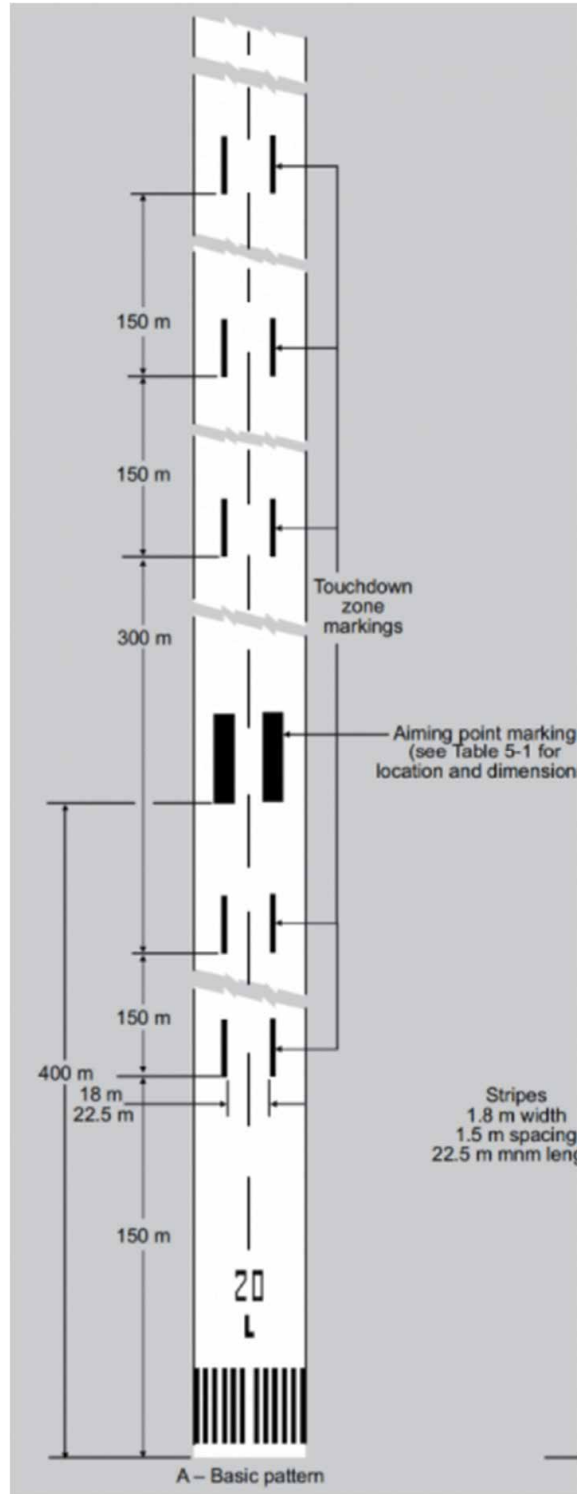
Figure 9
Example of Runway TDZ Markings

Heathrow Airport lies approximately 14 miles to the west of central London. It has two parallel runways, and Runway 27L, where the incident occurred, has a Landing Distance Available of 3,658 m. TDZs are marked by pairs of stripes symmetrically placed on the two sides of a runway centreline. The number of pairs depends on the runway length, with one pair for runways that are shorter than 900 m and six if the length is 2,400 m or more. The aiming point marking coincides with one of these pairs and is noticeably wider (Figure 9). The TDZ on Runway 27L has six pairs of stripes and is 900 m long.
