ACCIDENT

Aircraft Type and Registration:	Escapade, G-CGNV	
No & Type of Engines:	1 Rotax 912-UL piston engine	
Year of Manufacture:	2011 (Serial no: LAA 345-14901)	
Date & Time (UTC):	14 November 2021 at 1204 hrs	
Location:	Brighton Airfield, Selby, North Yorkshire	
Type of Flight:	Private	
Persons on Board:	Crew - 1	Passengers - None
Injuries:	Crew - 1 (Fatal)	Passengers - N/A
Nature of Damage:	Aircraft destroyed	
Commander's Licence:	Private Pilot's Licence (Aeroplanes)	
Commander's Age:	66 years	
Commander's Flying Experience:	945 hours (of which 4 were on type) Last 90 days - 9 hours Last 28 days - 3 hours	
Information Source:	AAIB Field Investigation

Synopsis

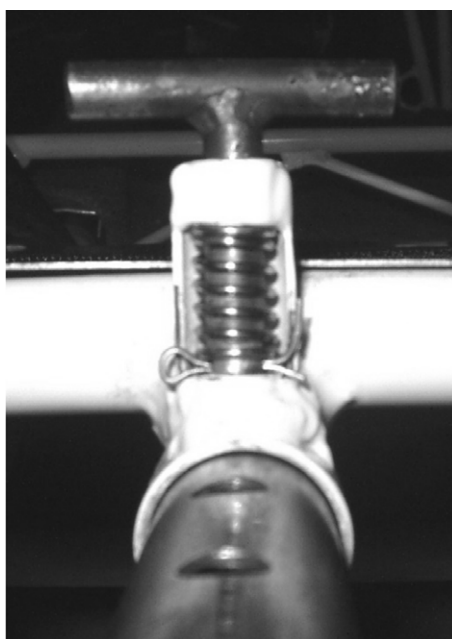
The seats are held in the selected position by a small spring-loaded pin centrally positioned at the front of each seat pan. The pin locates in equally spaced holes in a tube called an 'adjuster rail' attached to the cockpit floor middle and rear cross frame. Figure 7 shows the seat adjustment pin. The adjuster rail is attached by bolts and stiff nuts to lugs welded to the cross frames. The adjuster rail passes through a tubular bracing bracket, midway along the rail, which is bolted to the fuselage framework beneath the seat.

Image of seat pin from the aircraft assembly manual
(courtesy of the manufacturer)

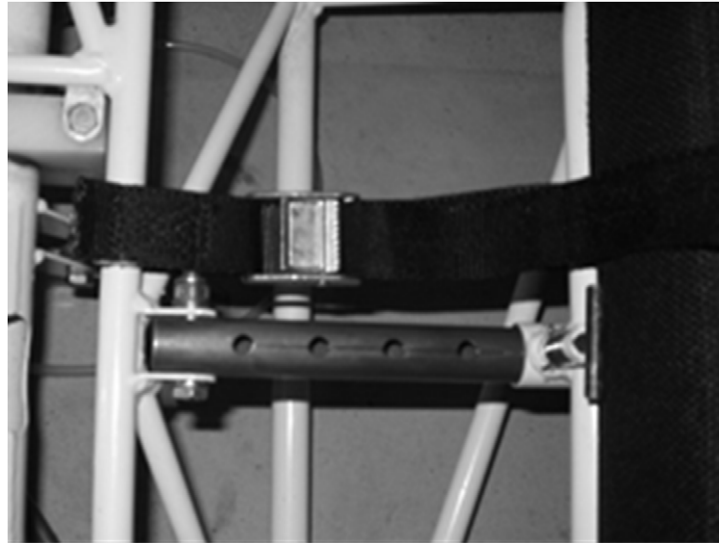
Figure 8

The seats in this aircraft had 150 mm of travel from their fully forward position abutting the cockpit floor middle cross frame, to a stop collar on the adjuster rail. Both seats were fitted with a 25 mm wide webbing loop and cam buckle looped around the seat pan front tube and tubes which were part of the middle cross frame. These were designed to be tightened after seat adjustment. They were known as '*seat adjuster backup straps*' (Figure 8). The installation manual states that these are '*a safety backup in case of seat pin failure.*' The straps should be tightened to remove any slack before flight, after the seat position has been finally adjusted.

Image of the seat adjuster backup strap from the aircraft assembly manual
(courtesy of the current manufacturer)
