ACCIDENT

Aircraft Type and Registration:	EV-97 Teameurostar UK, G-CFNW	
No & Type of Engines:	1 Rotax 912-UL piston engine	
Year of Manufacture:	2008 (Serial no: 3317)	
Date & Time (UTC):	5 March 2022 at 1100 hrs	
Location:	A6105, 1.5 Miles East of Duns, Scottish borders	
Type of Flight:	Private	
Persons on Board:	Crew - 1	Passengers - None
Injuries:	Crew - 1 (Minor)	Passengers - N/A
Nature of Damage:	Damaged beyond economical repair	
Commander's Licence:	National Private Pilot's Licence	
Commander's Age:	60 years	
Commander's Flying Experience:	950 hours (of which 499 were on type) Last 90 days - 7 hours Last 28 days - 6 hours	
Information Source:	Aircraft Accident Report Form submitted by the pilot

Synopsis

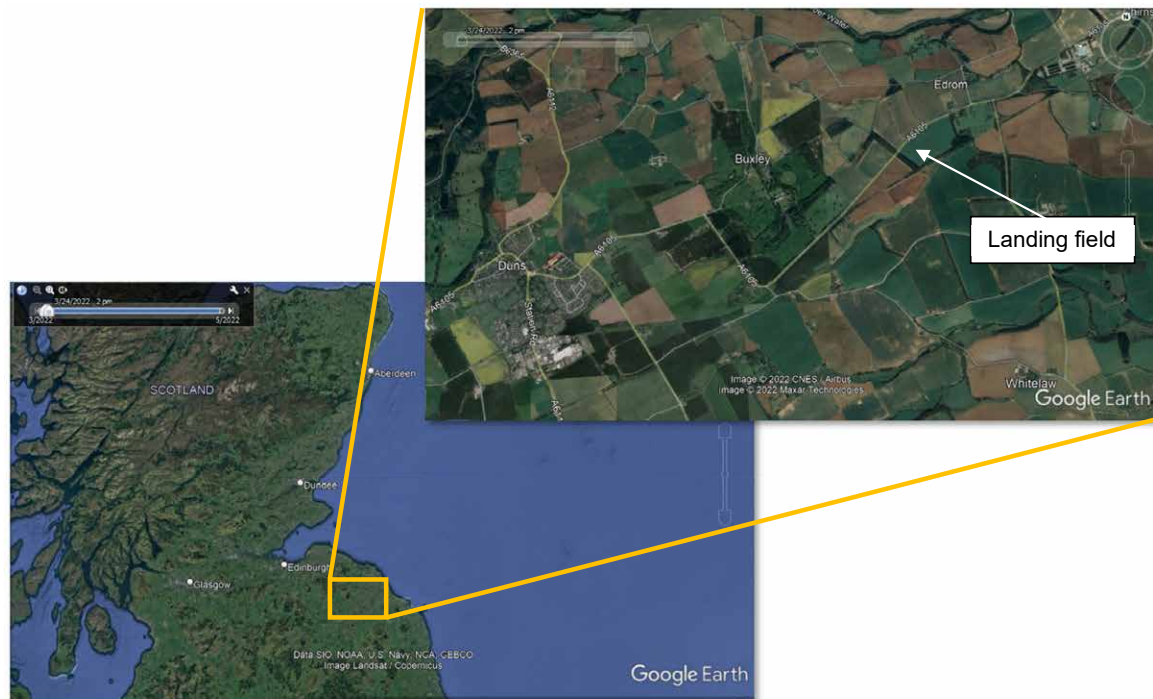
Figure 1

On 3 March 2022 the pilot was flying G-CFNW from Sherburn-in-Elmet Airfield in Yorkshire to Perth Airport in Scotland when he was confronted by deteriorating weather as he crossed the Scottish border. He descended to remain clear of cloud and, assessing that he would not be able to continue the flight under VFR, made a precautionary landing in the nearest suitable field just over 3 km to the east of Duns (Figure 1).

Location of precautionary landing field
