AAIB Bulletin S2/2022

SPECIAL

SERIOUS INCIDENT

Aircraft Type and Registration:	Bombardier CL-600-2B16 (604 variant), D-AAAY	
No & Type of Engines:	2 General Electric CF34-3B turbofan engines	
Year of Manufacture:	2004 (Serial no: 5602)	
Date & Time (UTC):	10 August 2022 at 1640 hrs	
Location:	In the climb after departing from Farnborough Airport, Hampshire	
Type of Flight:	Commercial Air Transport (Passenger)	
Persons on Board:	Crew - 3	Passengers - 7
Injuries:	Crew - None	Passengers - None
Nature of Damage:	Still under assessment	
Commander's Licence:	Airline Transport Pilot's Licence	
Commander's Age:	56 years	
Commander's Flying Experience:	13,091 hours (of which 5,655 were on type) Last 90 days – 102 hours Last 28 days – 41 hours	
Information Source:	AAIB Field Investigation

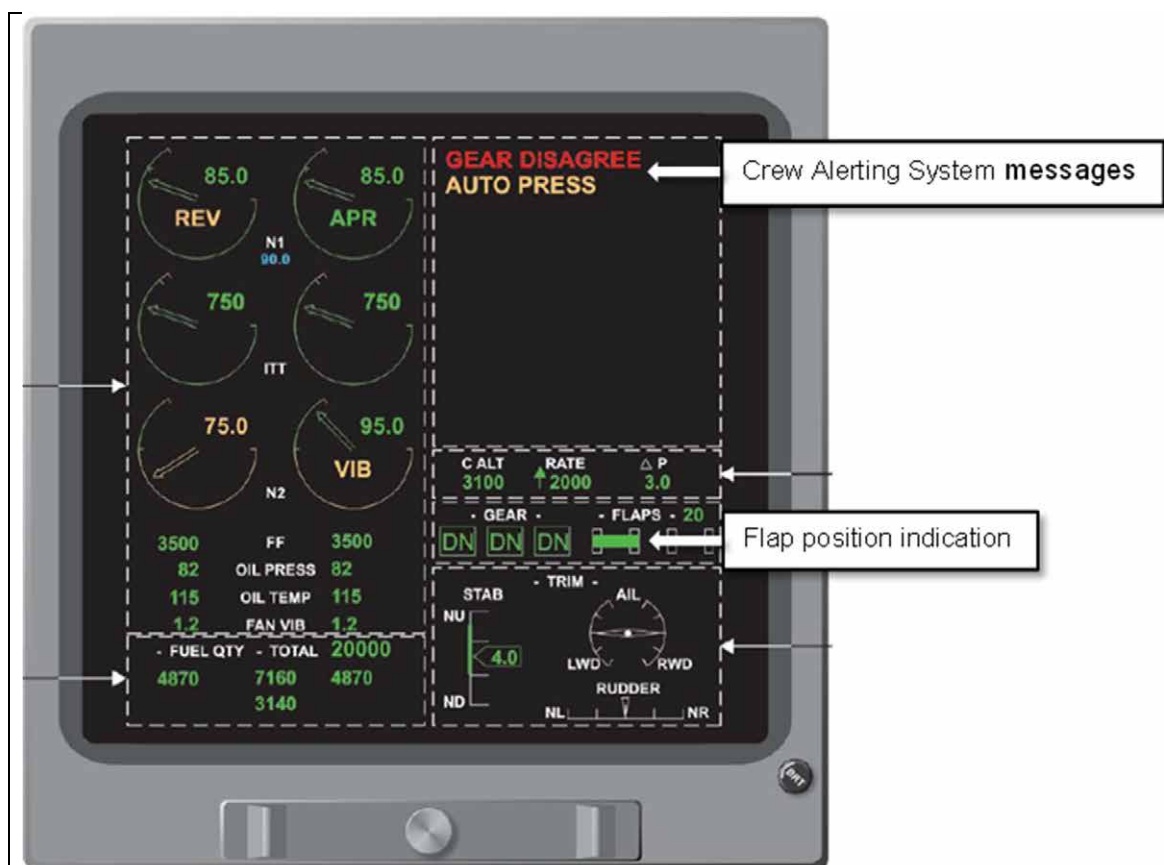
Figure 1

Illustration of EICAS primary page information

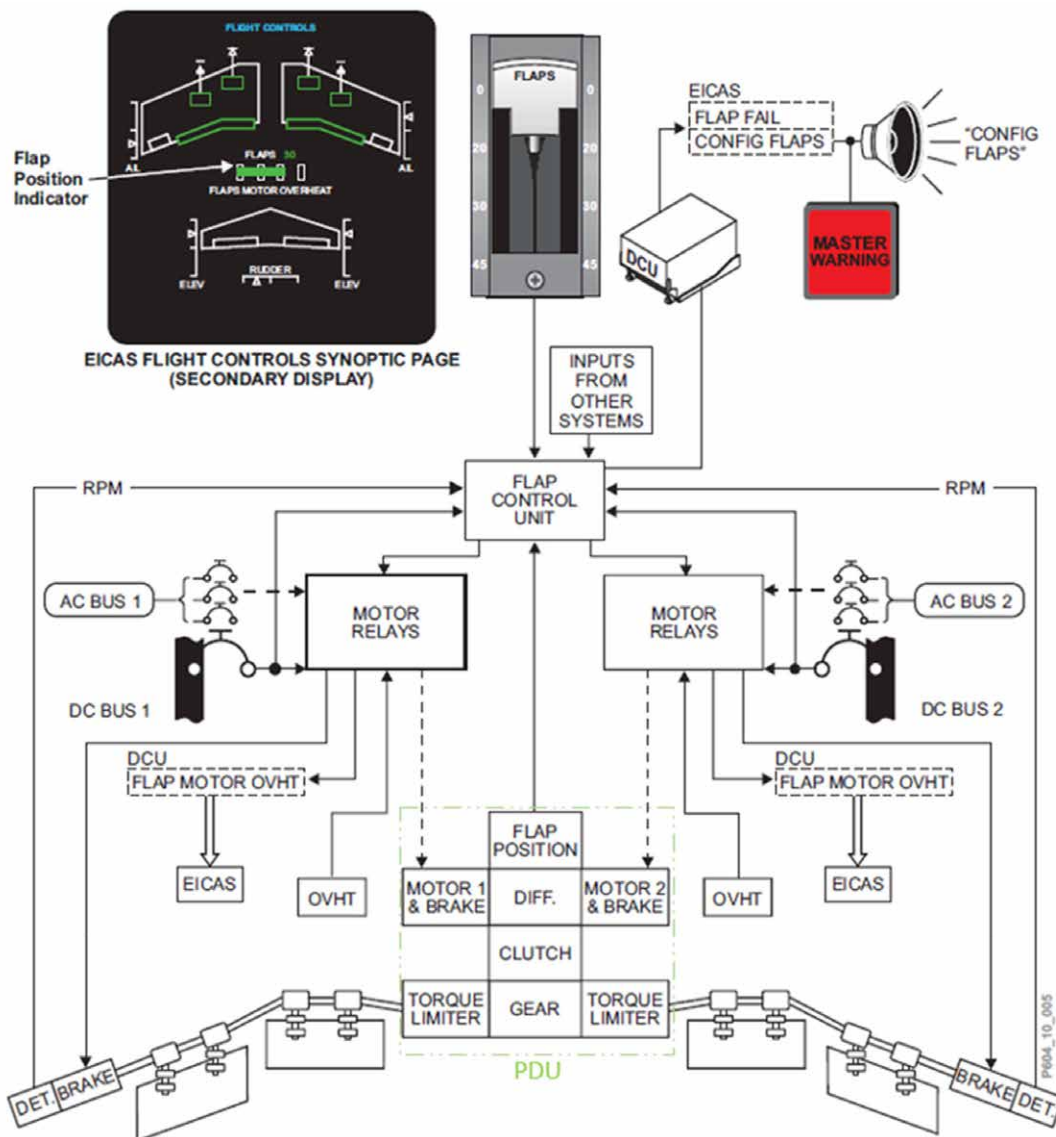
Figure 3

Schematic diagram of flap system

When both motors are operational, the flaps operate at normal speed. If one motor fails or is not commanded to operate due to a failure in its control system, the remaining motor will continue to drive the flaps, but the system will operate at half speed due to the gearbox arrangement in the PDU. If a motor fails due to overheat, a 'FLAPS MOTOR OVHT' status EICAS message will be displayed.

If a complete failure of the flap system occurs, such as both motors failing to operate, an asymmetry of greater than 2.75°, or a flap uncommanded movement, a 'FLAPS FAIL' caution message will be displayed on EICAS.

The FCU has an uncommanded movement protection system. If an uncommanded movement of the flaps occur and the actual flap position exceeds the commanded position by greater than three degrees, the system is activated to arrest further flap movement. Activation of the uncommanded motion monitor powers both the extend and retract commands to the motor relays to activate the protection. This engages the wing tip brakes, by de-energizing them, and removes power from both flap drive motors, arresting the movement, and a 'FLAP FAIL' EICAS message is displayed.
