AAIB Bulletin

10/2022

Aircraft Type and Registration:	BAe ATP, SE-LPS	
No & Type of Engines:	2 Pratt and Whitney Canada PW126A turboprop engines	
Year of Manufacture:	1991 (Serial no: 2043)	
Date & Time (UTC):	9 April 2021 at 0519 hrs	
Location:	Ronaldsway Airport, Isle of Man	
Type of Flight:	Commercial Air Transport (Cargo)	
Persons on Board:	Crew - 2	Passengers - None
Injuries:	Crew - None	Passengers - N/A
Nature of Damage:	None reported	
Commander's Licence:	Airline Transport Pilot's Licence	
Commander's Age:	54 years	
Commander's Flying Experience:	5,415 hours (of which 2,964 were on type) Last 90 days - 44 hours Last 28 days - 20 hours	
Information Source:	AAIB Field Investigation

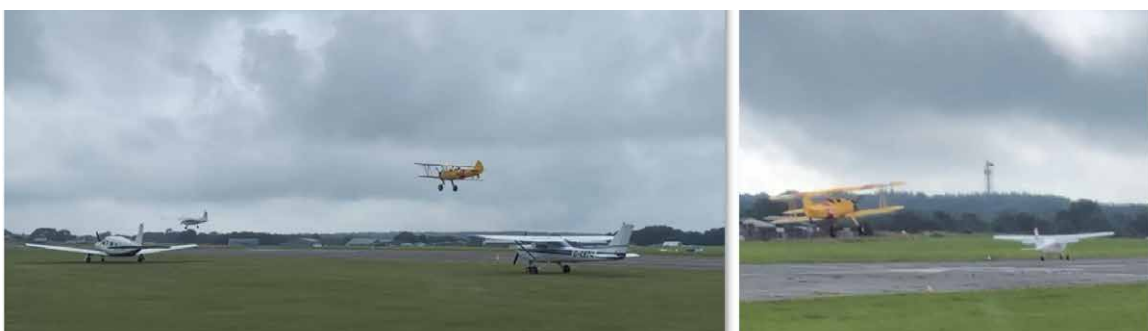
Figure 4

The pilot reported that he made a radio transmission as he started the base leg, then again when established on final. He then heard a final call from another aircraft and, assuming it was an aircraft positioning behind him, made an information call: “November 27 final, close to threshold”. There was no response from the other aircraft, so he continued with the approach. CCTV footage (Figure 3) showed that the Cessna had passed ahead of, and below, the Stearman before the Stearman had completed the base turn. Various witnesses reported seeing both aircraft on the final approach in very close proximity, “as though they were in formation” (Figure 4).

Aircraft on final approach
(images used with permission)

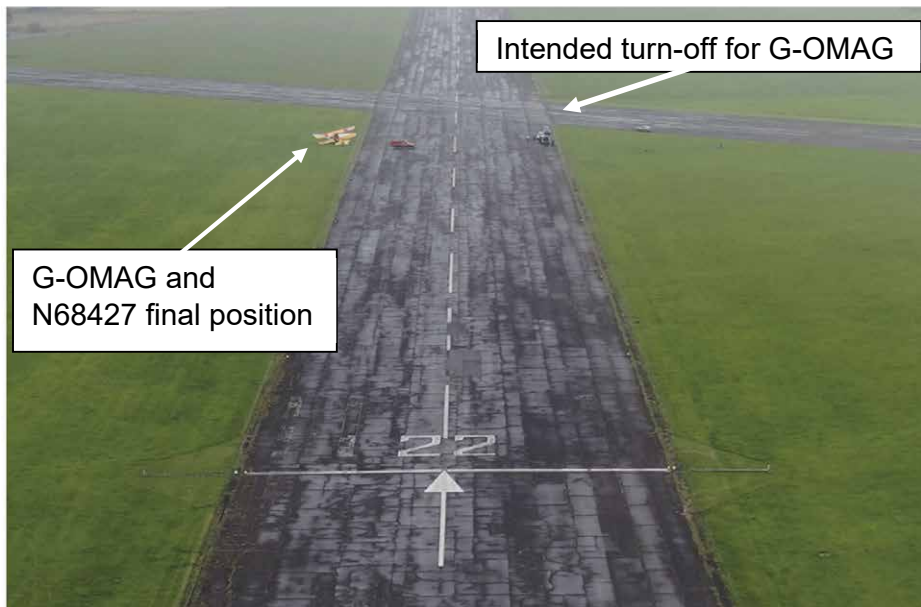
Figure 5

The pilot reported that the landing “didn’t feel right” and that the aircraft was not responding to control inputs. He applied power to correct what he felt was a drift to the left, then reduced power to idle. The aircraft continued to swing further to the left, off the runway and onto the grass (Figure 5).

Facing inset threshold of Runway 22
(image used with permission)

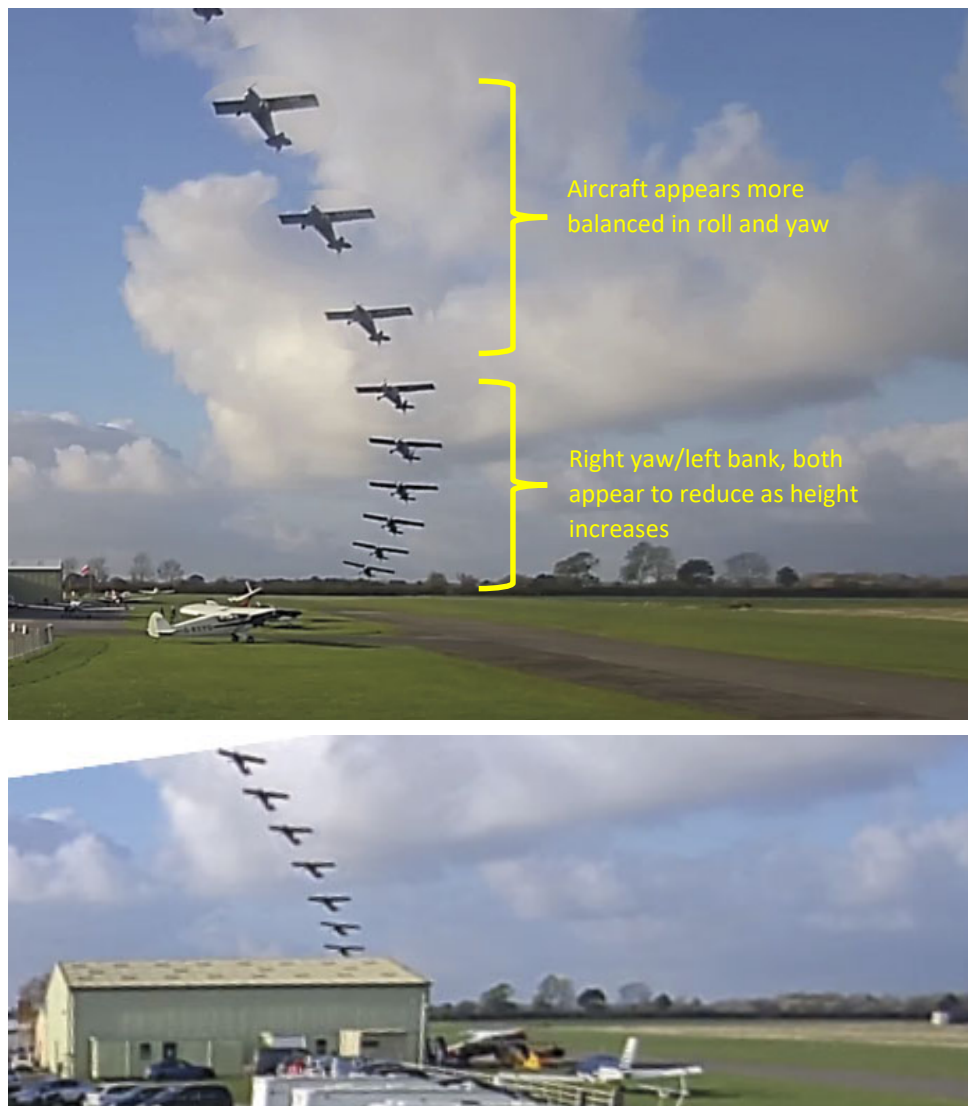
Figure 4

The recorded flight path of the accident flight is shown in Figure 3. The acceleration to takeoff was comparable with other recorded flights associated with this aircraft at the same airfield (some on the opposite runway). One of the CCTV cameras captured the takeoff roll and initial climb but there was insufficient contrast to calculate the aircraft orientation until the aircraft had climbed above the tree line in the background, at roughly 20 ft agl. As soon as it was visible, it was apparent that there was left roll and a left drift with the aircraft tracking to the right of the runway (Figure 4).

Cropped and combined snapshots of one of the CCTV recordings to show the aircraft flight path and orientation during a large part of the climb

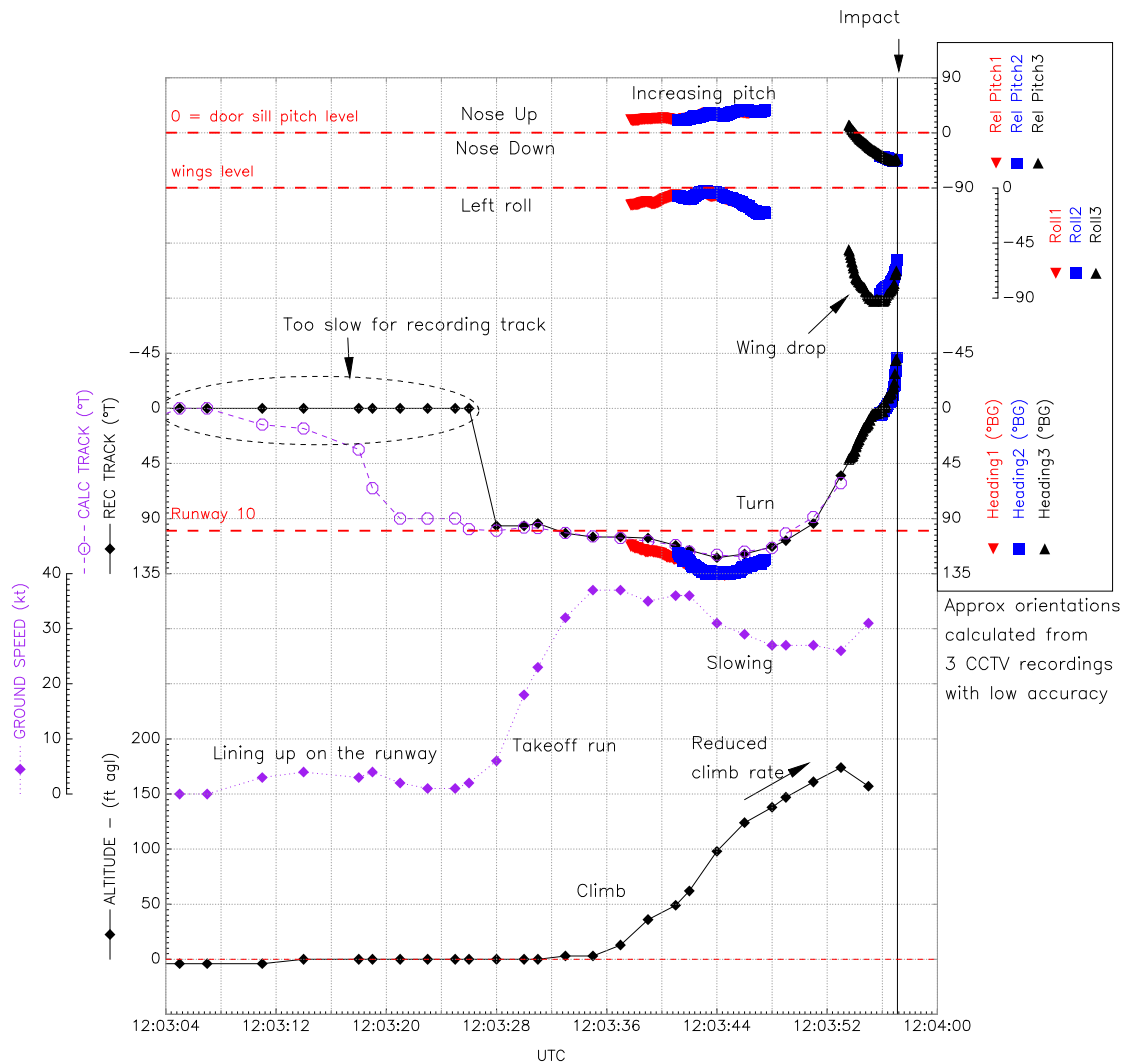
Figure 5

The flight path data and the approximate orientation of the aircraft for the accident flight are shown in Figure 5.

Data recorded by the Pilot Aware network and approximate orientation data derived from the CCTV recordings

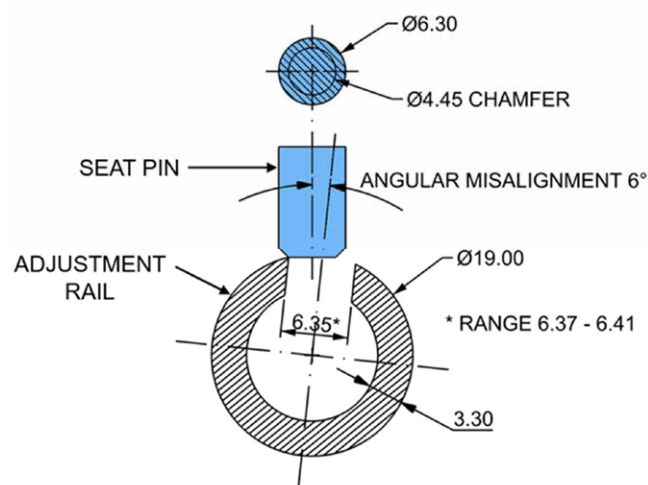
Figure 12

The aluminium alloy seat adjuster rail tube was 19.0 mm in diameter with a tube wall thickness of 3.3 mm. Where possible, measurements were taken of the visible holes which were found to have a diameter variation between 6.37 and 6.41 mm. The mark on the tube was 4.45 mm wide and offset against the hole centre line to the left by 0.43 mm. The pin was damaged and slightly bent but its engagement end could be accurately measured. The pin diameter was 6.30 mm and was chamfered leaving an end face diameter of 4.45 mm. The pin end is shown in Figure 11 and a schematic cross-sectional diagram of the dimensions and offset are shown in Figure 12. The offset shown in the diagram, represents the pin as it would naturally sit based on the dimensional evidence. The tolerance within the pin guide, plus any wear, allows the pin to advance further downwards such that the chamfer just engages in any of the adjuster rail holes against their edges. The evidence for this is shown in the preceding Figure 9.

Schematic cross-sectional diagram of the adjuster rail dimensions and pin offset (not to scale)

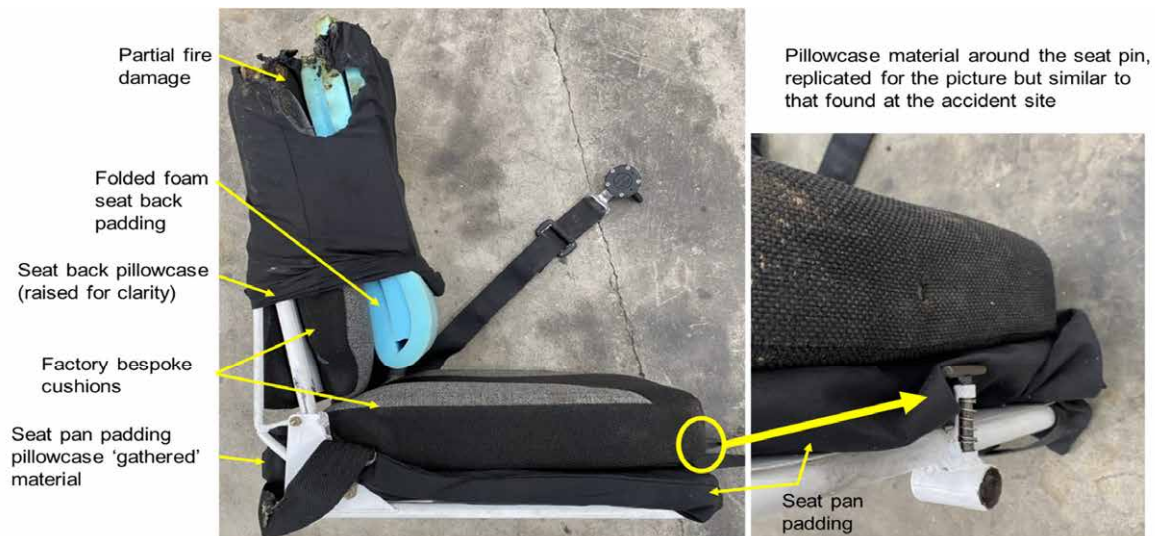
The seat pan foam padding was loosely placed under the factory-made cushion but was not fitted with the hook and loop strips positioned to attach the factory cushion to the seat pan. The seat back padding was fitted on the face of the factory-made seat back and the whole thing enclosed in a pillowcase and then slid over the seat back. Figure 16 shows the seat frame fitted with the padding and factory-made cushions.

Seat cushion and padding modifications

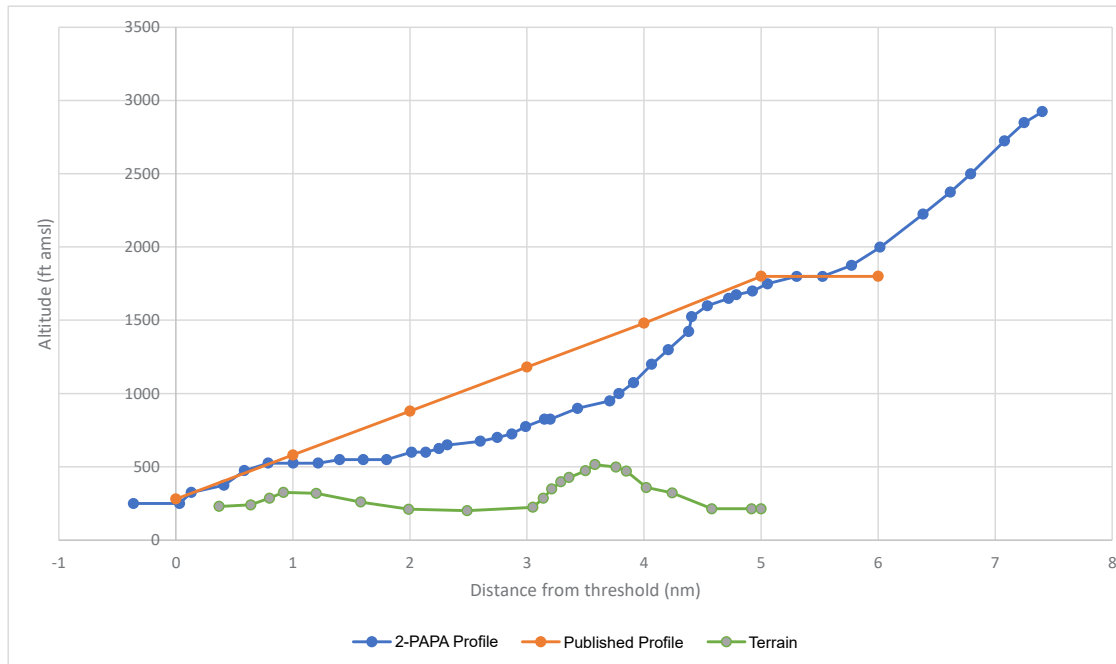
Figure 1

The aircraft was fitted with a FDR but no data was recovered from it. Data broadcast by the aircraft was used to create Figure 1. The profile flown by 2-PAPA is shown in blue and the published NDB/DME approach profile is shown in orange. The terrain under the approach path is shown in green.

Profile flown by 2-PAPA compared to the published profile and terrain

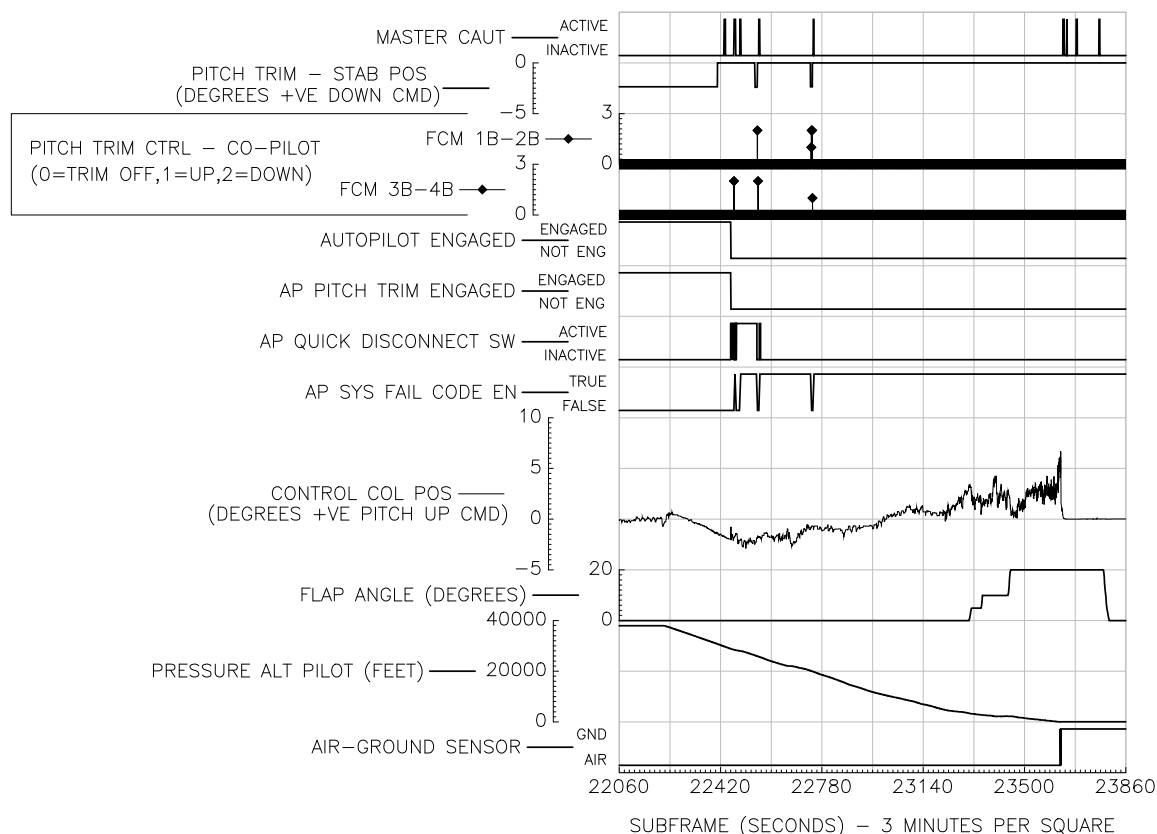
Figure 1

that this -2.4° of pitch trim reflected the actual pitch trim of the HSTAB during the approach and landing as this was the last value recorded before the parameter switched to reading an unreasonable value of 0° and there was no recorded trim activity after that. Less than normal pitch up trim is also indicated by greater than the normal pitch up control inputs required by the pilot.

Pertinent extracts from the flight data recording
