SERIOUS INCIDENT

Aircraft Type and Registration:	Boeing 737-800, G-JZHL	
No & Type of Engines:	2 CFM CFM56-7B26E turbofan engines	
Year of Manufacture:	2016 (Serial no: 63568)	
Date & Time (UTC):	1 December 2021 at 1452 hrs	
Location:	Kuusamo Airport, Finland	
Type of Flight:	Commercial Air Transport (Passenger)	
Persons on Board:	Crew - 6	Passengers - None
Injuries:	Crew - None	Passengers - N/A
Nature of Damage:	None	
Commander's Licence:	Airline Transport Pilot's Licence	
Commander's Age:	44 years	
Commander's Flying Experience:	7,459 hours (of which 3,344 were on type) Last 90 days - 204 hours Last 28 days - 47 hours	
Information Source:	AAIB Field Investigation

Synopsis

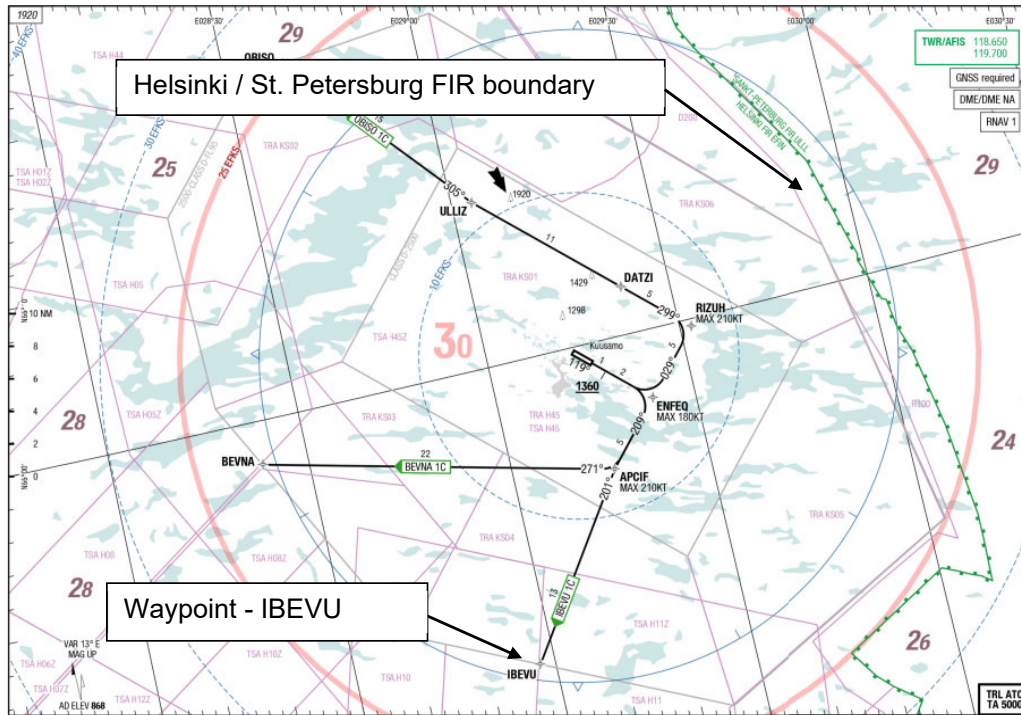
Figure 4
IFR Departure Chart for Kuusamo Airport

The insert in Figure 1 shows the location of the airport, which is approximately 10 nm from the boundary between Helsinki and St Petersburg Flight Information Regions (FIR). Figure 4 is an extract from the IFR plates used by the operator. The chart shows the proximity of the border (in green) and the waypoint IBEVU which the crew were cleared to route via after departure. There is a restricted area (R100) along the border and a danger area to the north (D200). These are depicted on the IFR chart (Figure 4) but are shown more clearly in Figure 5 (this was not available to the flight crew in flight). The danger area exists from the surface to 1,000 ft agl, but the restricted area covers all altitudes.

The Airport Operational Information section of the operator's IFR charts for Kuusamo contains the note '*aircraft with a MTOW exceeding 2000kg: after TKOF from RWY 12 turn right*' (the note is extracted from the Finnish Aeronautical Information Publication (AIP)). The flight crew had also been cleared via a waypoint to the south of the airport. They, therefore, intended to turn right but were not aware of any obligation or requirement for them to report this to the FISO.

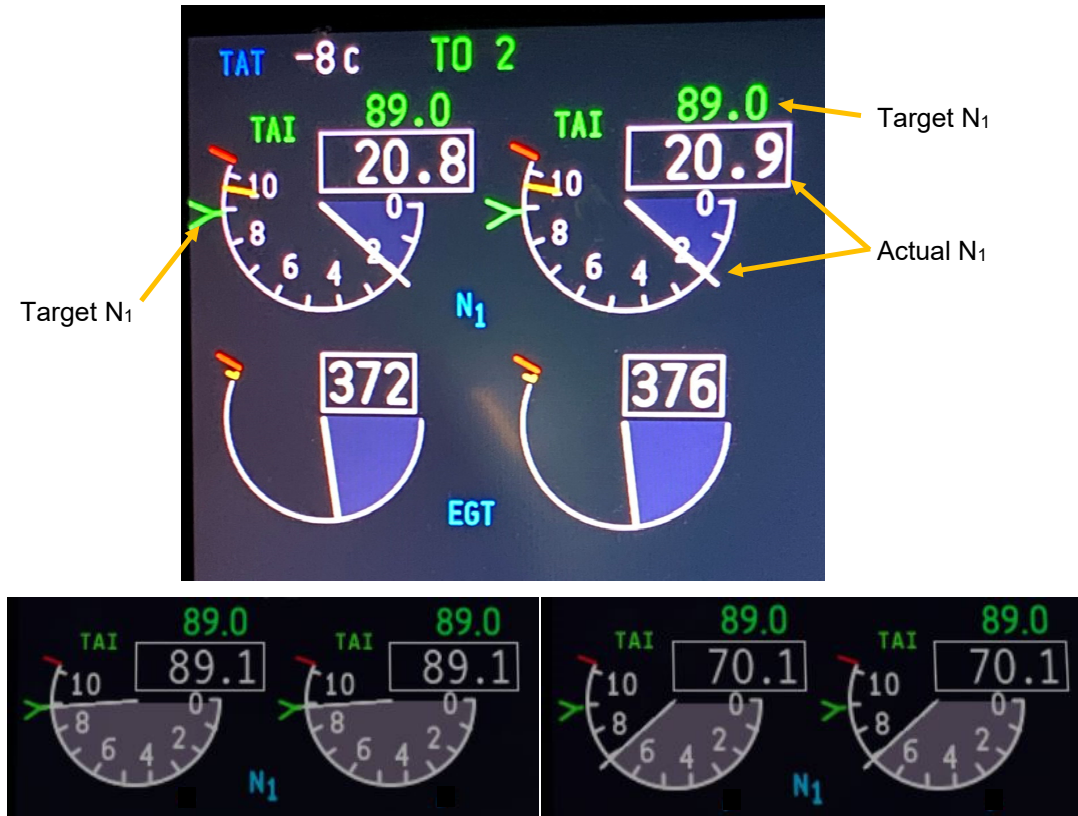
During the takeoff roll, prior to 80 kt, both pilots are required to verify the correct takeoff thrust is set (marked as note 2 in Figure 7). This requires the pilots to verify the actual N_1 display on the upper centre display matches the target N_1 (Figure 8). The actual N_1 and the target N_1 are shown in digits and on a rotary dial. The lower images in Figure 8 show the indications with the correct thrust set (left image) and with approximately 70% N_1 set (right image).

Primary engine instruments shown on the upper centre screen (images captured in a simulator)

Having omitted the thrust set check after answering the radio call, the commander had seven seconds until the aircraft passed 80 kt, a further five seconds until V_1 , then a further 25 seconds before V_R . During the takeoff roll the pilot monitoring would normally be monitoring the aircraft for any abnormal indications. There were several indications on the flight deck which might have alerted him that the thrust was not set correctly and that TOGA had not been pressed. The needles on the N_1 gauges would not have been aligned with the target bugs and the digits would have been different from the target digits (Figure 8). With hindsight these indications may seem obvious, but it is common for humans to see what they expect to see or 'look without seeing' (Footnote 8). This is more common with an indication which is normally correct. Experienced pilots who have seen hundreds of takeoffs will nearly always have seen the thrust correctly set. On the one occasion when it is not set, it is possible that they will not see it, they will just see what they expect to see.

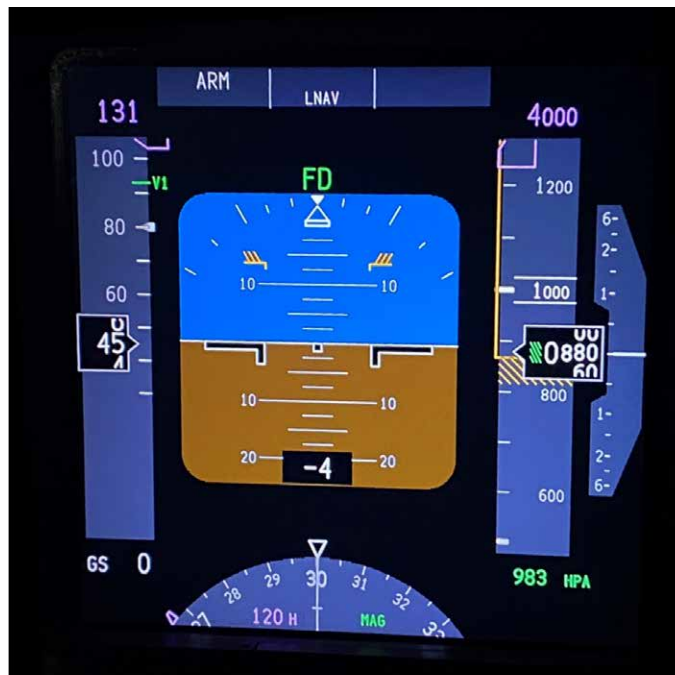
The top section of the PFD contains the Flight Mode Annunciator (FMA). The FMA tells the pilot which autothrottle, flight director and autopilot modes are armed or active. Figure 9 shows the PFD prior to the takeoff as it was set up on the incident flight. The autothrottle is armed (ARM in white in the left column of the FMA), the flight director roll mode has LNAV (lateral navigation system) armed (LNAV in white in the centre column) and the pitch mode (right column) is blank.

PFD prior to starting the takeoff (image captured in a simulator)
