AAIB Bulletin

11/2022

Special Bulletin S2/2022: Bombardier CL-600-2B16 (604 variant)	D-AAAY	10-Aug-22	3
---	--------	-----------	---

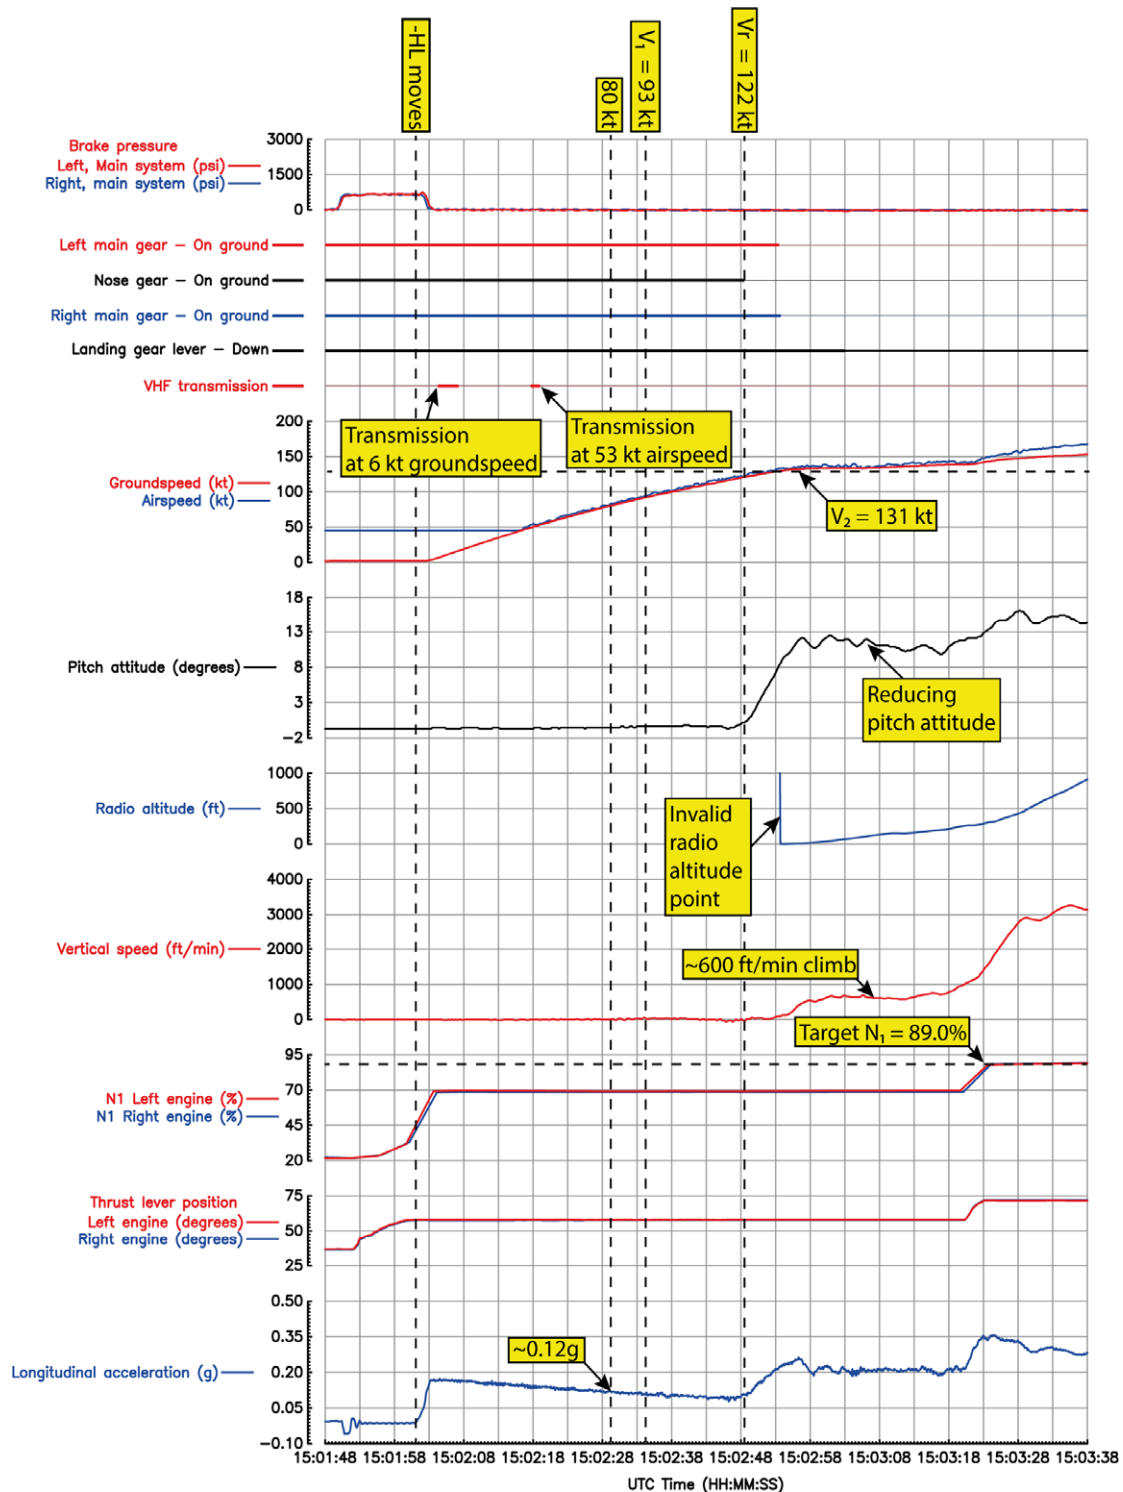
Figure 2

FDR data for G-JZHL's takeoff and second segment climb

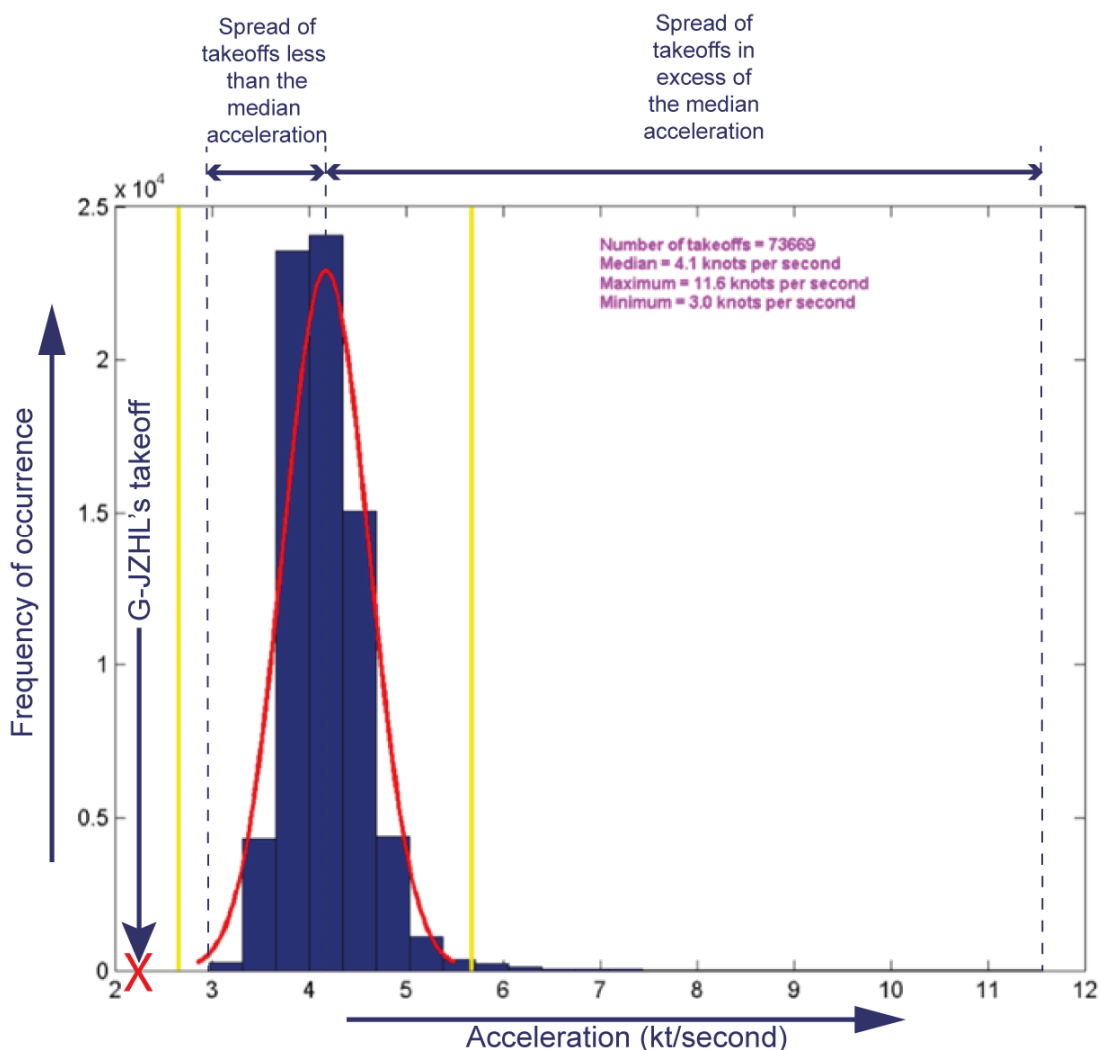
G-JZHL's acceleration on takeoff compared with other 737-800 takeoffs.
Used with permission

By comparison, G-JZHL was accelerating at 2.25 kt/second, as it passed through 80 kt airspeed. This value is shown on Figure 11 by the red cross.

The histogram in Figure 11 is heavily skewed, showing a much larger spread of takeoffs where the acceleration exceeded the median value of 4.1 kt/second than for accelerations below the median. The maximum recorded value (11.6 kt/second) is 7.5 kt/second above the median, whereas the minimum value (3.0 kt/second) is only 1.1 kt/second below the median.

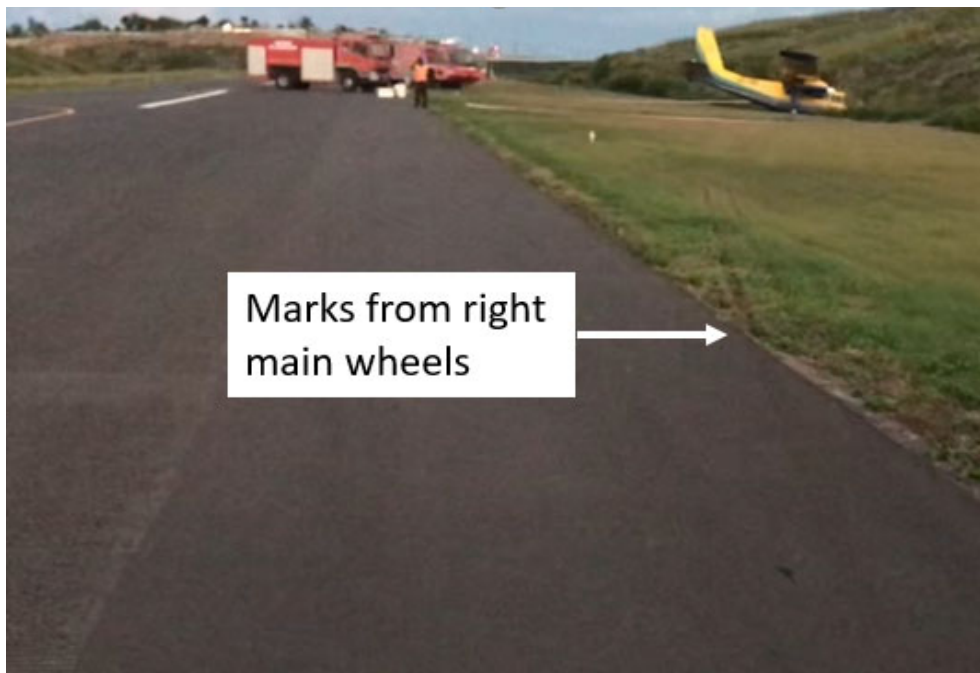
Figure 1

The pilot reported he commenced the approach, flying an approach speed of 65 kt, reducing to 60 kt as the aircraft touched down. The runway surface was dry and the pilot described the landing as “smooth”. After the main landing gear touched down, but prior to the nosewheel contacting the runway, the pilot applied the brakes. He reported that the left brake felt “spongy” and did not seem to act, but that the right brake felt normal. The pilot was unable to maintain directional control of the aircraft which veered to the right two seconds after touchdown, departing the runway a further three seconds later. The aircraft continued across the adjacent grassed area before impacting an embankment close to the runway (Figure 1).

Still image captured from a video showing the aircraft's departure point from Runway 10 and final resting place

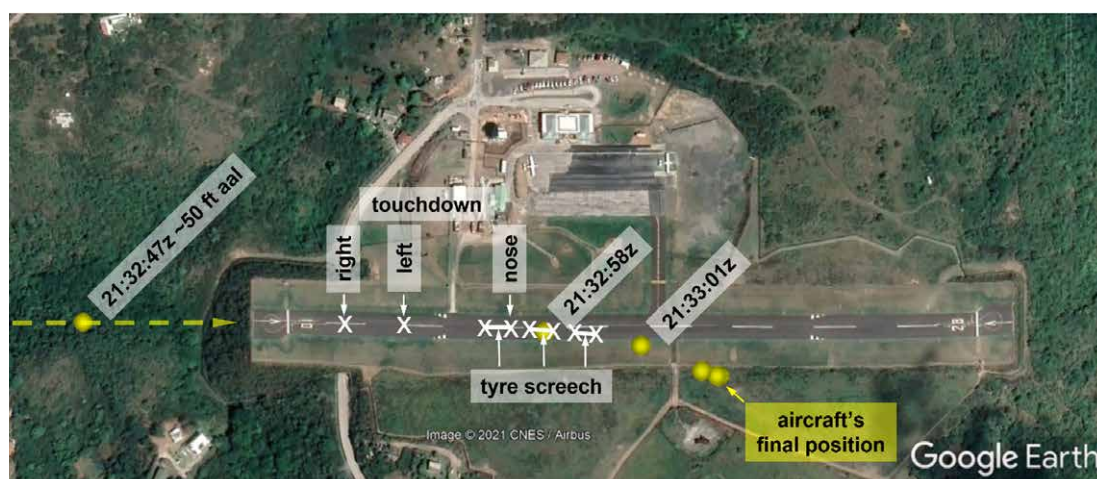
Figure 4

The data from the GPS device was downloaded and, together with airport CCTV footage and video taken from within the cabin by a passenger, an approximate track of the aircraft's ground track was generated (Figure 4).

GPS ground track based on CCTV (white crosses) and GPS (yellow circles)

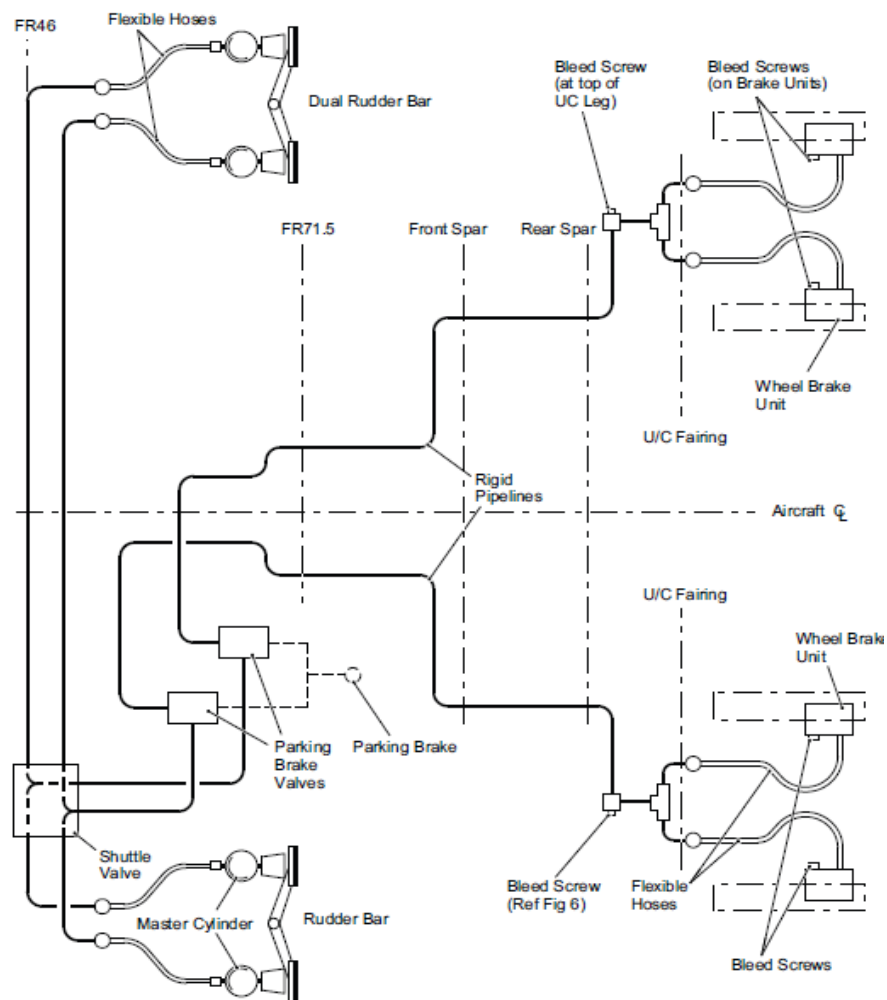
Figure 5

The brake system consists of master cylinders attached to each of the pilot's rudder pedals. Operation of the left brake pedal supplies brake fluid under pressure to the left brake calliper. Pistons in the calliper push friction pads against a brake disc in proportion to the pressure applied to provide braking. Likewise, operation of the right pedal supplies pressure to the right brakes to provide braking. The pilot operates the individual brake pedals to obtain the required braking action. During the landing roll, this would normally be both equally together to ensure the aircraft stops in a straight line. The co-pilot's rudder pedals are also fitted with master cylinders and operation of these pedals supplies pressure to the brakes in a similar way to the pilot's but through shuttle valves which allow the highest pressure applied to supply the brakes. In common with other similar aircraft, there is no anti-skid system and as a result, the pilot is required to adjust the brake pressure manually to ensure the braked wheels do not skid. A parking brake is available and when applied it maintains any pressure applied to the brakes (Figure 5).

Schematic diagram of braking system

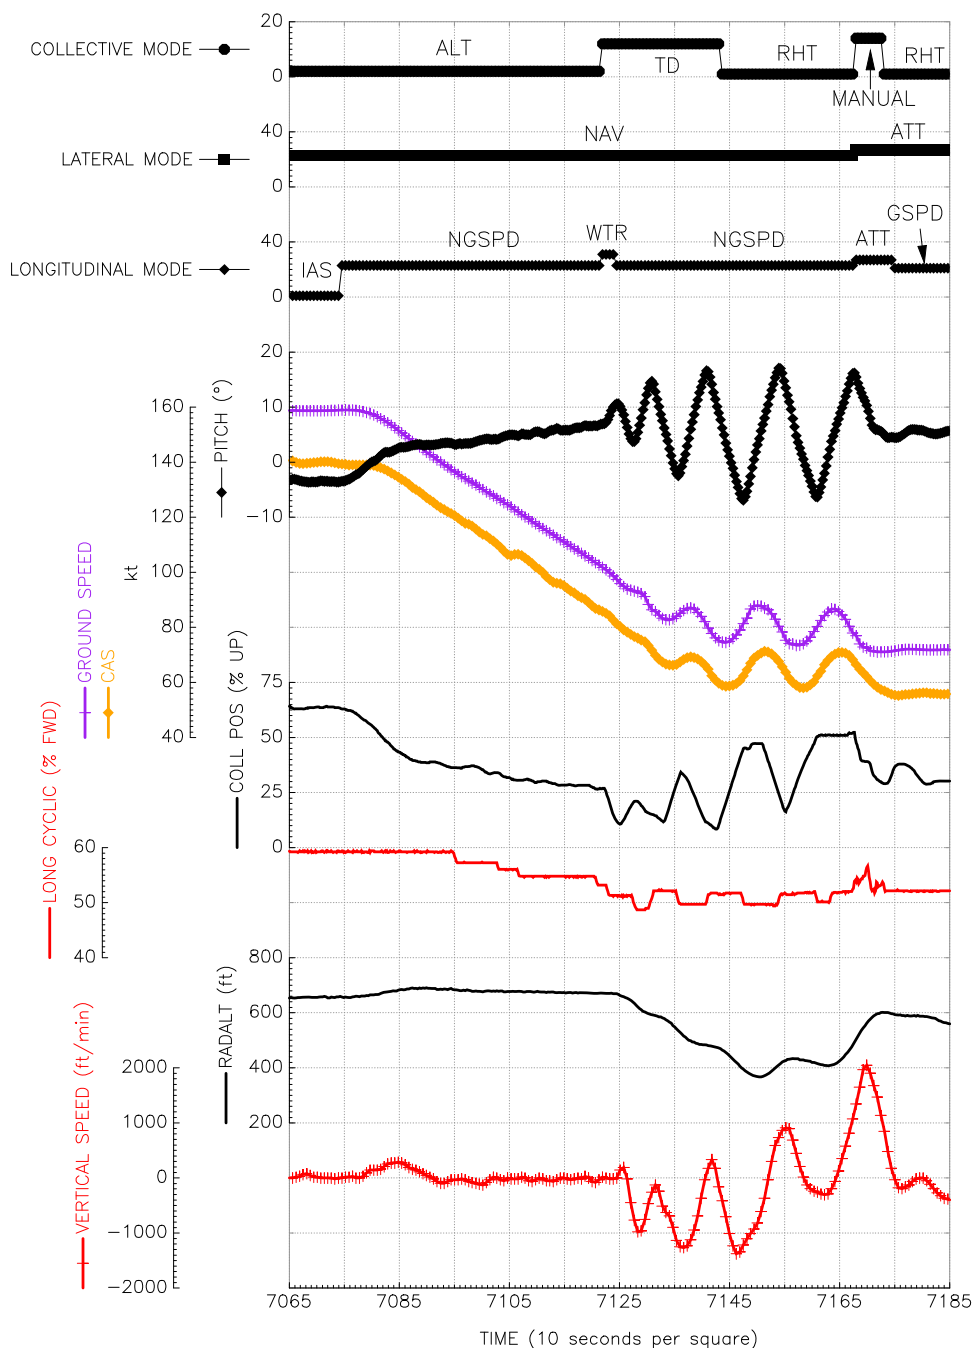
Figure 4
 Pertinent extracts of FDM data from the 5 July 2021 incident

One aspect of the investigation centred on the AFCS modes displayed to the crew. The recorded AFCS modes are stored as numbers that are then referenced to a table that identifies the relevant mode. These are the same numbers that are sent to the displays that control the PFD mode annunciations. Figure 4 is annotated with what is displayed when the recorded numbers are sent to the displays. As discussed later in the report, the investigation identified that this does not accurately reflect the actual AFCS active modes under certain circumstances.

The sequence shown in Figure 4 started with AFCS collective mode ALT captured, maintaining a selected altitude, lateral NAV mode captured, following an FMS path, and longitudinal IAS, holding approximately 140 KCAS. The longitudinal mode switched to NGSPD indicating that a search pattern had been activated. The helicopter pitched up slowly to decelerate to a target groundspeed associated with the search pattern.

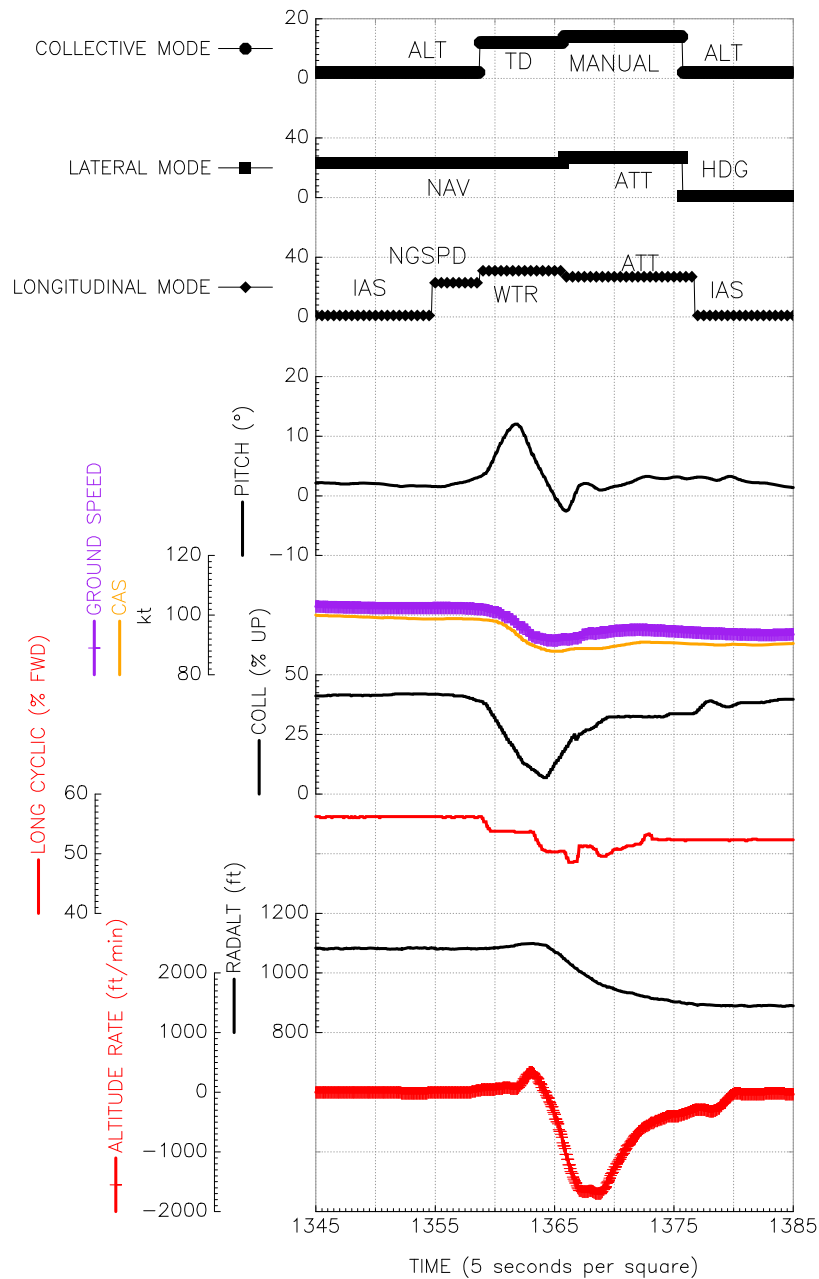
This event started with the helicopter flying at approximately 1,100 ft agl and 100 KCAS, with the AFCS collective ALT mode captured, along with the NAV and IAS modes. The longitudinal mode switched to NGPSD indicating the activation of an FMS directed search pattern. The helicopter started pitching up to reduce speed. The collective TD mode was selected to initiate a descent, and the recorded longitudinal mode switched to WTR. This

was the same behaviour as observed on the 5 July 2021 incident and resulted in the same erroneous indication that WTR was captured. The switch to TD resulted in an increased rate of pitching up. The helicopter reached a peak of approximately 12° nose up and then started pitching down. As the pitch reached approximately 3° nose down, the AFCS upper modes were deselected, and the crew took manual control.

Figure 5
 Pertinent extracts of flight recorder data from the 30 July 2021 incident

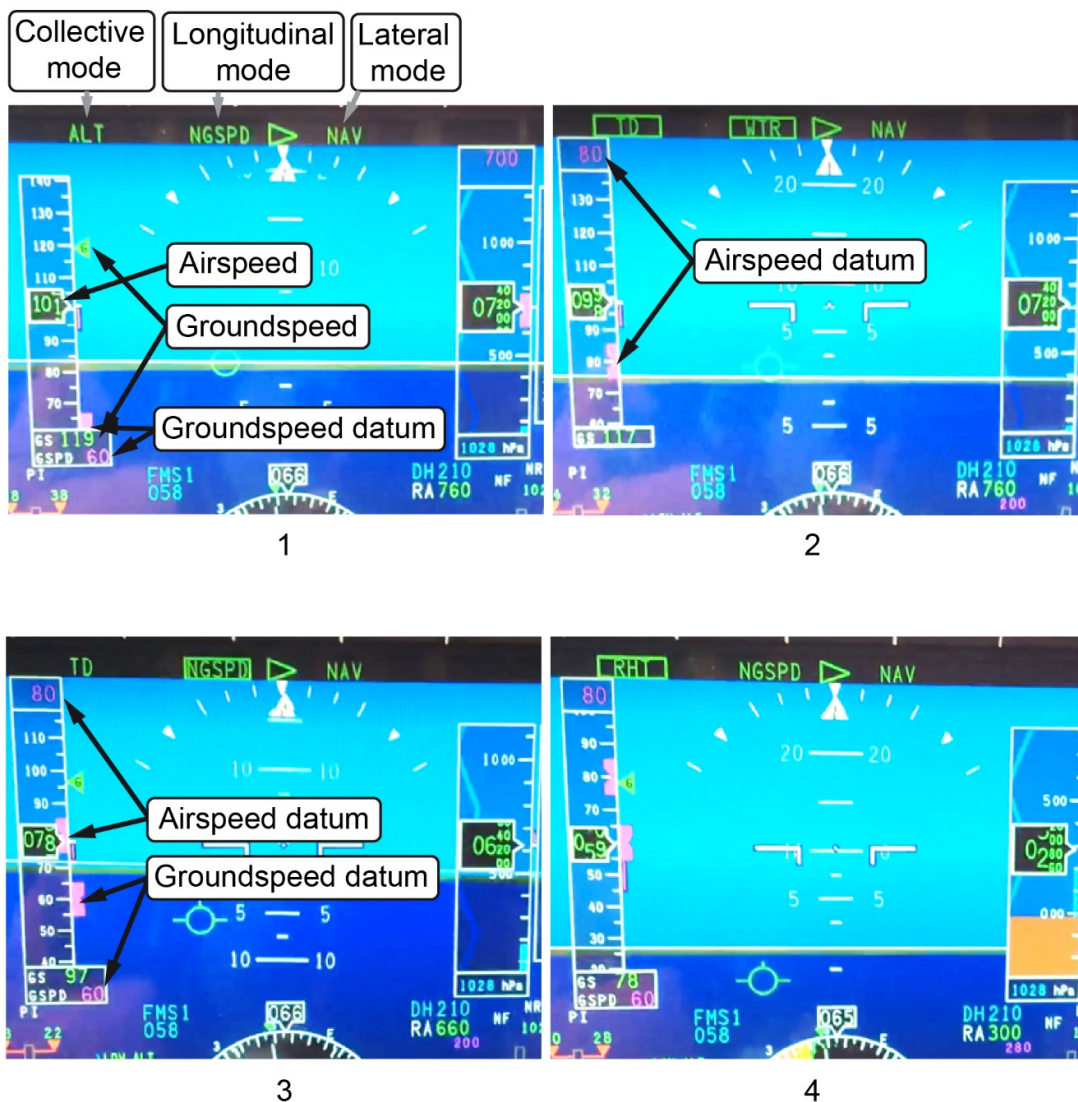
A video recording of the PFD was made on the test flights conducted by the operator. Heights and speeds were not reproduced but the behaviour associated with the incorrect annunciations and the simultaneous groundspeed and IAS target speeds were recorded. Figure 6 shows a similar sequence to that which occurred during the 5 July event.

- 1 NGSPD active.
- 2 TD activated, longitudinal mode WTR annunciated, pitch oscillations start.
- 3 Slowed through 80 KIAS, longitudinal mode of TD switch to IAS, annunciation change to NGSPD, both groundspeed and airspeed datums.
- 4 FTR triggered height datum change, collective mode change to RHT, two speed datums persist, pitch oscillations persist until NGSPD deselected.

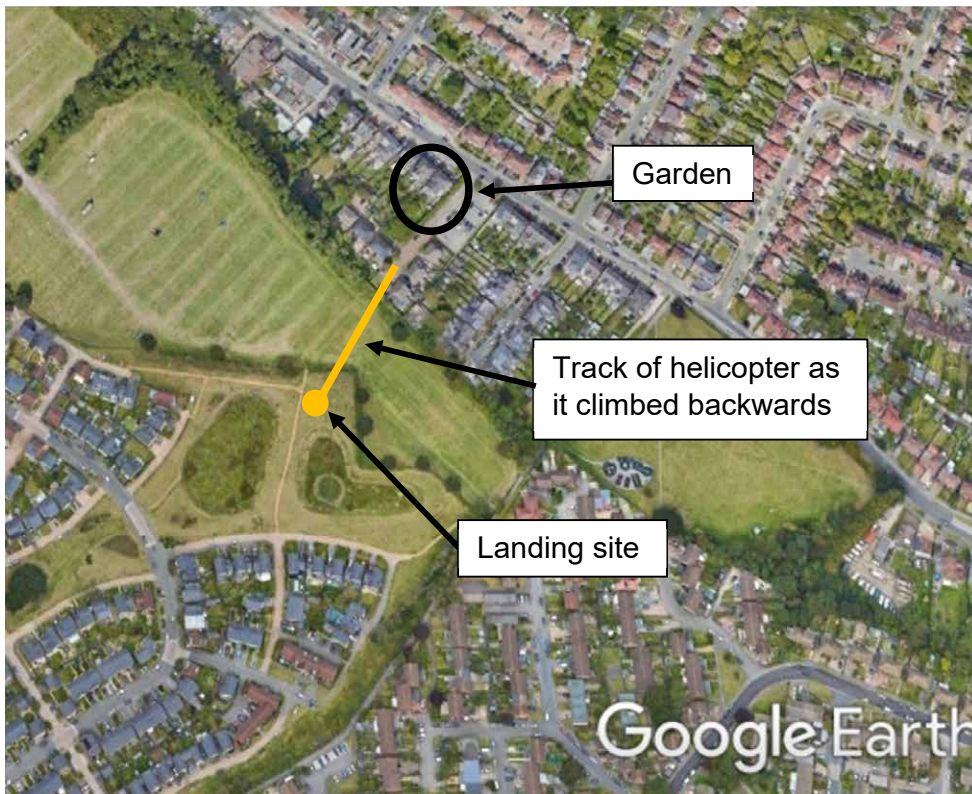
Data was available for the flight of the helicopter. Figure 1 shows the landing site of the helicopter and its track rearwards on its departure. It also shows the garden in which the injury occurred.

The location of the helicopter and garden in which the incident occurred

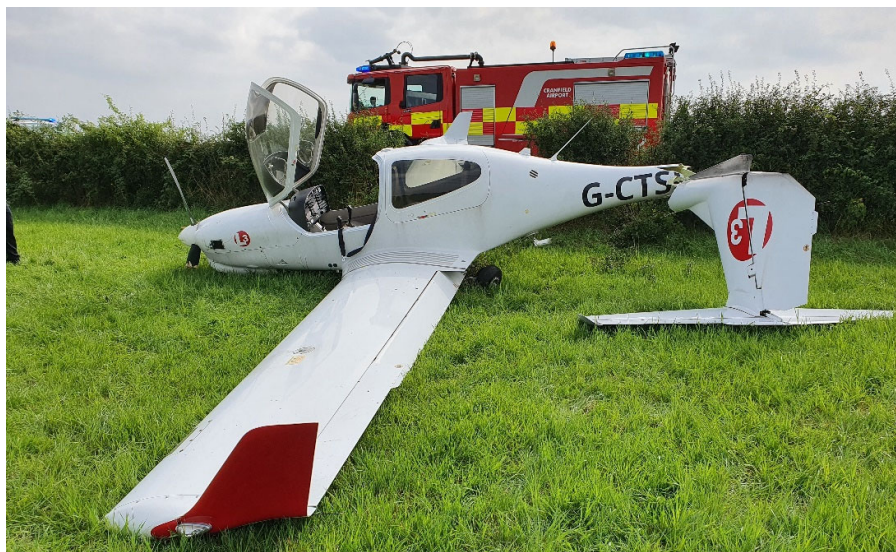
The aircraft was damaged beyond economical repair.

Figure 1
G-CTSR after the accident

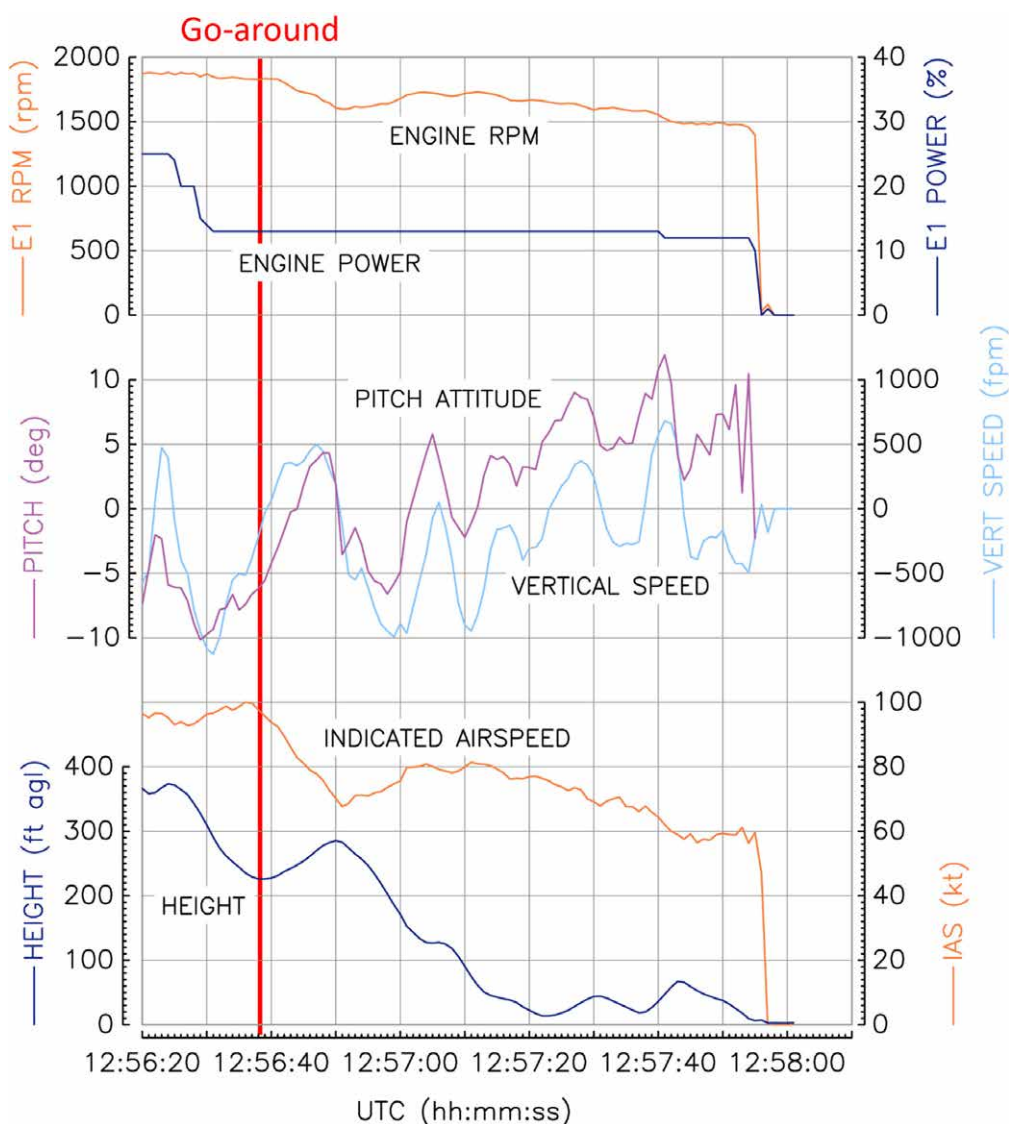
Figure 2

The aircraft was fitted with an integrated electronic flight instrument system (EFIS), and its removable memory card was downloaded. Pertinent data from the flight is shown in Figure 2. The data shows that the GA was initiated at about 215 ft aal, at which point the IAS was 100 kt, and the pitch attitude of the aircraft slowly increased to about 4° nose up. The IAS then decreased to 68 kt as the height increased slightly to about 240 ft aal. The aircraft then began a descent during which the IAS increased to about 80 kt. The aircraft's height then varied slightly, although it stayed predominantly below about 60 ft aal, and the IAS began to reduce again. Finally, the aircraft descended further and struck the hedge. Throughout the GA the engine power remained stable at about 13%.

Graph showing pertinent data from the EFIS
