**ACCIDENT**

<b>Aircraft Type and Registration:</b>	Boeing 787-8, G-ZBJB	
<b>No &amp; Type of Engines:</b>	2 Rolls-Royce Trent 1000-AE3 turbofan engines	
<b>Year of Manufacture:</b>	2013 (Serial no: 38610)	
<b>Date &amp; Time (UTC):</b>	18 June 2021 at 0651 hrs	
<b>Location:</b>	London Heathrow Airport Stand 583	
<b>Type of Flight:</b>	Commercial Air Transport (Cargo)	
<b>Persons on Board:</b>	Crew - 2	Passengers - None Other - 6
<b>Injuries:</b>	Crew - 1 (Minor)	Passengers - N/A Other - 1 (Minor)
<b>Nature of Damage:</b>	Underside of forward fuselage, door 2L and forward lower engines cowlings damaged	
<b>Commander's Licence:</b>	Airline Transport Pilot's Licence	
<b>Commander's Age:</b>	47 years	
<b>Commander's Flying Experience:</b>	8,364 hours (of which 587 were on type) Last 90 days - 26 hours Last 28 days - 0 hours	
<b>Information Source:</b>	AAIB Field Investigation

**Synopsis**

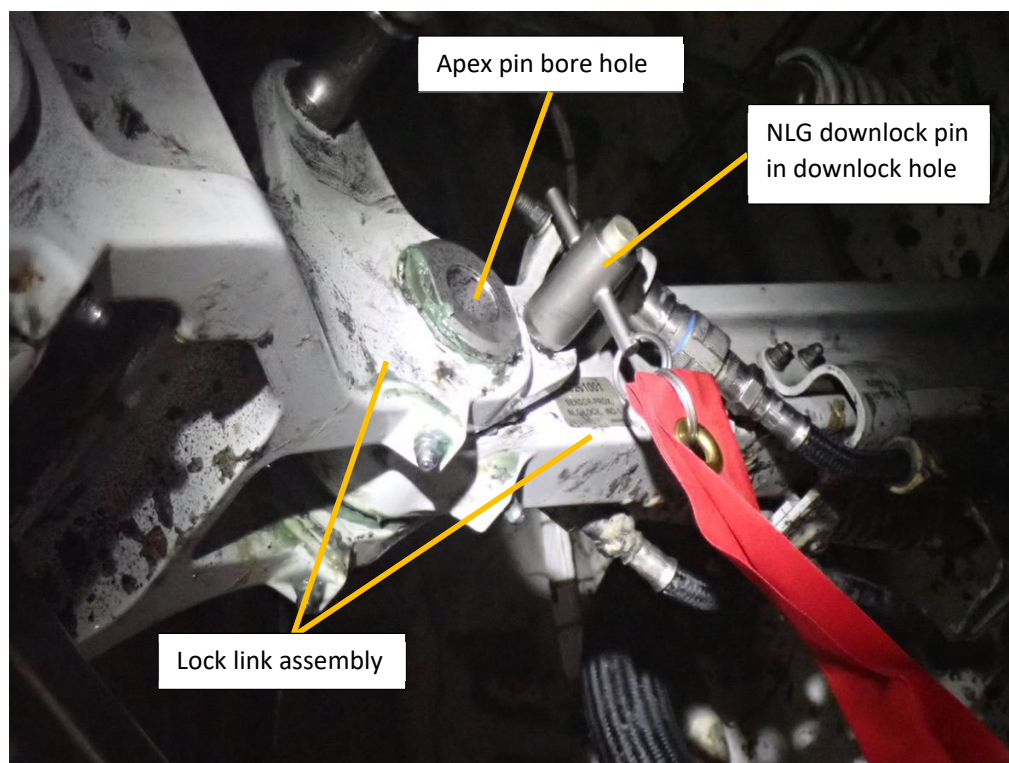
**Figure 16**

When the NLG bay was accessed, the NLG downlock pin was found to be in the leg's apex bore hole rather than the downlock pin hole (Figure 9). The downlock pin was transferred to the correct position to lock the gear down and to allow the inflatable mats to be removed so the aircraft could be towed to a suitable quarantine hangar.

The lock link assembly can be prevented from moving away from the over-centre position with the aircraft on the ground and during maintenance procedures by using a downlock pin. The pin is inserted in the downlock hole, aft of the lock link assembly apex pin bore hole, to fix the lock link in position and prevent retraction of the NLG even with hydraulic power applied and the landing gear selected to UP (Figure 16).

NLG downlock pin inserted into lock link assembly downlock hole

Boeing has received reports of the NLG downlock pin being incorrectly installed in the inner bore of the apex pin on the NLG lock link assembly, adjacent to the correct hole. The correct location is shown in Fig 1 of AMM Task B787-A-32-00-30-00A-720A-A Landing Gear Downlock Pin Installation.
