Rail Accident Investigation Branch

Rail Accident Report

Collision between a passenger train and a hand trolley at Challow, Oxfordshire 21 October 2021

Report 11/2022
October 2022

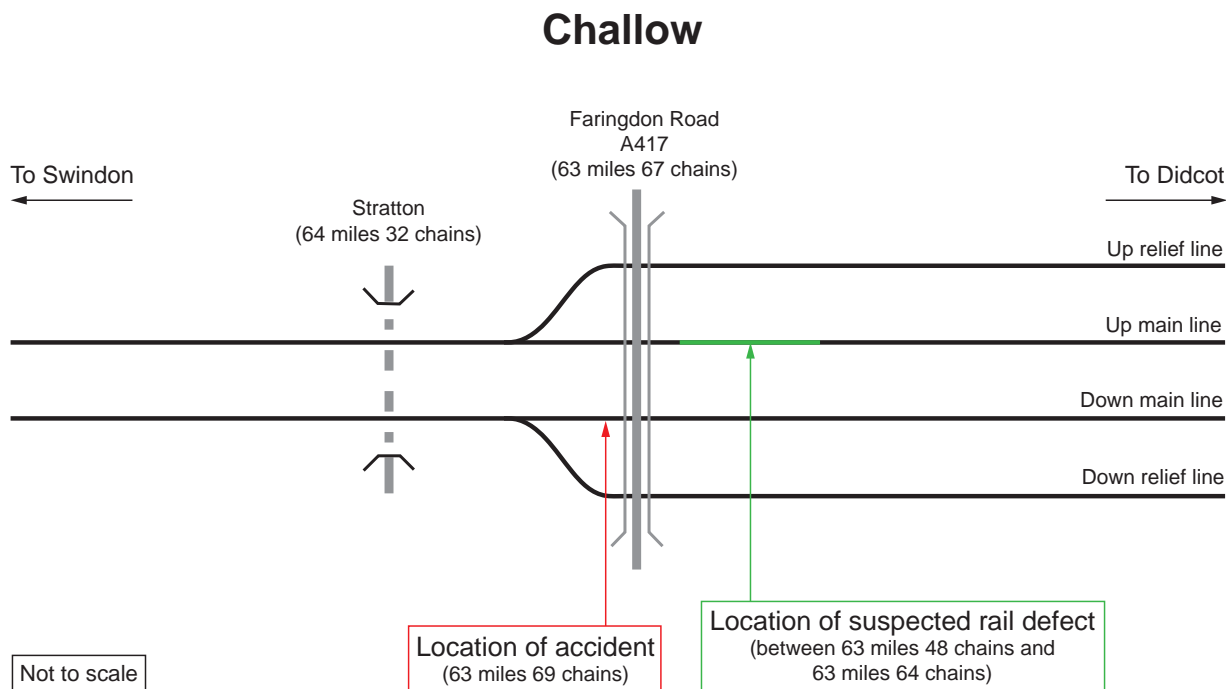
Figure 4: Track layout at Challow

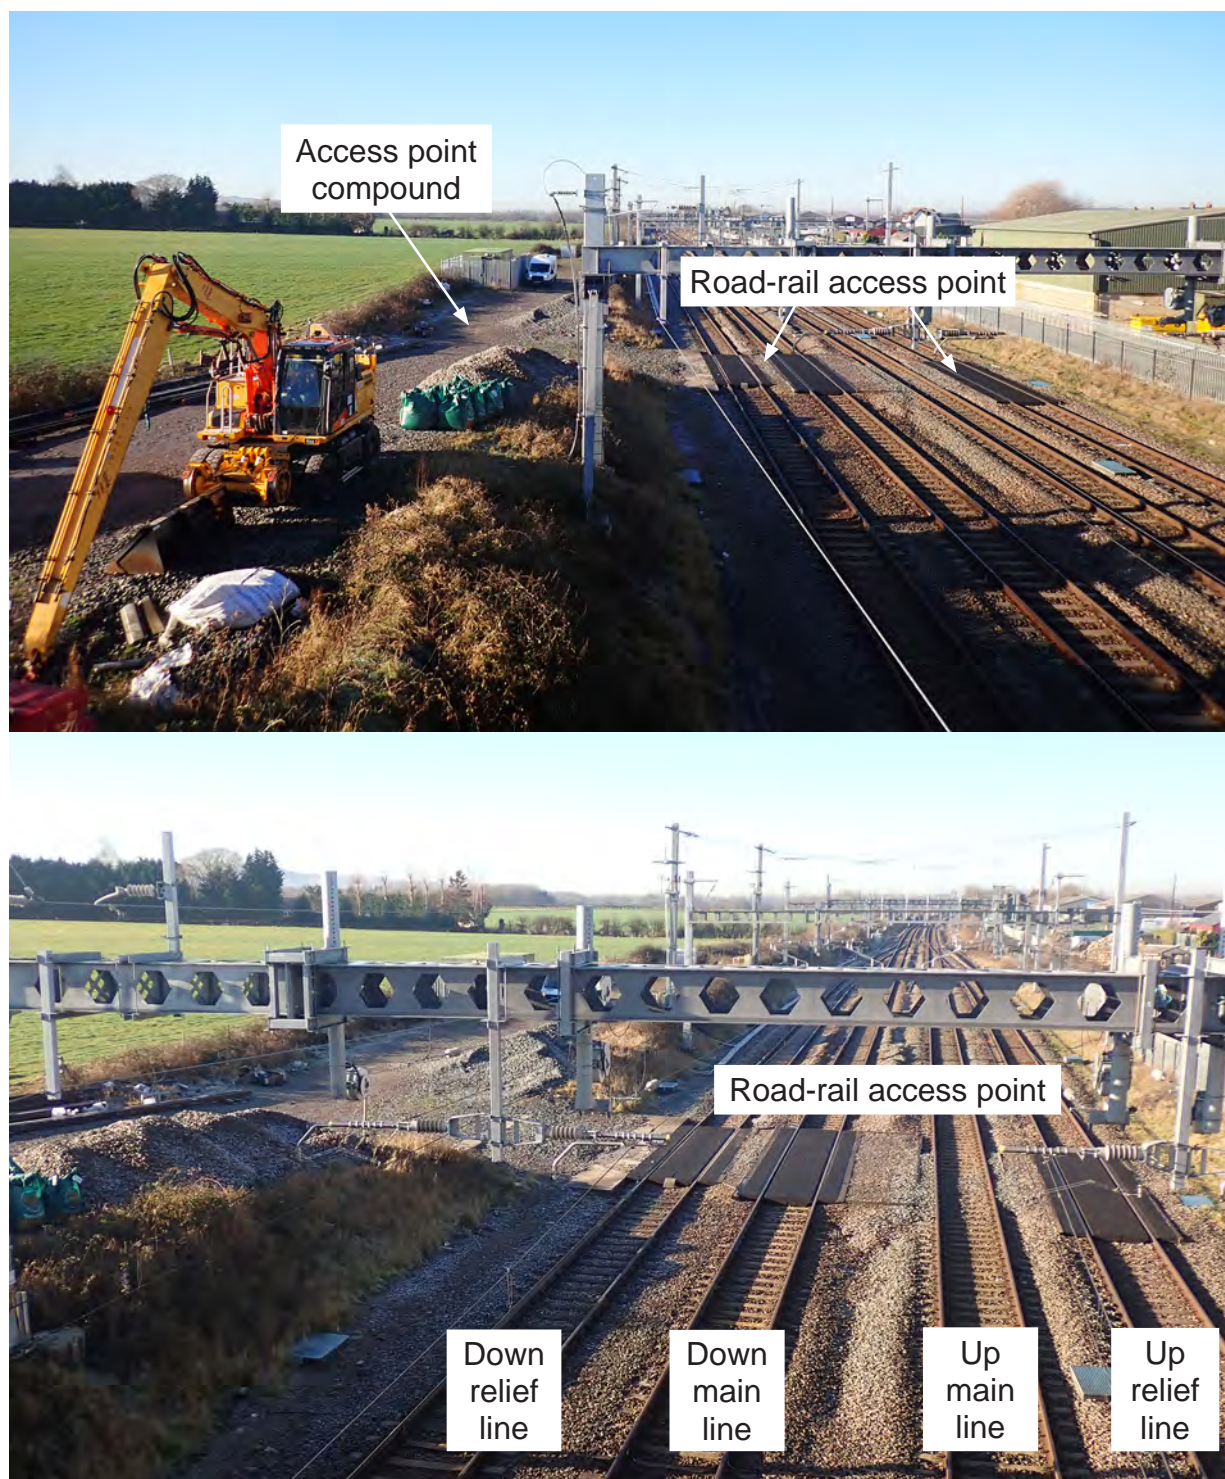
- 7 Challow is an authorised access point and is used by railway staff to gain access to the railway. It is also a designated road-rail access point (often referred to as a RRAP), where adapted vehicles that can run on either a road or railway (road-rail vehicles (RRVs)), can transfer from one to the other. It comprises large rubber panels, like those found at some level crossings, to provide a level surface for vehicles to drive onto (figure 5). The hand trolley involved in this accident was on the track at the road-rail access point.

Figure 5: The road-rail access point at Challow

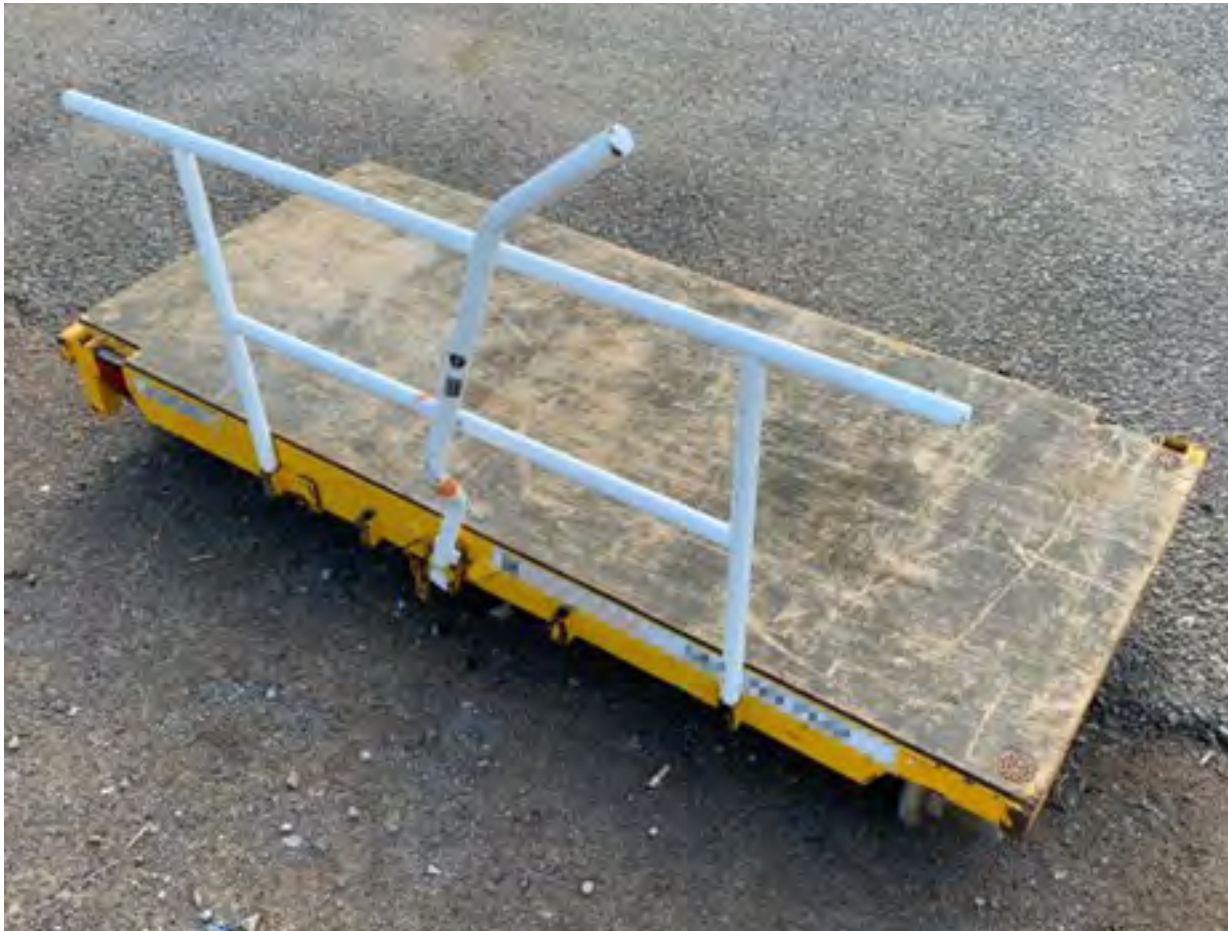
- 13 The hand trolley that was struck was a Permaquip link trolley (figure 6). This type of hand trolley has a wooden deck on top of a metal frame that is painted yellow. Its wheels are electrically conductive and are braked. The brakes are controlled by a detachable brake handle that slots into the trolley. The trolley was 1.68 metres wide, 0.75 metres long and its deck sits 0.22 metres above the head of the rails. Such trolleys weigh about 48 kilograms and can carry a uniformly distributed load of up to 1000 kilograms.

Figure 6: The type of hand trolley struck by train 1C00 (courtesy of Network Rail)

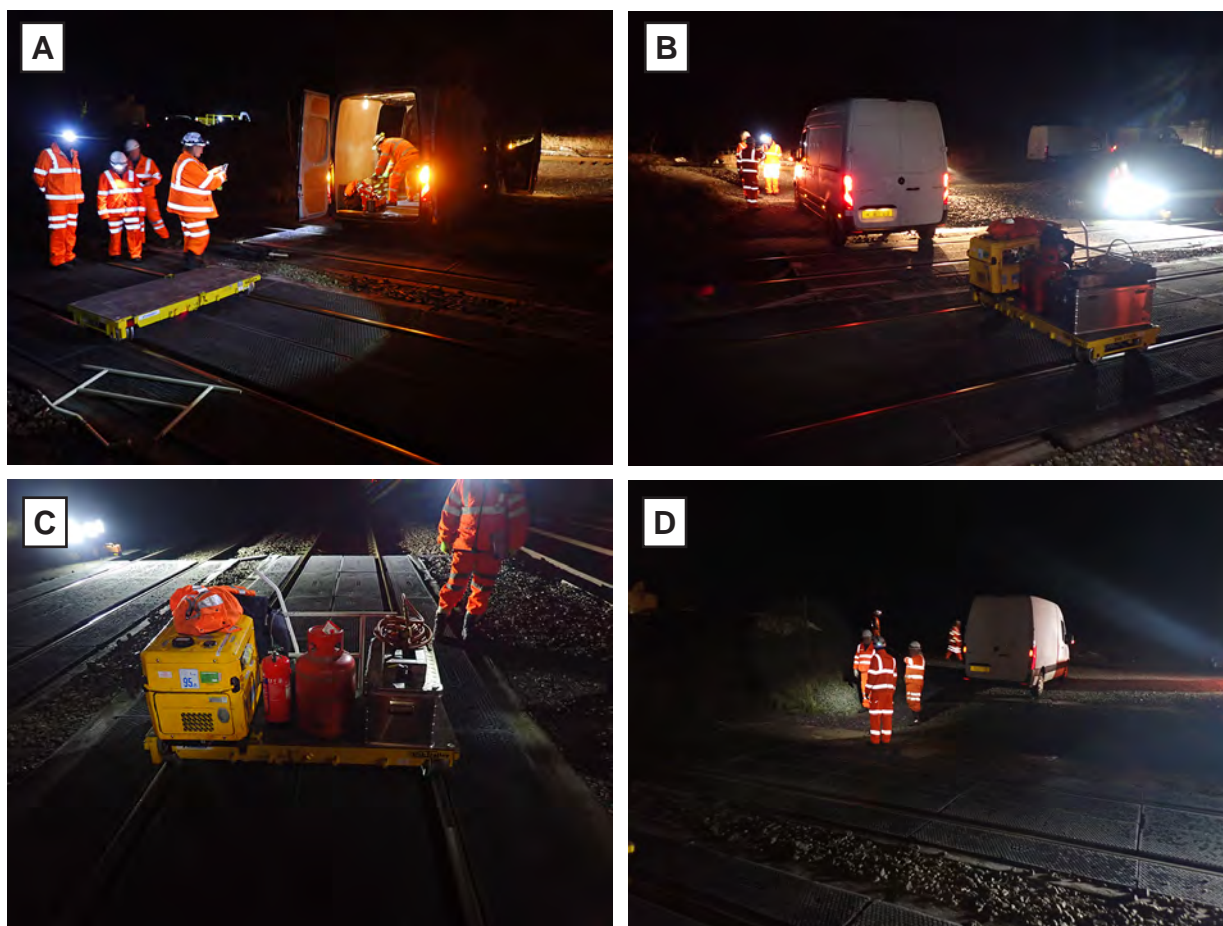
- 28 Shortly afterwards, at about 01:00 hrs, the welder reversed the van onto the road-rail access point (figure 7). The welder and the COSS then took their hand trolley out of the back of the van and placed it on the down main line and loaded equipment onto it. Once the trolley was loaded, the welder moved the van forward a short distance and left it parked near to the road-rail access point. The welder and the COSS then set off towards Didcot Parkway, with the COSS pushing the loaded hand trolley along the down main line, while the welder walked along the up main line (figure 4).

Figure 7: A reconstruction undertaken following the accident, showing the van reversing onto the road-rail access point to load equipment onto the hand trolley and then parked afterwards

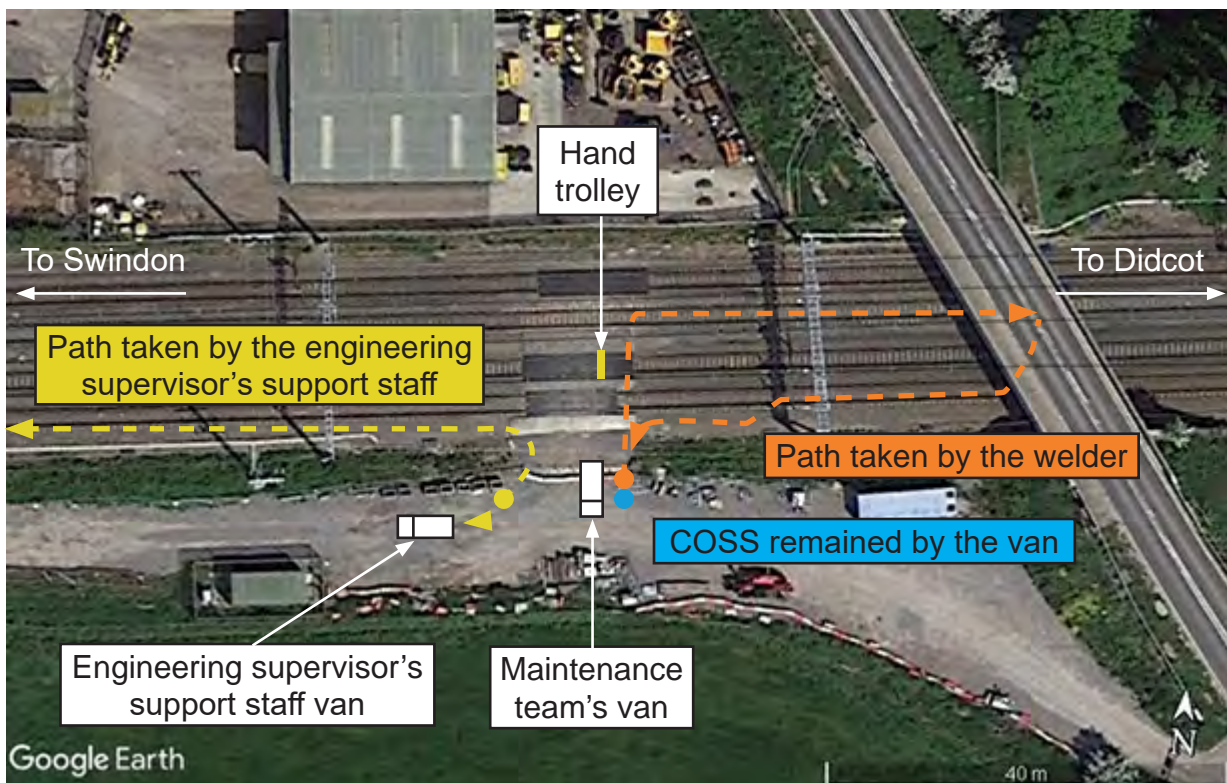
Figure 12: Aerial view of the path taken by the welder when looking for the van keys and the path taken by the engineering supervisor's support staff to collect the work site protection

53 By this time, the welder was walking under the nearby road-over-rail bridge (figure 12). In response to the COSS's call, the welder turned back and crossed over the down main line to the down relief line. After walking along this line for a short distance, he moved into the cess to complete his journey back to the road-rail access point. Meanwhile, the COSS had used the keys to unlock the parked van and had begun loading the equipment into it through the side door. The welder joined the COSS at the side of the van and together they loaded the heavier equipment and remaining items into the van through the side door. The van's rear doors remained closed throughout.

- 61 After the COSS found the van keys, the welder walked straight back to the van (figure 12) to help load the equipment. He walked past the edge of the road-rail access point, but he did not see the hand trolley because it was dark and because the trolley was positioned about 8 to 10 metres away from the closest point of his route.

- 62 The member of the engineering supervisor's support staff (paragraph 30) also did not see the hand trolley on the road-rail access point. He had arrived at Challow just after the COSS and the welder had finished loading their van. When the engineering supervisor asked him to remove the work site protection at about 03:50 hrs, he accessed the track near the road-rail access point, but only walked past its edge to walk west towards Swindon (figure 12). After collecting the protection equipment, he followed the same path in reverse back to his van. He too passed within about 8 to 10 metres of the hand trolley but also did not see it in the dark.

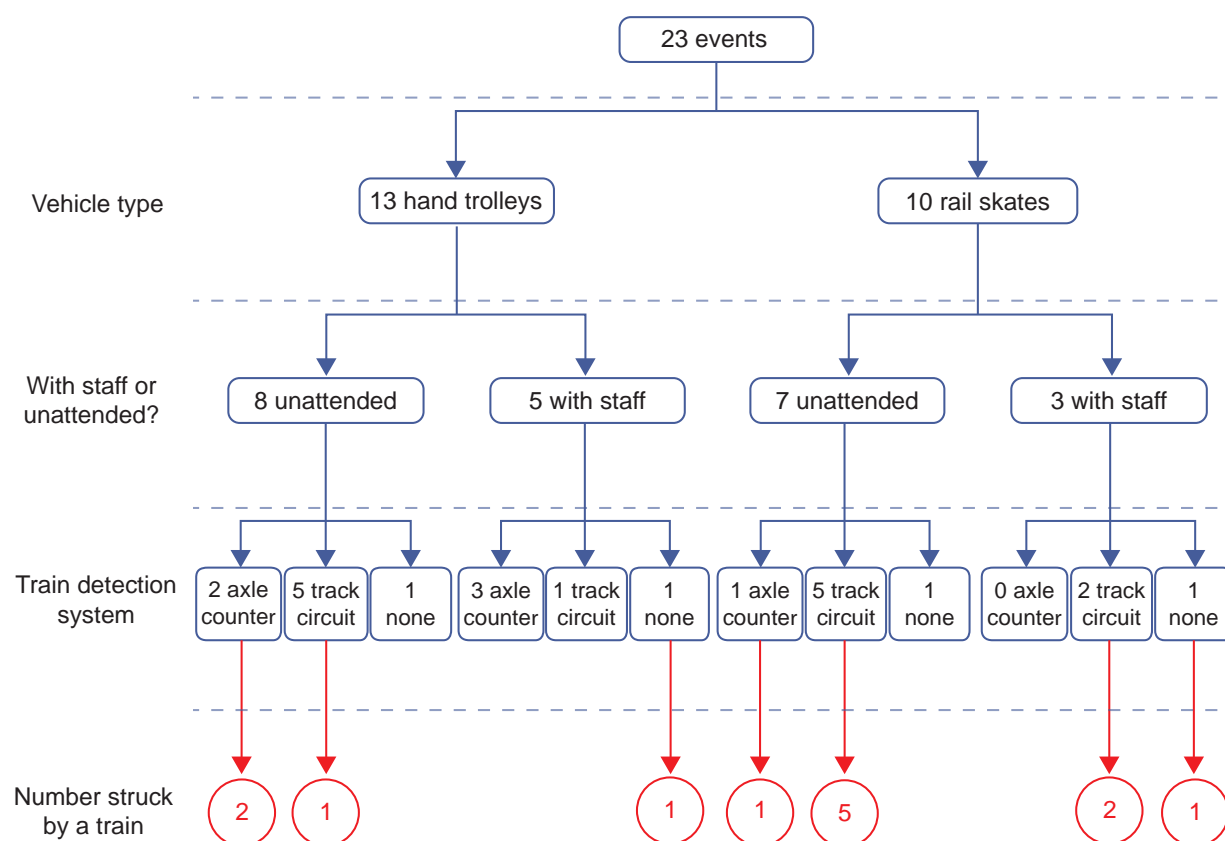
136 RAIB identified 23 events, including Challow, where a hand trolley or rail skate had been left on or near the track when the railway was handed back by maintenance staff for the normal operation of trains. Of these events, thirteen involved hand trolleys and on eight occasions the hand trolley was left unattended on the track (figure 17). On two occasions, hand trolleys were left unattended in an axle counter area and both were struck by trains. Meanwhile, four out of the five trolleys left unattended in a track circuited area were detected by the signalling system. Out of the ten events that involved rail skates being left unattended on the track, nine were struck by a train.

Figure 17: Events involving hand trolleys or rail skates left on or near the track after handback by maintenance staff

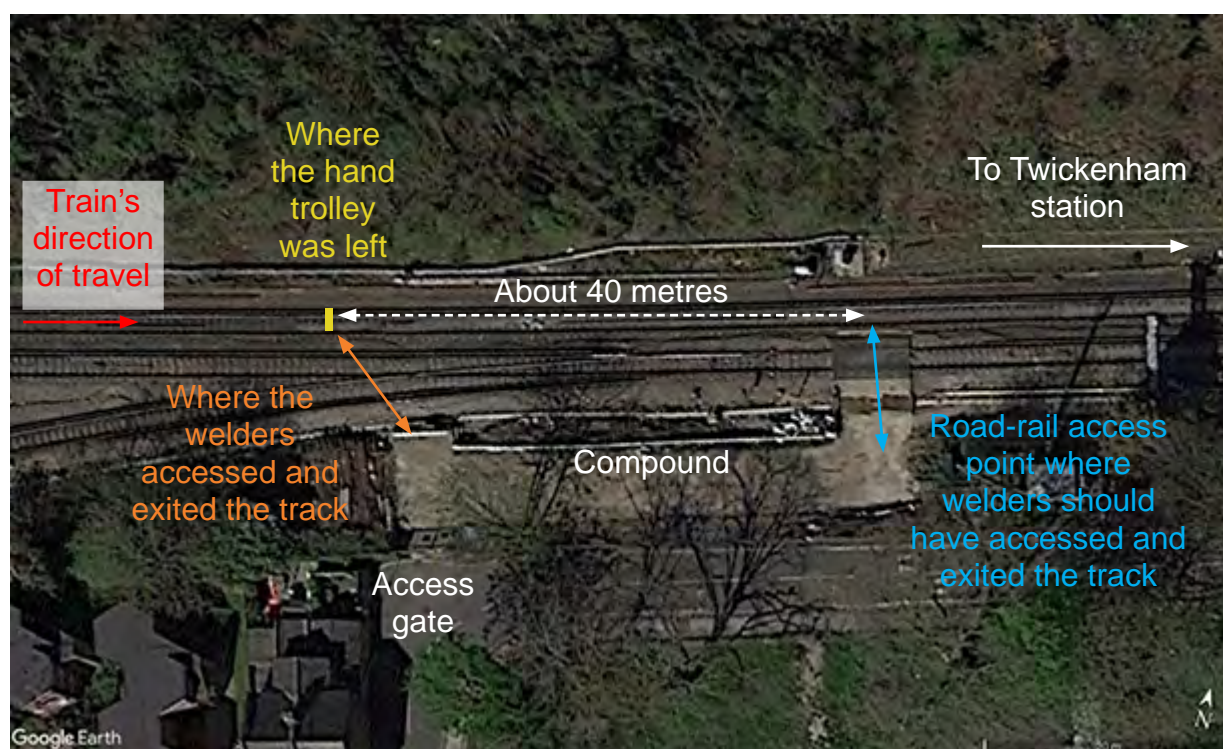
Figure 19: The layout at the access point near Twickenham

141 After finishing their work, the welders went back to the place they had used to access the track and unloaded their equipment. They then left one of the hand trolleys on the track, thinking that someone else would take it off the track before the work site was handed back. As the welders had gone about 40 metres beyond the official access point, no one checked beyond this point when the work site was handed back.
