**ACCIDENT**

| <b>Aircraft Type and Registration:</b> | Piper PA-28R-200-2, G-EGVA | |

**Synopsis**

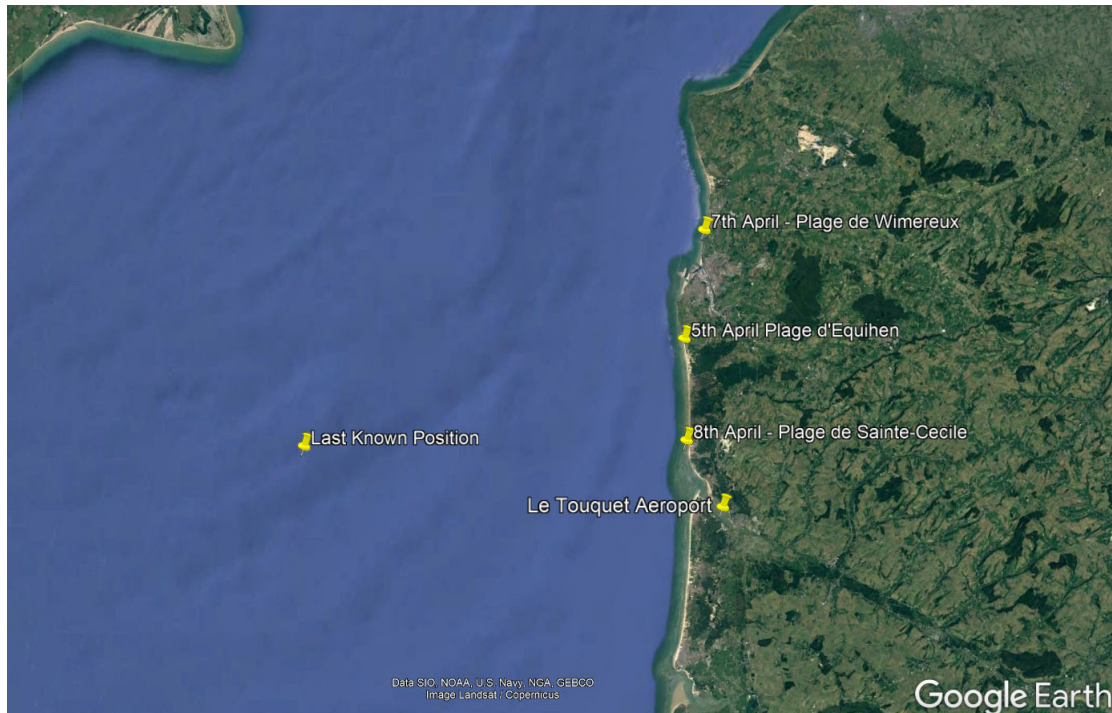
**Figure 6**

In the days after the accident several items were found on the French coastline which had come from the aircraft. On 5 April 2022 a bag belonging to the left seat pilot was found at Plage d'Equihen, containing his flying licence, logbook and other flight documents. On 7 April 2022 a kneeboard belonging to the right seat pilot was found at Plage de Wimereux and on 8 April 2022 a seat from G-EGVA was found on Plage de Sainte-Cecile. Figure 6 shows the approximate location of each item found and the final known position of G-EGVA.

Location of items found on the French coastline

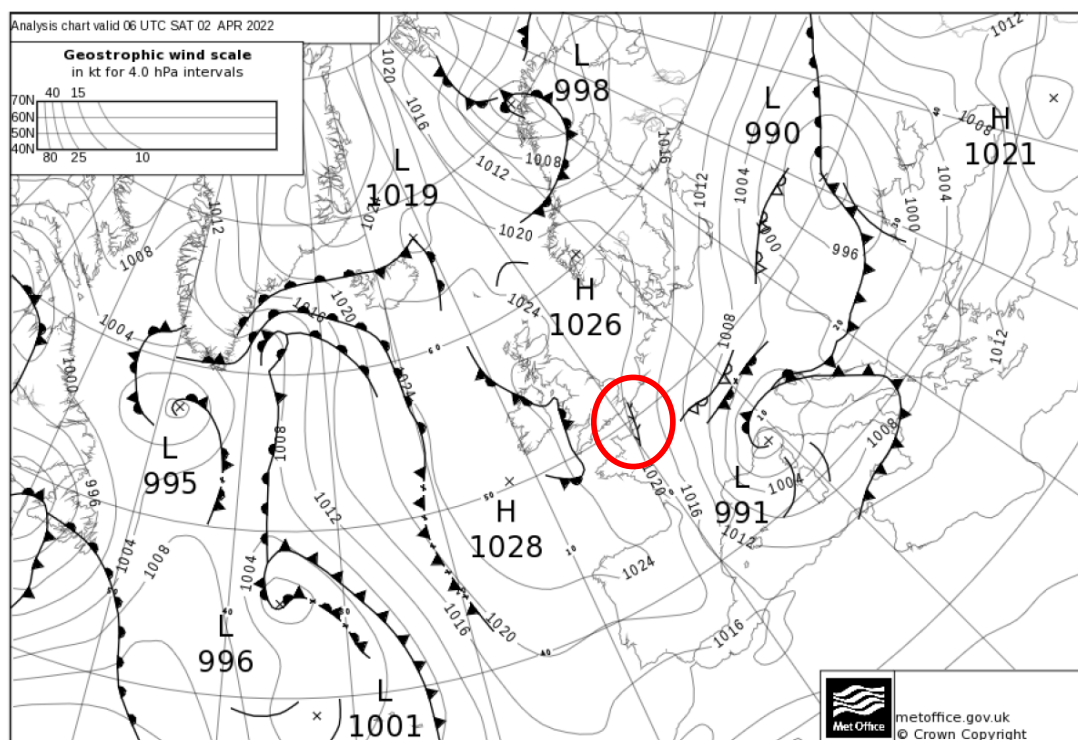
**Figure 11**

On the 2 April 2022 a generally slack pressure pattern existed across the UK in association with high pressure. A convergence line lay from the Dover Strait to Le Mans, France. The convergence line was shown on the surface analysis chart valid at 0600 hrs (Figure 11).

Surface analysis chart valid at 0600 hrs 2 April 2022  
(convergence line highlighted in red)

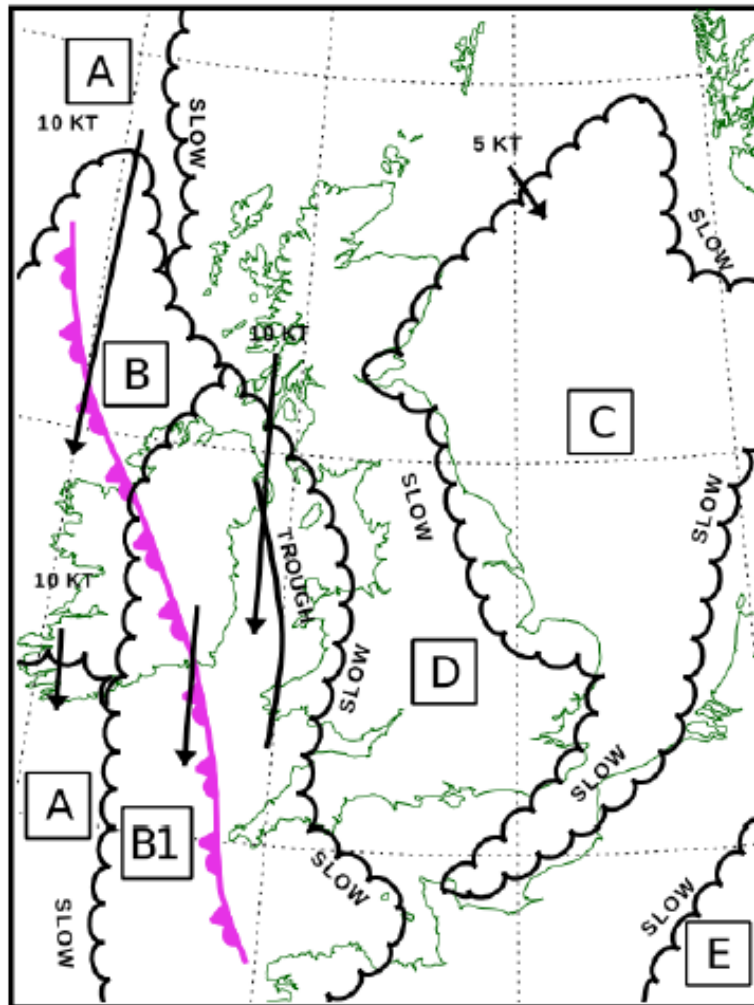
Figure 12

An extract from the Met Office UK low-level forecast chart (F215) issued on the morning of the 2 April 2022 is shown in Figure 12. The forecast was valid between 0200 hrs and 1100 hrs. Initially the flight would have been in Area D. The conditions were forecast to be generally 40 km visibility with scattered or broken (SCT/BKN) cloud with a base between 2,000 and 5,000 ft amsl. However, there would be isolated (ISOL) patches of mist (BR) reducing visibility to 3,000 m at times, with a further risk of visibilities reducing to 200 m in freezing fog (FZFG) until 1000 hrs. Associated with this there would be scattered or broken (SCT/BKN) cloud with a base between 500 and 1000 ft, lowering to the surface at times in fog.

On reaching the South Coast and the English Channel, the flight moved into Area C. Again, general conditions were expected to be 40 km visibility, with few or scattered, occasionally broken (FEW/SCT (OCNL BKN)) cloud with a base between 2000 ft and 4000 ft. Due to the convergence line occasional (OCNL) showers of rain and snow (SHRASN) were forecast to reduce visibility to 5,000 m in places. This would reduce further in isolated (ISOL) heavy rain and snow showers or thunderstorms with small hail or snow pellets (+SHRASN/+TSRAGS)

and be associated with severe icing and turbulence. The heavier showers were expected to be generated by cumulonimbus (CB) cloud with a base between 1,500 ft and 3,000 ft. The convergence line was not depicted on the F215.

Extracts from the Met Office F215 valid 2 April 2022 between 0200 – 1100 hrs

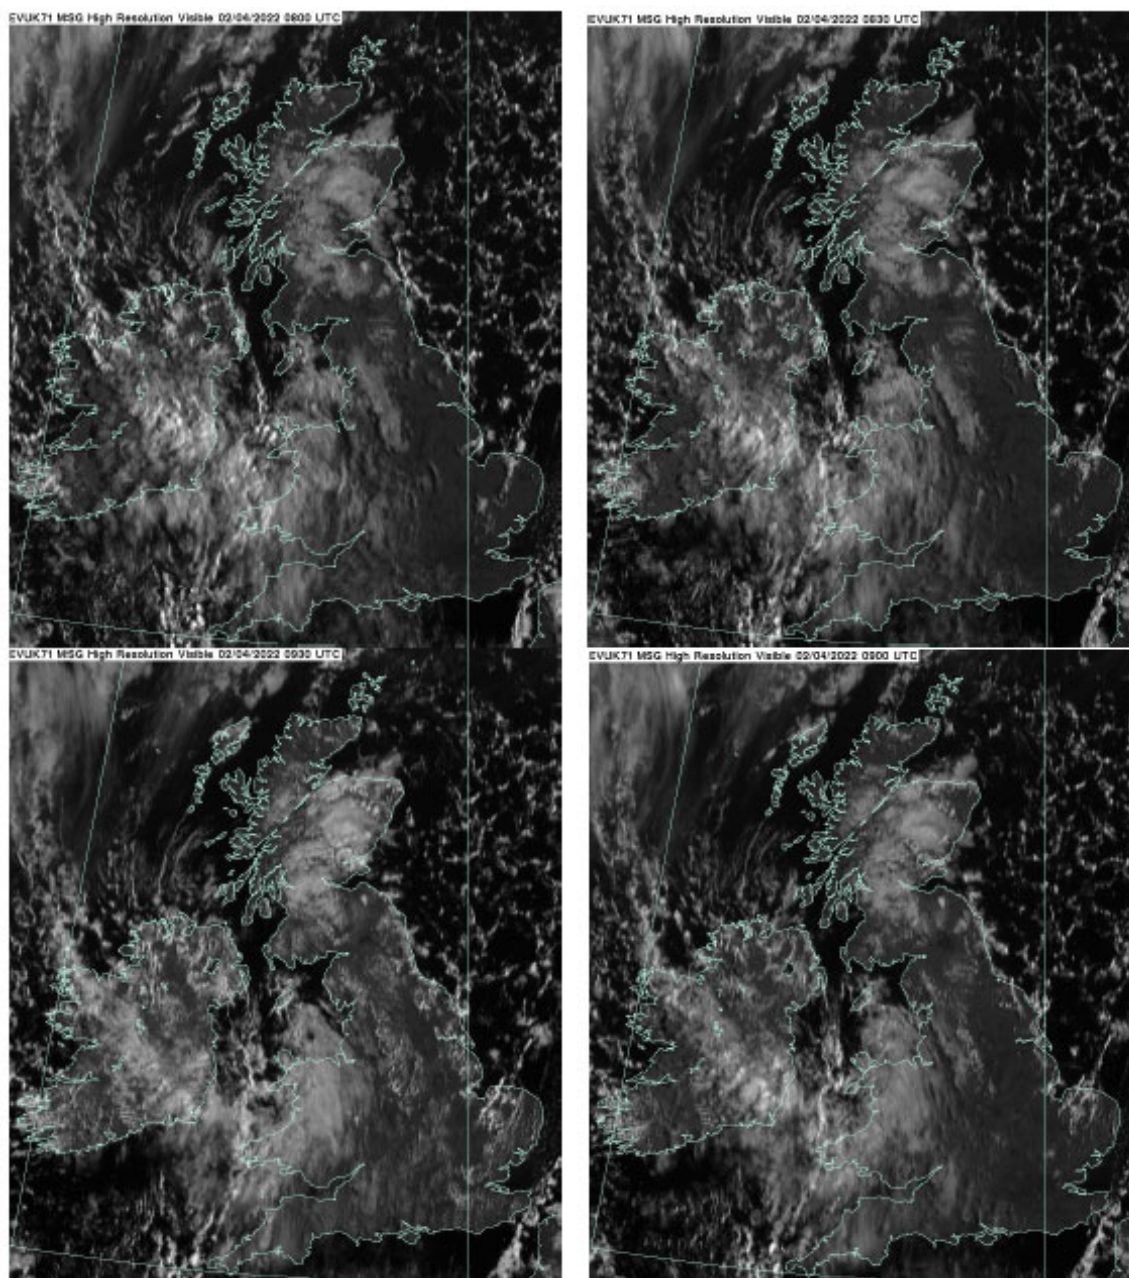
**Figure 13**

Satellite images taken at half hour intervals between 0800 hrs and 0930 hrs on 2 April 2022 are shown in Figure 13. The images show small amounts of cloud across mainland southern England, with clearer skies across the south-east. A band of cloud lay through the Dover Strait into northern France at 0800 hrs, moving slightly westwards through this time period. The white colour of the cloud in the imagery indicates higher cloud tops which, along with the shape of the cloud structure, suggests showery activity.

Satellite Imagery between 0800 hrs and 0930 hrs on 2 April 2022

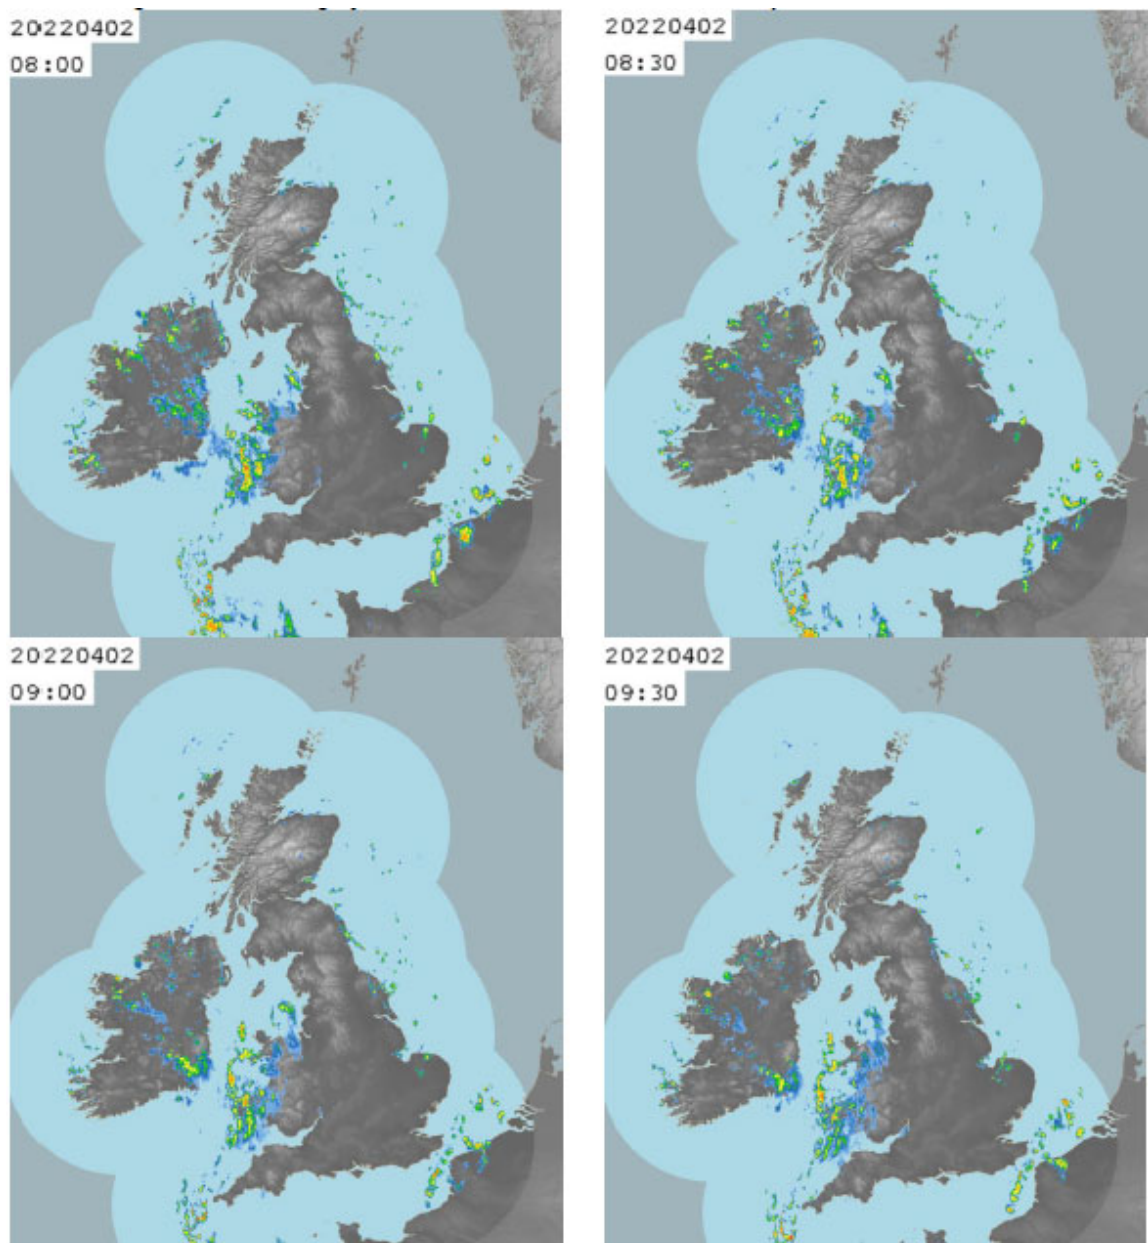
**Figure 14**

Figure 14 shows four radar images between 0800 hrs and 0930 hrs on 2 April 2022. These show dry conditions across central and southern England. A band of showers is shown lying through the Dover Strait, which ties in with the cloud structure observed in satellite imagery. The colouring of the radar returns suggests some heavy precipitation to the west of Le Touquet around 0900 hrs.

Radar imagery between 0800 hrs and 0930 hrs on 2 April 2022
