ACCIDENT

Aircraft Type and Registration:	Avy Aera 1.5	
No & Type of Engines:	5 Electric motors	
Year of Manufacture:	2021 (Serial no: 007)	
Date & Time (UTC):	6 May 2022 at 1225 hrs	
Location:	Lamlash, Isle of Arran	
Type of Flight:	Private	
Persons on Board:	Crew - N/A	Passengers - N/A
Injuries:	Crew - N/A	Passengers - N/A
Nature of Damage:	Damage to lift motor boom, fuselage and landing gear	
Commander's Licence:	Other	
Commander's Age:	34 years	
Commander's Flying Experience:	1,784 hours (of which 75 were on type) Last 90 days - 12 hours Last 28 days - 5 hours	
Information Source:	Aircraft Accident Report Form submitted by the pilot and further enquiries made by the AAIB

Synopsis

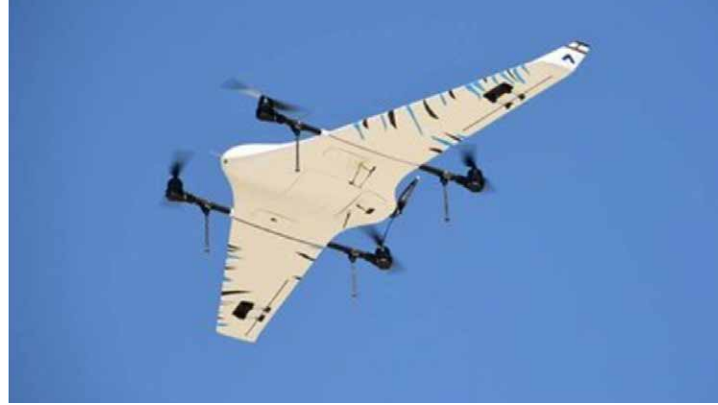
Figure 1

Avy Aera 1.5 in flight
(image courtesy of manufacturer)

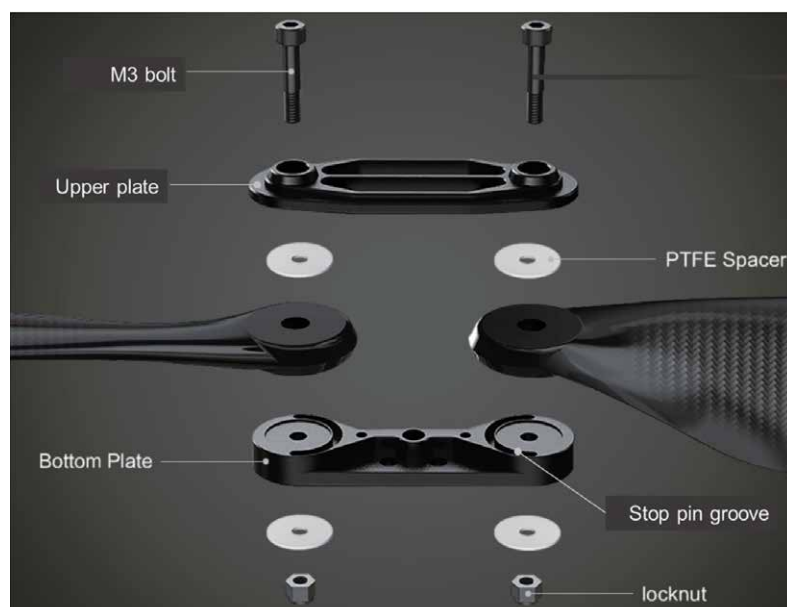
The lift propellers consist of two blades held between upper and bottom plates which form an articulated propellor hub. Each blade is held in place by a single M3 bolt and a stiff nut and are designed to pivot around the bolt in the horizontal plane. A small stop pin protrudes from the underside of the blade boss which engages with a groove in the bottom plate. This is designed to prevent the blade from 'overshooting' ie travelling too far and folding back on itself. Figure 2 shows the propeller hub assembly components.

Propeller hub components
(image courtesy of the manufacturer)

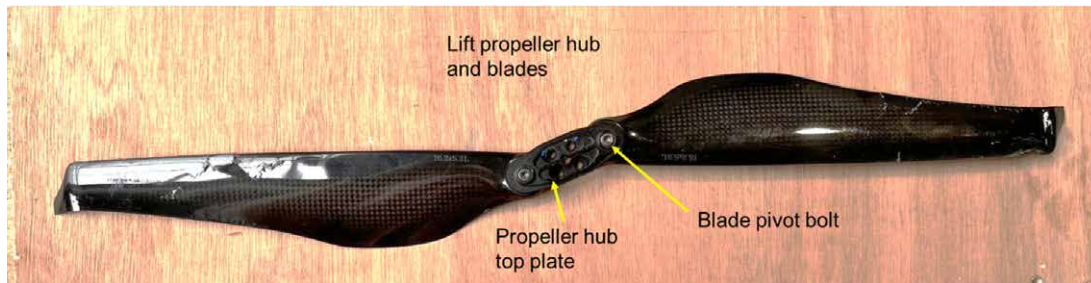
The blades are fixed pitch, and the thrust is varied by increasing or decreasing the speed of the motor. Figure 3 shows a lift propeller (there is slight damage apparent on this example, but it is not the propeller that failed).

Example lift propeller
(image courtesy of the manufacturer)
