CONTENTS**SPECIAL BULLETINS / INTERIM REPORTS**

Boeing 787-8	G-ZBJB	18-Jun-21	3
--------------	--------	-----------	---

Boeing A75N1(PT17) Stearman	N707TJ	4-Sept-21	37
Piper PA-28R-200-2	G-EGVA	2-Apr-22	56

Aircraft Type and Registration:	Boeing 787-8, G-ZBJB	
No & Type of Engines:	2 Rolls-Royce Trent 1000-AE3 turbofan engines	
Year of Manufacture:	2013 (Serial no: 38610)	
Date & Time (UTC):	18 June 2021 at 0651 hrs	
Location:	London Heathrow Airport Stand 583	
Type of Flight:	Commercial Air Transport (Cargo)	
Persons on Board:	Crew - 2	Passengers - None Other - 6
Injuries:	Crew - 1 (Minor)	Passengers - N/A Other - 1 (Minor)
Nature of Damage:	Underside of forward fuselage, door 2L and forward lower engines cowlings damaged	
Commander's Licence:	Airline Transport Pilot's Licence	
Commander's Age:	47 years	
Commander's Flying Experience:	8,364 hours (of which 587 were on type) Last 90 days - 26 hours Last 28 days - 0 hours	
Information Source:	AAIB Field Investigation

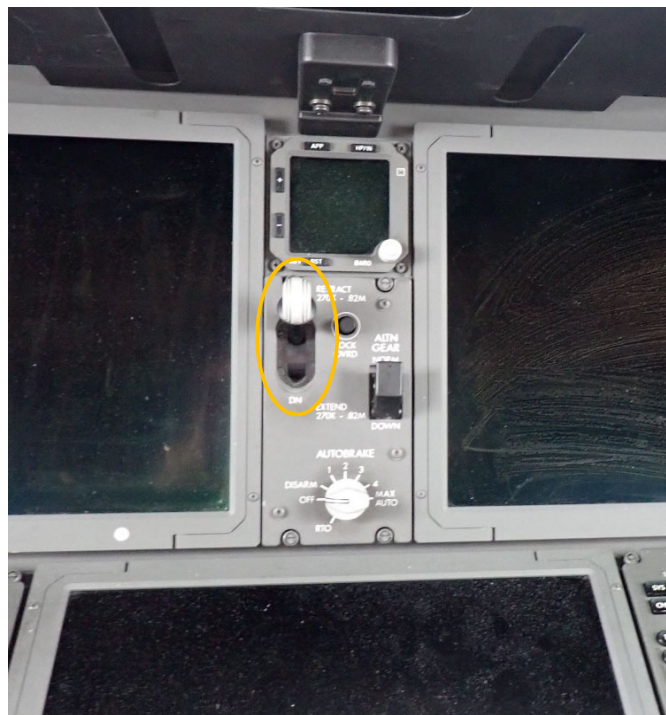
Figure 7

On the flight deck, the landing gear selection lever remained in the UP position (Figure 7) but AC power had been lost when the nose of the aircraft crushed the ground power cables.

Landing gear selector lever in the UP position

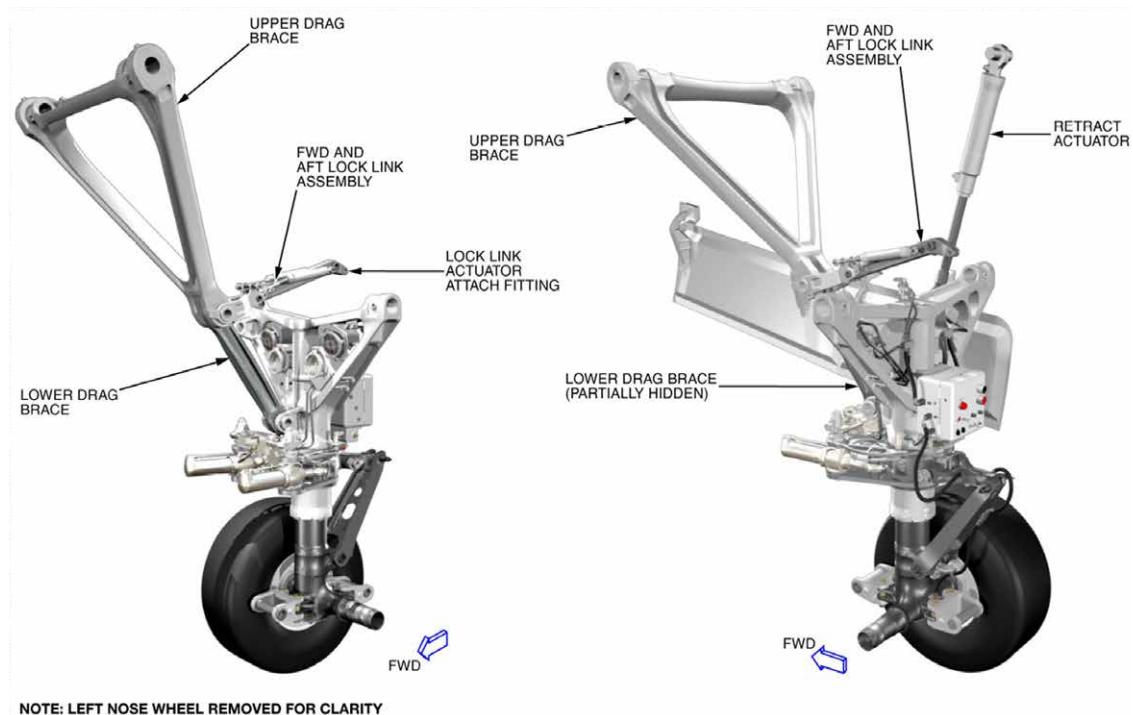
Figure 13

The NLG consists of a shock strut, an extension and retraction mechanism, (Figure 13), two unbraked wheels, a torque link and a nosewheel steering system. The shock strut provides shock absorption to dissipate the vertical forces experienced during aircraft taxi, takeoff and landing. The strut uses a mixture of compressed air, which acts as a spring to absorb vertical shock loads, and hydraulic oil, which provides damping to reduce the harmonic bouncing effect of the compressed air spring.

NLG showing the extension and retraction components

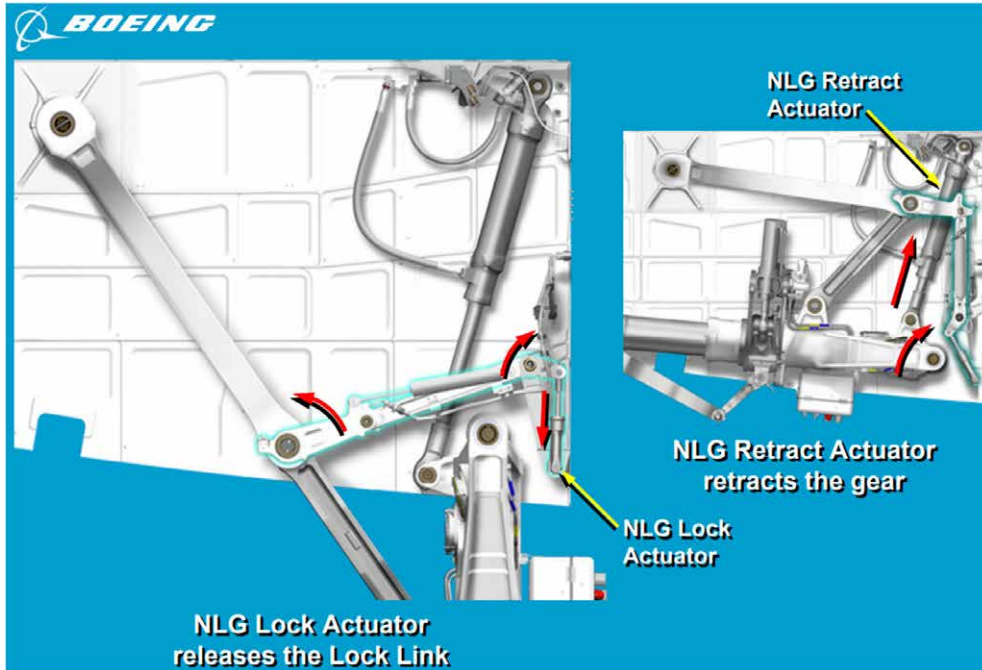
Figure 14

The extension and retraction mechanism employs a hydraulic NLG lock actuator to lock and unlock a lock link assembly. The lock link assembly is designed to form a geometric lock when it is in an over-centre position which prevents the landing gear from retracting or extending. Lock link springs hold the over-centre position when there is no hydraulic pressure to the actuator. During the NLG retraction process, hydraulic pressure forces the lock link actuator piston to retract which in turn causes the lock link assembly to move away from the over-centre position, unlocking the NLG. Hydraulic power to the NLG retract actuator then forces the NLG to retract into the wheel bay. The lock link actuator piston moves the lock link assembly to the over-centre position again where the actuator and springs fix it in position, thereby locking the NLG in the up position (Figure 14).

NLG lock link release from over-centre and gear retraction process
Copyright Boeing. Used with permission

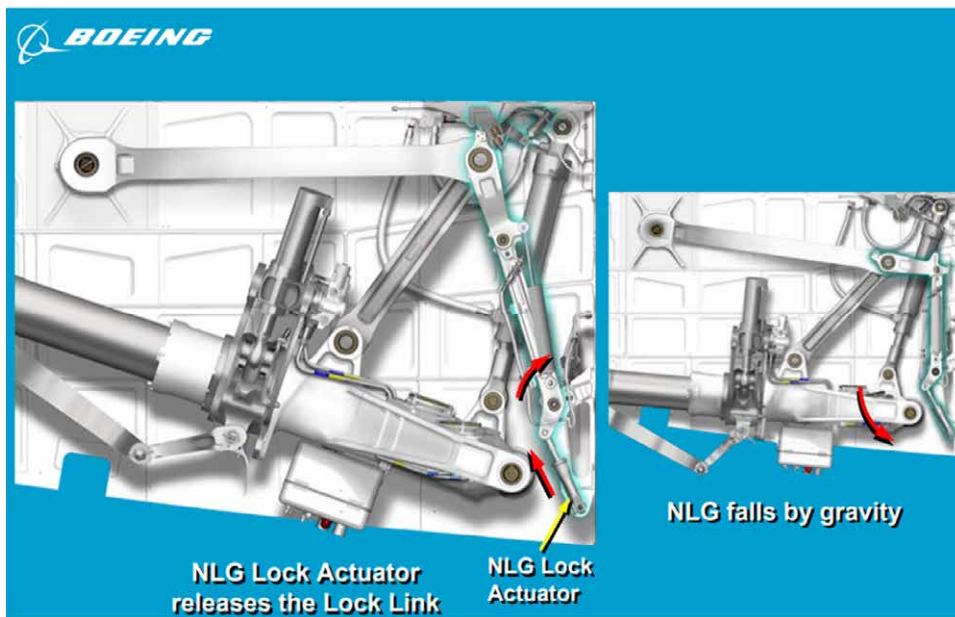
Figure 15

The NLG pivots down under gravity. Once down, the lock link actuator drives the lock link assembly into the over-centre position where springs and the actuator hold the assembly in place. This locks the NLG in the down position (Figure 15).

NLG lock link release from over-centre and gear extension process
Copyright Boeing. Used with permission

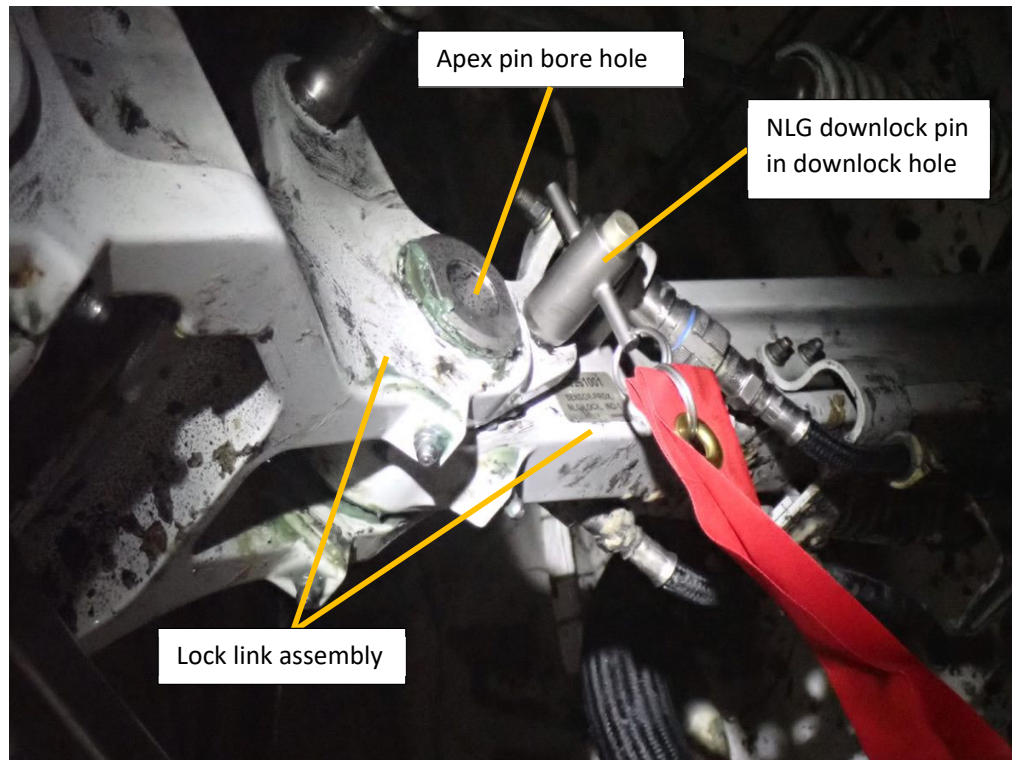
Figure 16

The lock link assembly can be prevented from moving away from the over-centre position with the aircraft on the ground and during maintenance procedures by using a downlock pin. The pin is inserted in the downlock hole, aft of the lock link assembly apex pin bore hole, to fix the lock link in position and prevent retraction of the NLG even with hydraulic power applied and the landing gear selected to UP (Figure 16).

NLG downlock pin inserted into lock link assembly downlock hole

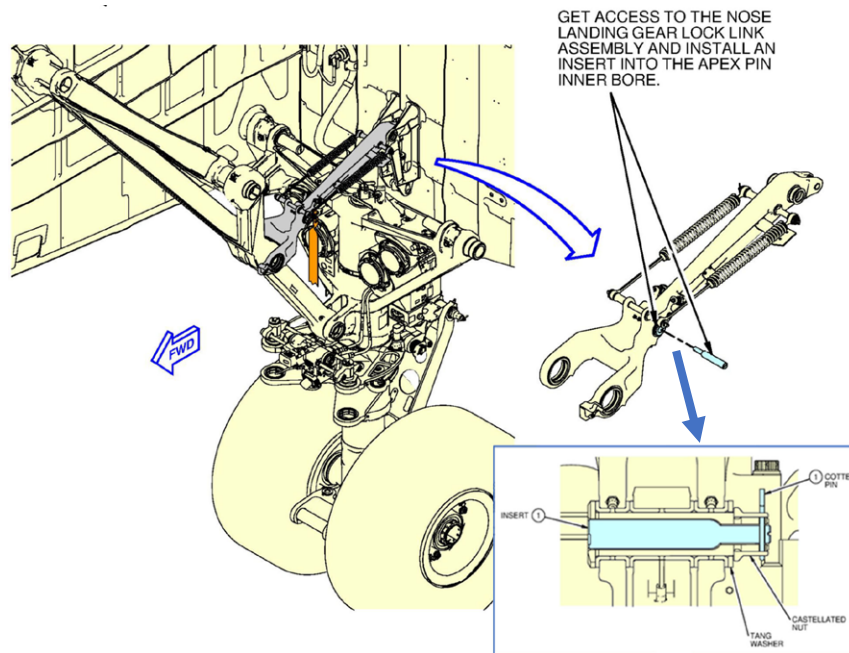
Figure 17

SB illustration of NLG lock link assembly and apex inner bore insert
Copyright Boeing. Used with permission

'If this Service Bulletin is not done, the NLG can be retracted on the ground during maintenance or fault isolation if the NLG pin is accidentally installed in the apex pin inner bore, which can cause damage to the airplane and injuries to personnel.'

The FAA issued AD 2019-23-07 to address this issue, which could result in the NLG retracting on the ground, possibly causing serious injuries and substantial aircraft damage. The associated SB 320040 installs an insert into the apex pin bore to prevent incorrect installation of the downlock pin. The current 787-8 and -9 fleets will have this SB incorporated before the compliance end date (Jan '23). 787-10 G-ZBLA and all subsequent deliveries will have this change from production.

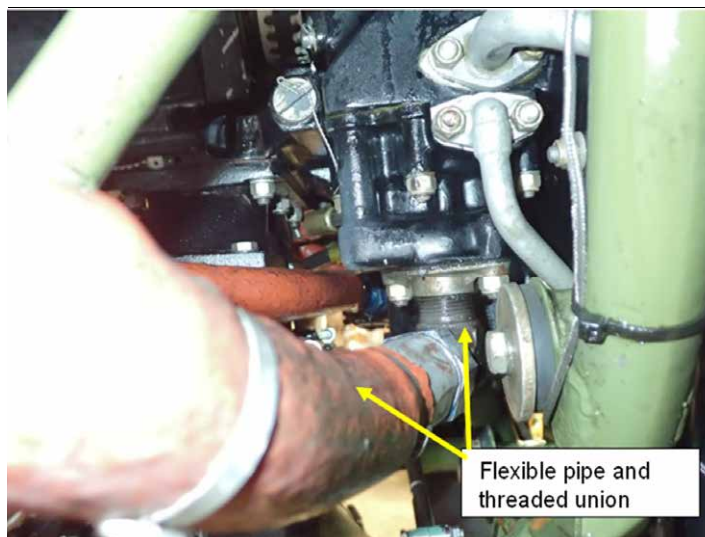
Figure 12

The oil inlet pipe on the second aircraft was comprised only of a flexible pipe, which was shorter than that on N707TJ and a 90° threaded union (Figure 12). There were no supporting straps and the oil temperature probe was mounted separately.

Alternative installation: flexible oil pipe and 90° threaded union, no support strap

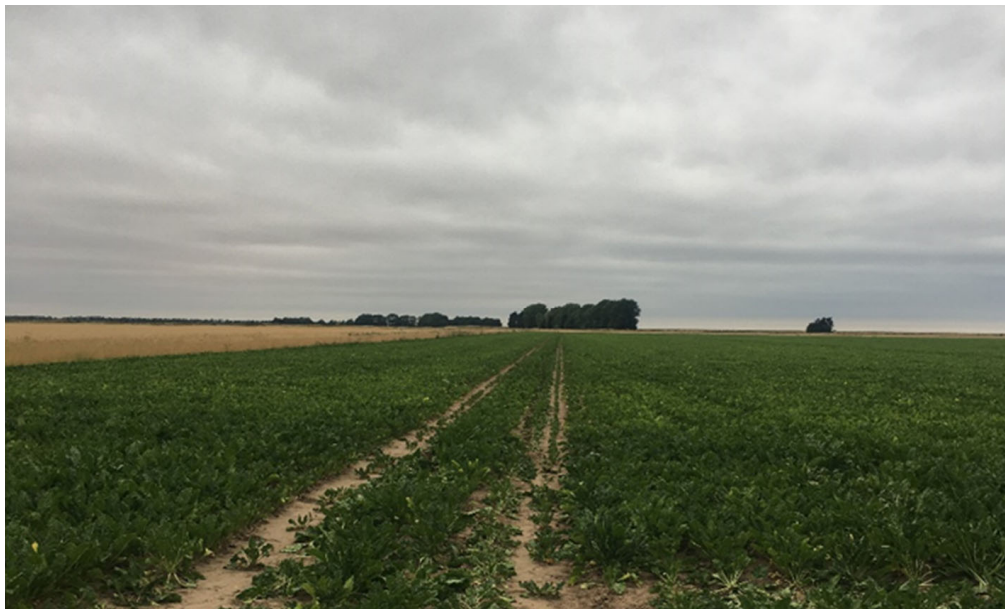
Figure 1

The aircraft suffered extensive damage to the lower cowl, engine firewall, windscreen, and tail and wing surfaces, and the engine was shock loaded.

Accident field showing the tracks used by the pilot and the sugar beet crop
(used with permission)

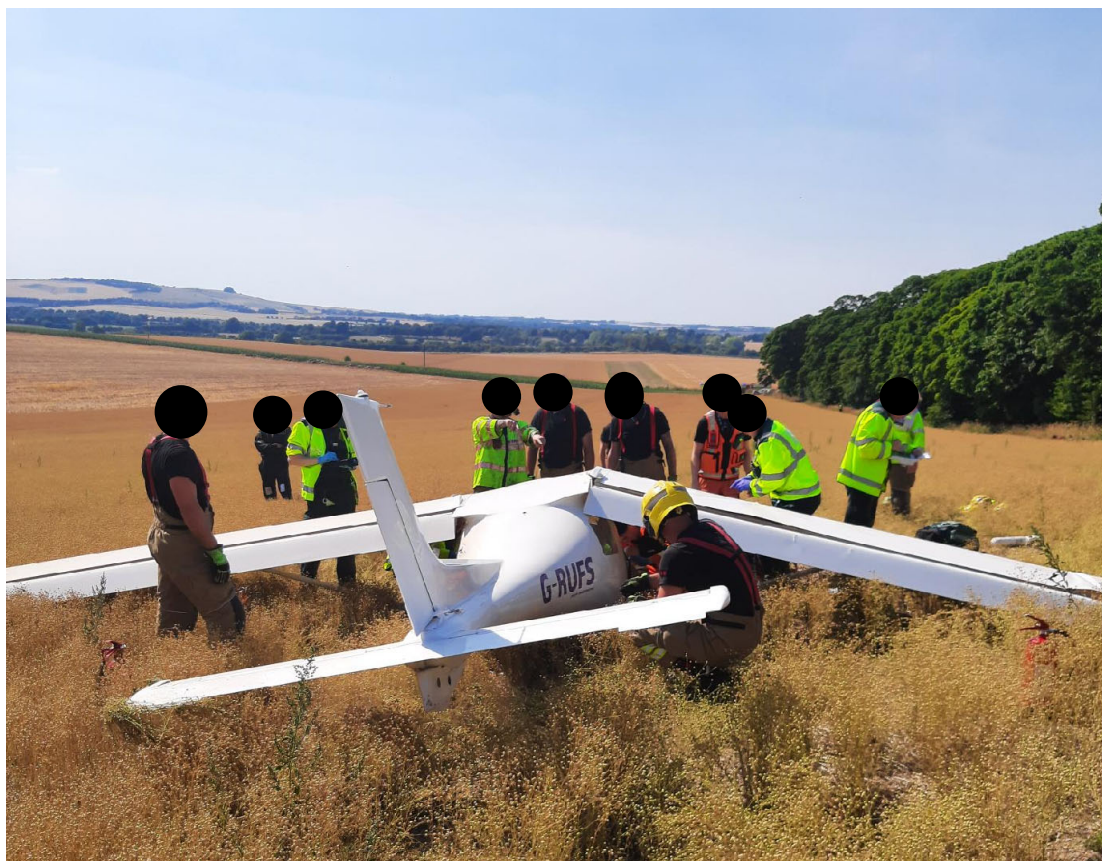
Figure 1

G-RUFS after the accident with the runway in the distance ahead of the aircraft. The aircraft is facing in the opposite direction to its flightpath before impact

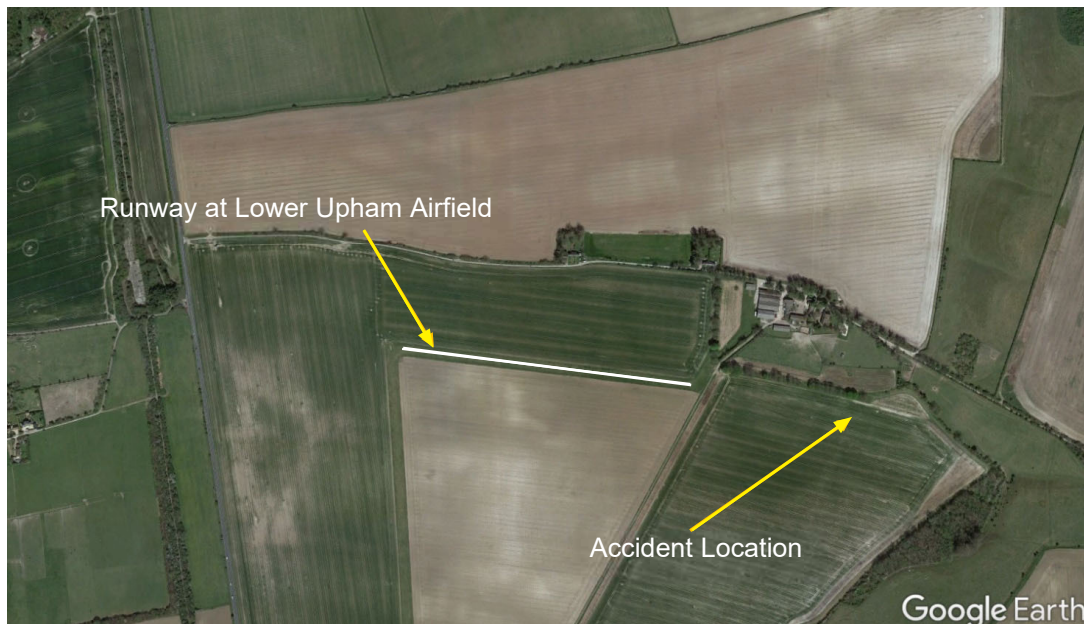
Figure 2

Aerial View of Lower Upham Airfield (runway highlighted with a white line)

The grass runway at Lower Upham is approximately 550 m long and is 560 ft above mean sea level (Figure 2). The runway is orientated roughly east west and slopes up from the west to the east. The accident location elevation is 80 ft higher than the threshold of the easterly runway.

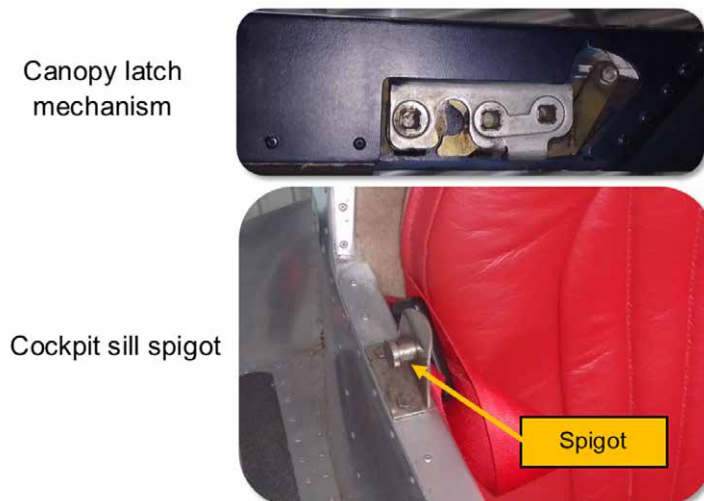
Figure 3

G-CDAL has a one-piece canopy, hinged at the front of the canopy frame. Independent latching mechanisms to secure the canopy for flight are located toward the rear of the canopy frame on each side of the cockpit. These latches engage automatically in corresponding spigots on the cockpit sills when the canopy is closed (Figure 3).

Latch components on canopy frame and cockpit sill

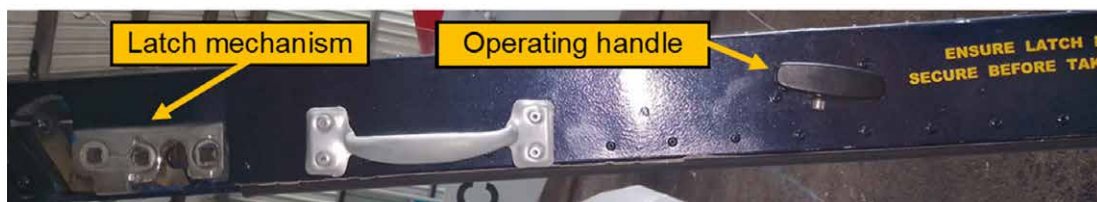
Figure 4

Handles located on each side of the canopy frame are connected to their respective latch mechanism and are used when exiting the aircraft to release the latches, thereby allowing the canopy to be opened (Figure 4).

Left side of canopy frame showing latch mechanism and operating handle

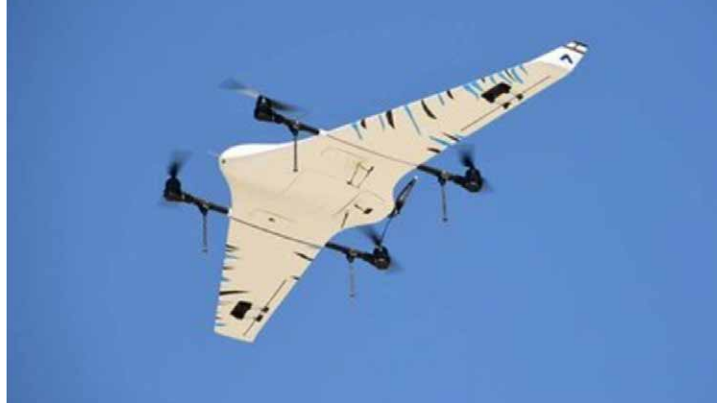
Figure 1

Avy Aera 1.5 in flight
(image courtesy of manufacturer)

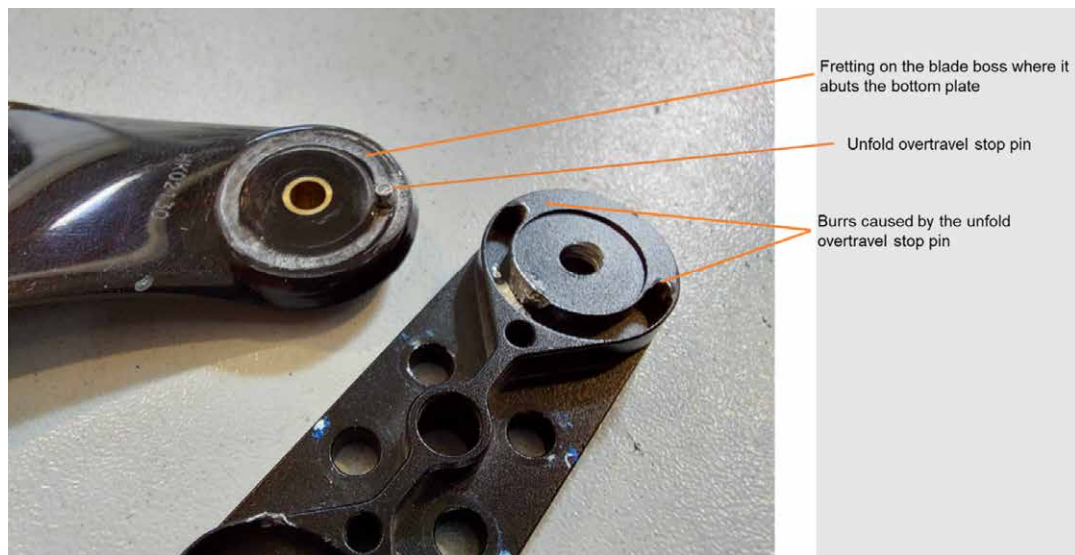
Figure 5

The manufacturer carried out a metallurgical examination of the M3 bolt and concluded that it had failed due to fatigue within the threaded portion under the nut. Further investigation, which included test running of example propellers, identified the probable causes of the fatigue failure of the bolt to lie with the design of the propeller and the loads they encounter in flight.

It was found that design features of the hub plates and blades could lead to a backlash between the blade boss and the bolt. This in turn can result in vibrations when the propeller is rotating. Results of the testing suggested that these vibrations lead to cyclical loads which manifest themselves as shear and bending loads in the bolt. In addition, it was also found that the failed propeller hub assembly stop pin groove was damaged and showed evidence of fretting on the underside of the blade boss (Figure 5).

Fretting on the blade boss and damage to the ends of the stop pin groove
(image courtesy of the manufacturer)
