ACCIDENT

Aircraft Type and Registration:	Evolve Dynamics Sky Mantis	
No & Type of Engines:	4 electric motors	
Year of Manufacture:	2020 (Serial no: ED-SKM-2020-08-030)	
Date & Time (UTC):	25 July 2022 at 1300 hrs	
Location:	St Albans, Hertfordshire	
Type of Flight:	Commercial Operations (UAS)	
Persons on Board:	Crew - N/A	Passengers - N/A
Injuries:	Crew - N/A	Passengers - N/A
Nature of Damage:	Aircraft destroyed	
Commander's Licence:	Other	
Commander's Age:	52 years	
Commander's Flying Experience:	20 hours (of which 8 were on type) Last 90 days - 3 hours Last 28 days - 0 hours	
Information Source:	Aircraft Accident Report Form submitted by the pilot

Synopsis

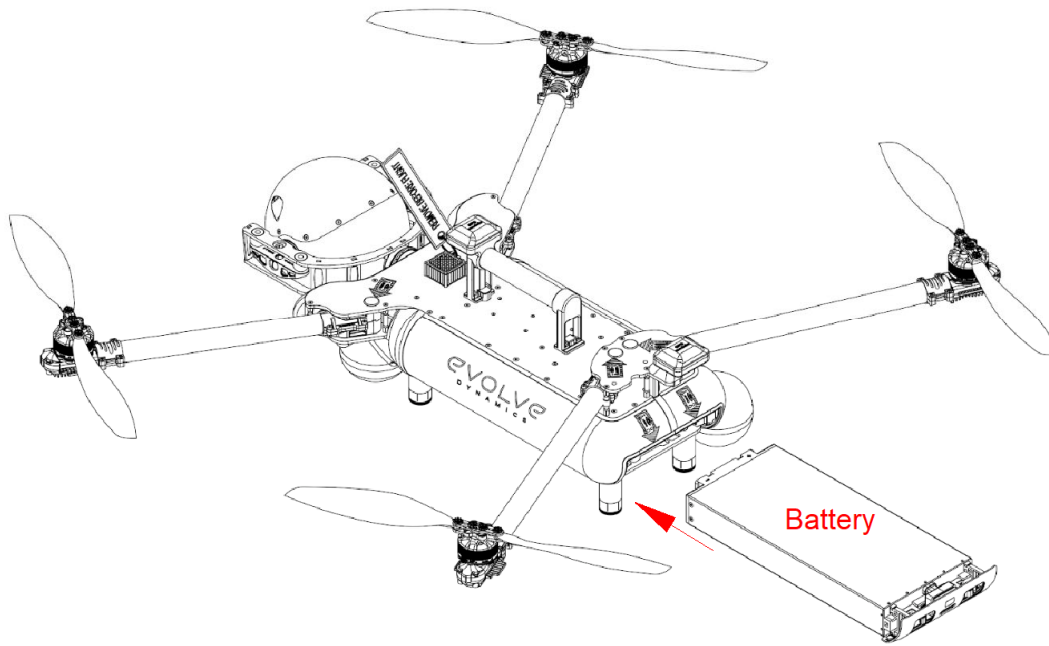
Figure 2
Sky Mantis battery insertion

Aircraft electrical power is provided by a 34Ah Lithium-ion battery (Figure 2). This is fitted into the rear of the aircraft and secured in place using a locking mechanism, which provides a visual indication when it is correctly latched. The battery charge level is displayed using four LED's that are fitted adjacent to the latches on the rear of the battery (Figure 3).

At the front of the battery is an electrical connector that mates with contacts inside the aircraft. This provides multiple paths for electrical power to be provided so that the loads can be evenly distributed. The connections on the battery are provided by pads that are held in place by thermoplastic composite material, and the corresponding mating pins inside the aircraft are spring loaded.

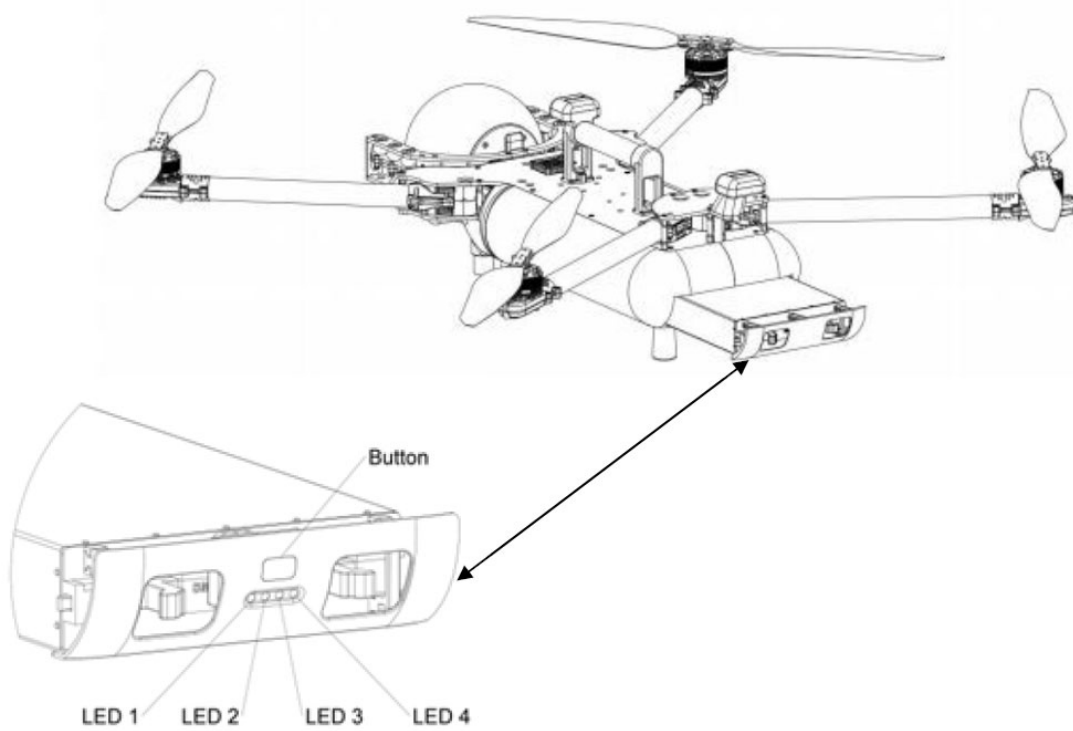
Figure 3
Sky Mantis battery charge indicator

The manufacturer stated that the damage to the connectors was a result of the number of pins in contact within the connector having been progressively reduced, which led to the electrical current through the remaining connections causing sufficient heat to distort the plastic of the connector. This led to the further loss of electrical load sharing between connections and additional heat, until the point where a complete loss of electrical power occurred. The recorded flight logs were also consistent with this, showing that at 13 minutes 27 seconds into the accident flight, there was a complete loss of electrical power. In the final minute of the flight preceding the loss of power, there were also several rapid fluctuations in the battery supply voltage and current flow to the aircraft. These were considered to be related to the connector starting to fail. A check of the battery charge indicator after the accident showed that it was at 75% charge remaining.
