Report on the investigation into the

stand up paddleboarding accident

that resulted in four fatalities

at Haverfordwest Town Weir, Wales

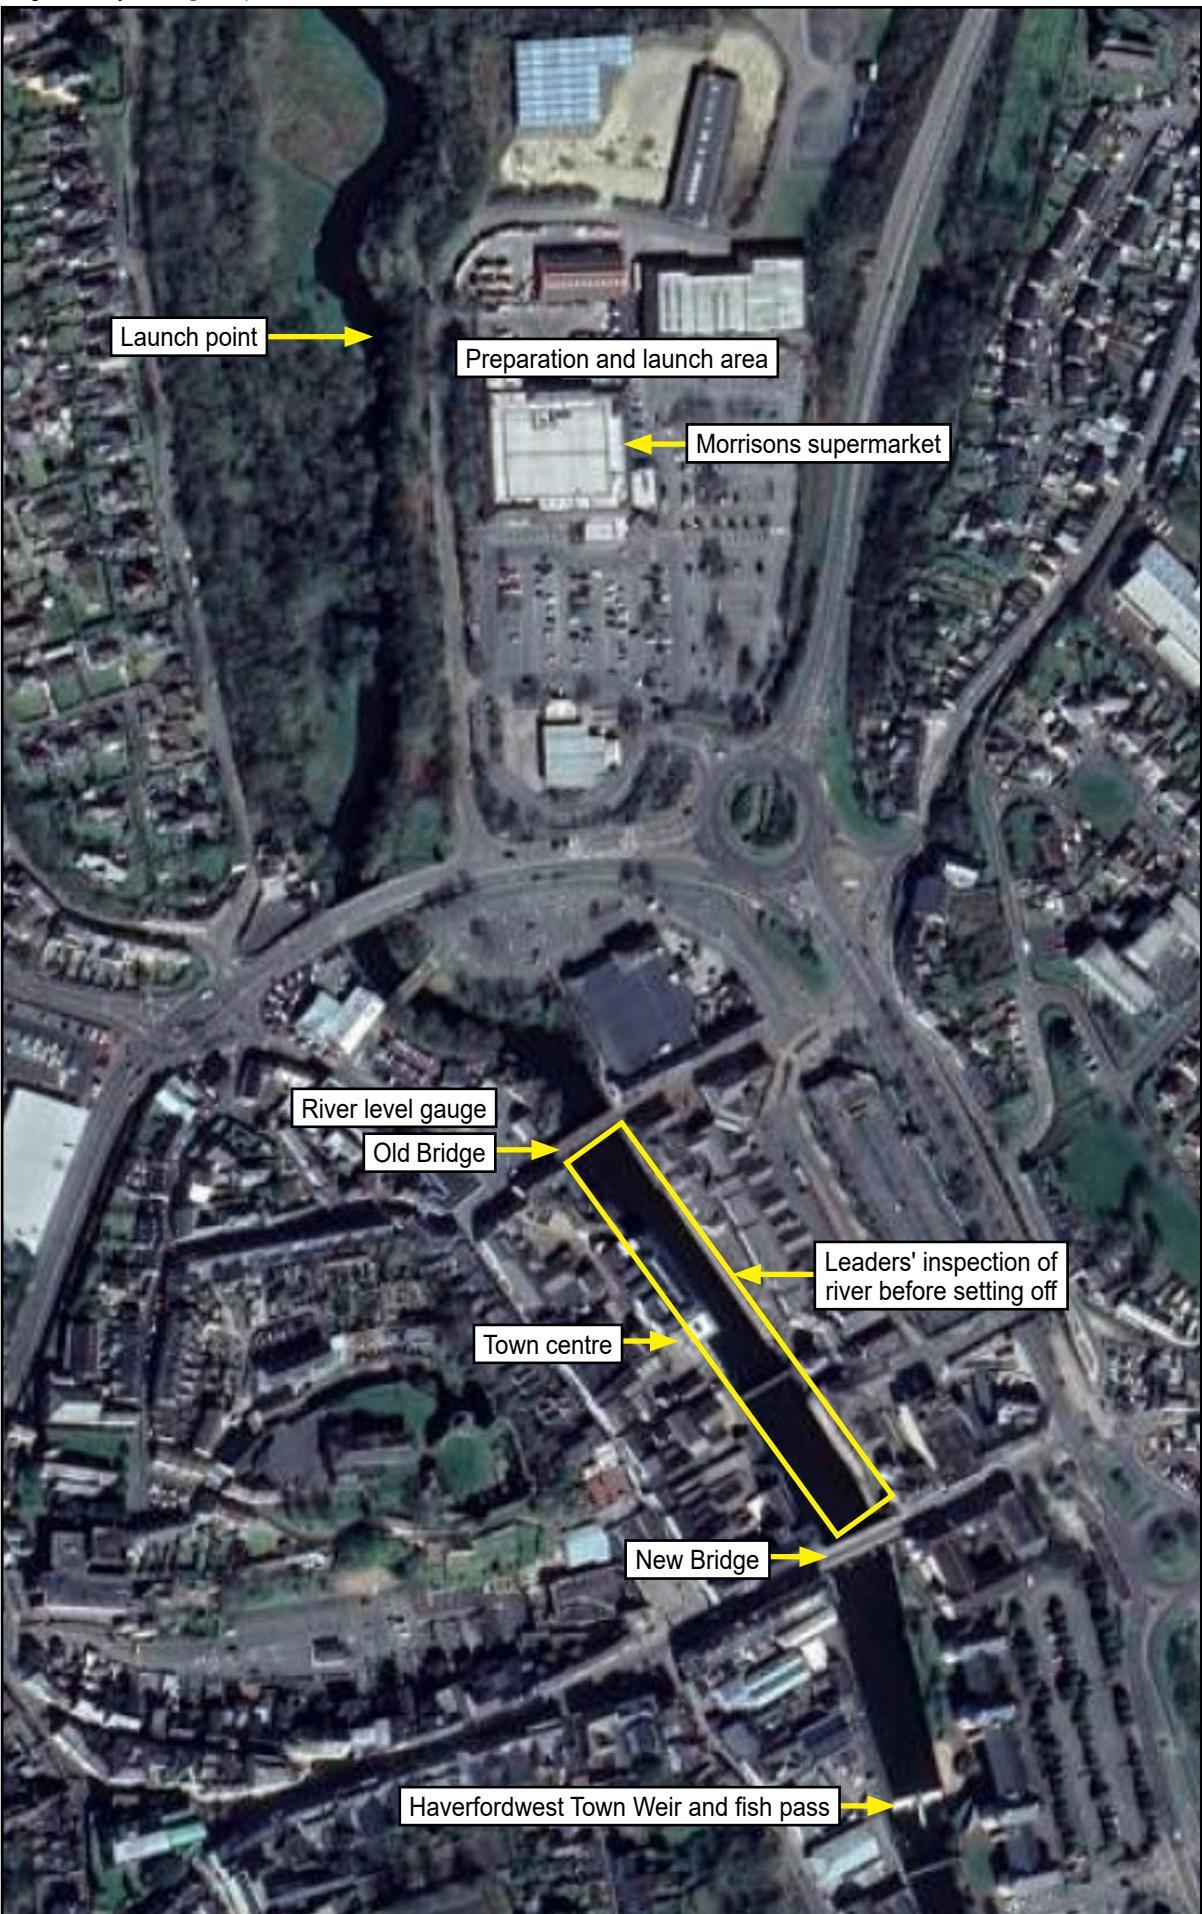
Figure 2: Aerial photograph of Western Cleddau, showing significant locations

On the day of the accident, the Pembrokeshire Tour leaders stopped their van in Haverfordwest town centre and inspected the river between the Old Bridge and the New Bridge; however, they did not inspect conditions at the weir (**Figure 2**). In addition, although the leaders circulated within the group before they set off, the participants were not briefed on the presence of the weir or how to descend it.

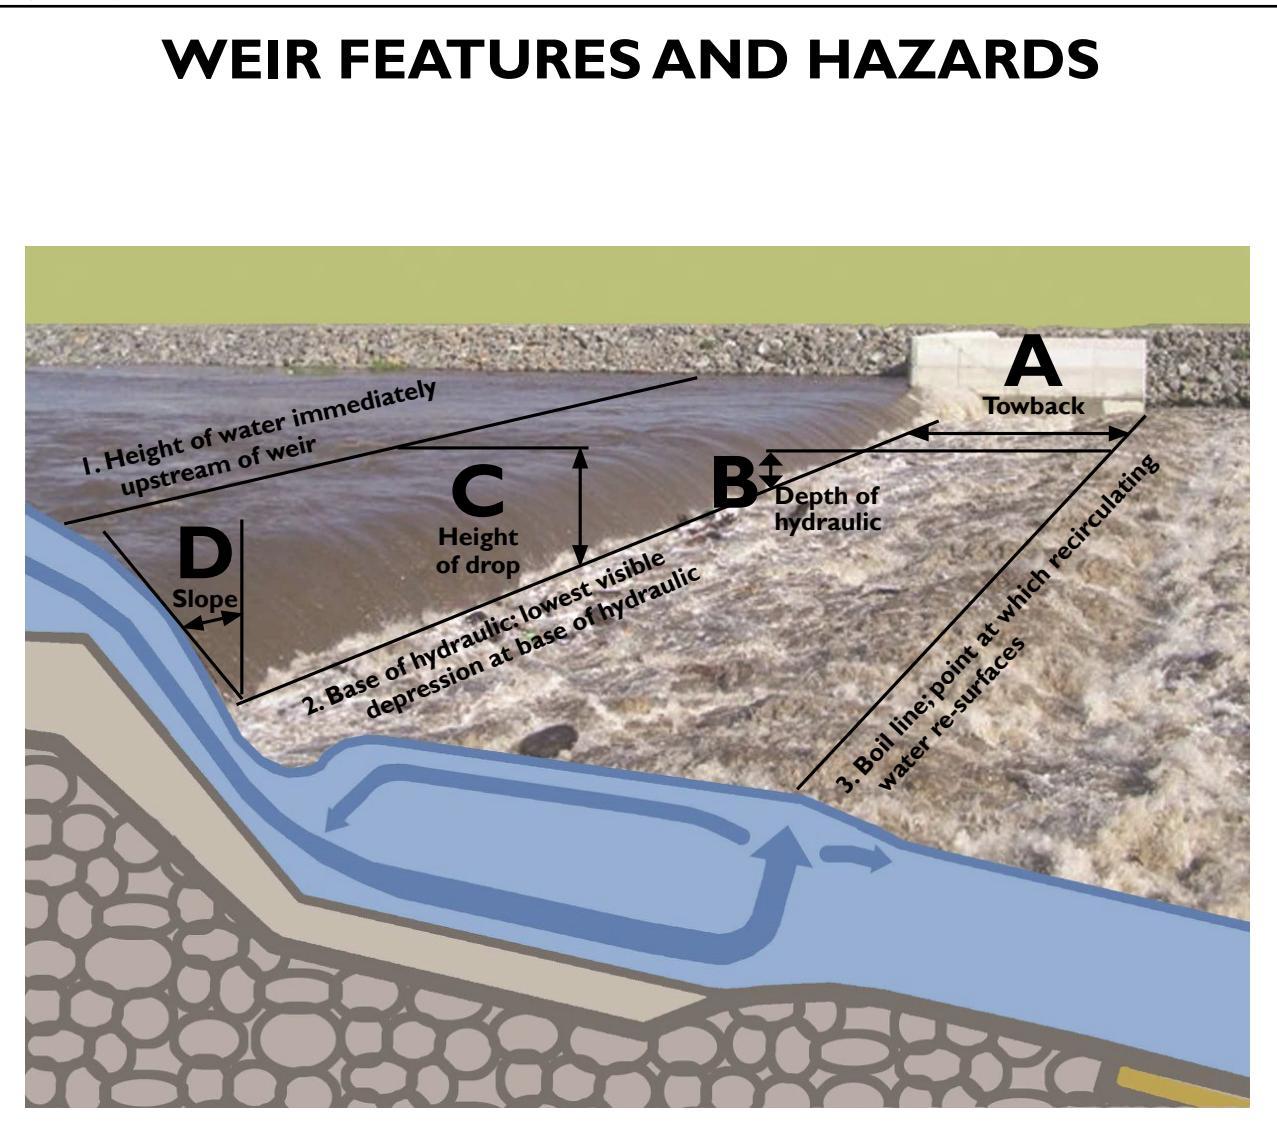
FEATURES/HAZARDS

A.Towback: The distance from the base of the hydraulic/stopper (2) to the boil line (3)

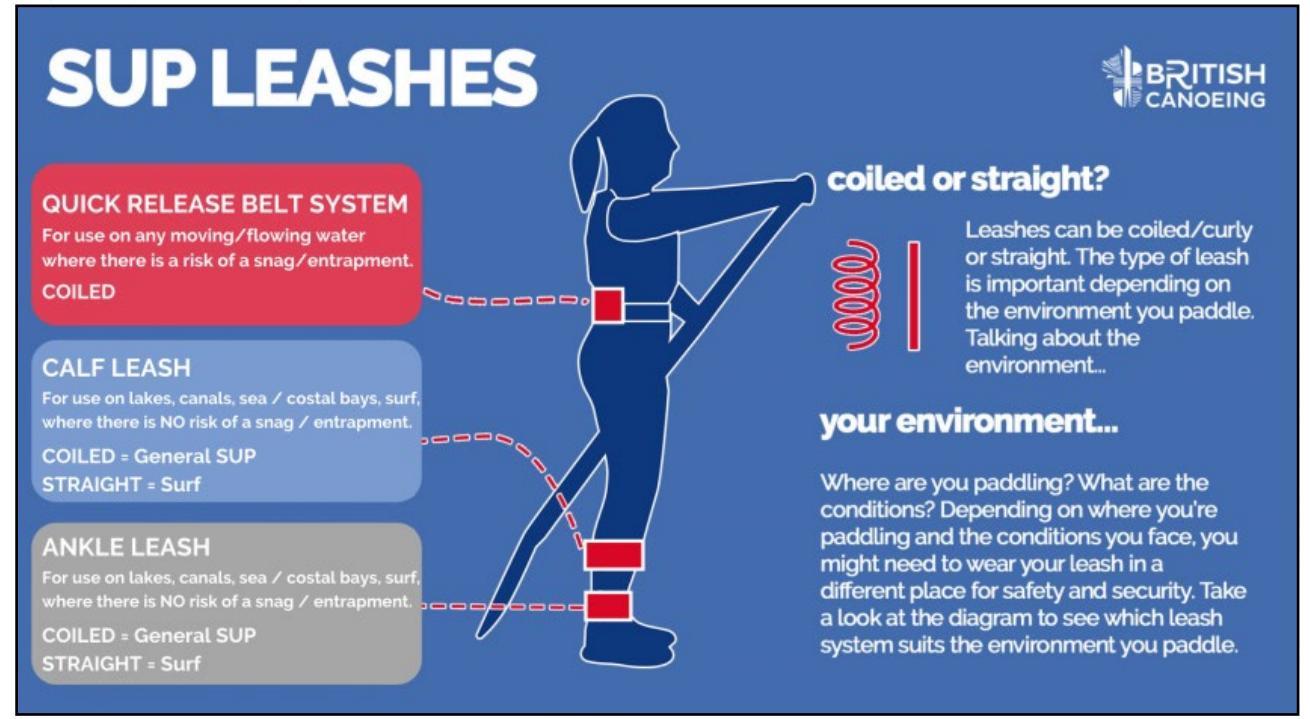
Figure 16: British Canoeing poster, providing advice on SUP leashes

At the time of the accident, British Canoeing had issued specific safety advice to SUP users on choosing the right leash **(Annex C** and **Figure 16)**. Surf England had issued advice for the surf zone; since the accident this has been updated to reflect British Canoeing's advice²⁹.
