ACCIDENT

Aircraft Type and Registration:	Enstrom 280FX, G-OJBB	
No & Type of Engines:	1 Lycoming HIO-360-F1AD piston engine	
Year of Manufacture:	1999 (Serial no: 2084)	
Date & Time (UTC):	25 August 2021 at 1618 hrs	
Location:	Rhobell Fawr, Dolgellau, Gwynedd	
Type of Flight:	Private	
Persons on Board:	Crew - 1	Passengers - None
Injuries:	Crew - 1 (Minor)	Passengers - N/A
Nature of Damage:	Damaged beyond economic repair	
Commander's Licence:	Private Pilot's Licence	
Commander's Age:	65 years	
Commander's Flying Experience:	419 hours (of which 419 were on type) Last 90 days - 12 hours Last 28 days - 4 hours	
Information Source:	AAIB Field Investigation

Synopsis

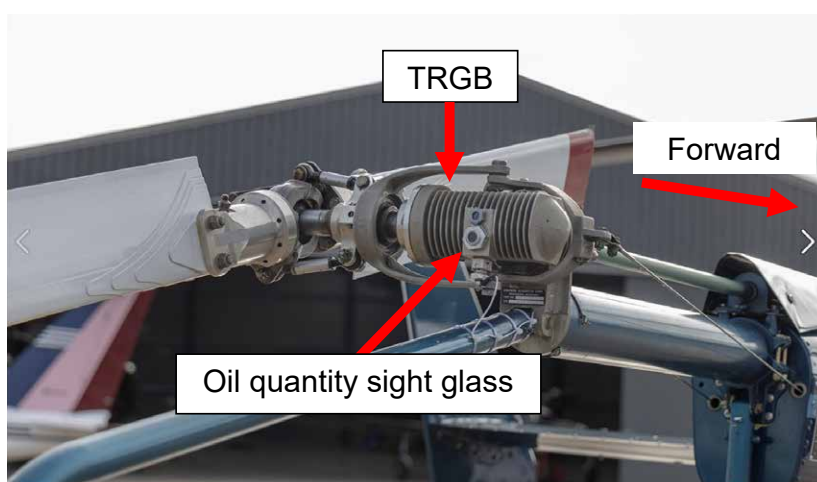
Figure 4

The Enstrom 280FX is a single engine light helicopter powered by a Lycoming HIO-360-F1AD piston engine. It is fitted with a three-bladed main rotor and a two-bladed teetering tail rotor driven by a TRGB mounted at the aft end of the tail boom (Figure 4). A drive shaft attached to the upper pulley of the main rotor transmission provides input drive to the TRGB. At a nominal engine speed of 3,050 rpm, the main rotor rotates at 351 rpm and the tail rotor at 2,514 rpm.

TRGB viewed from rear of 280FX helicopter

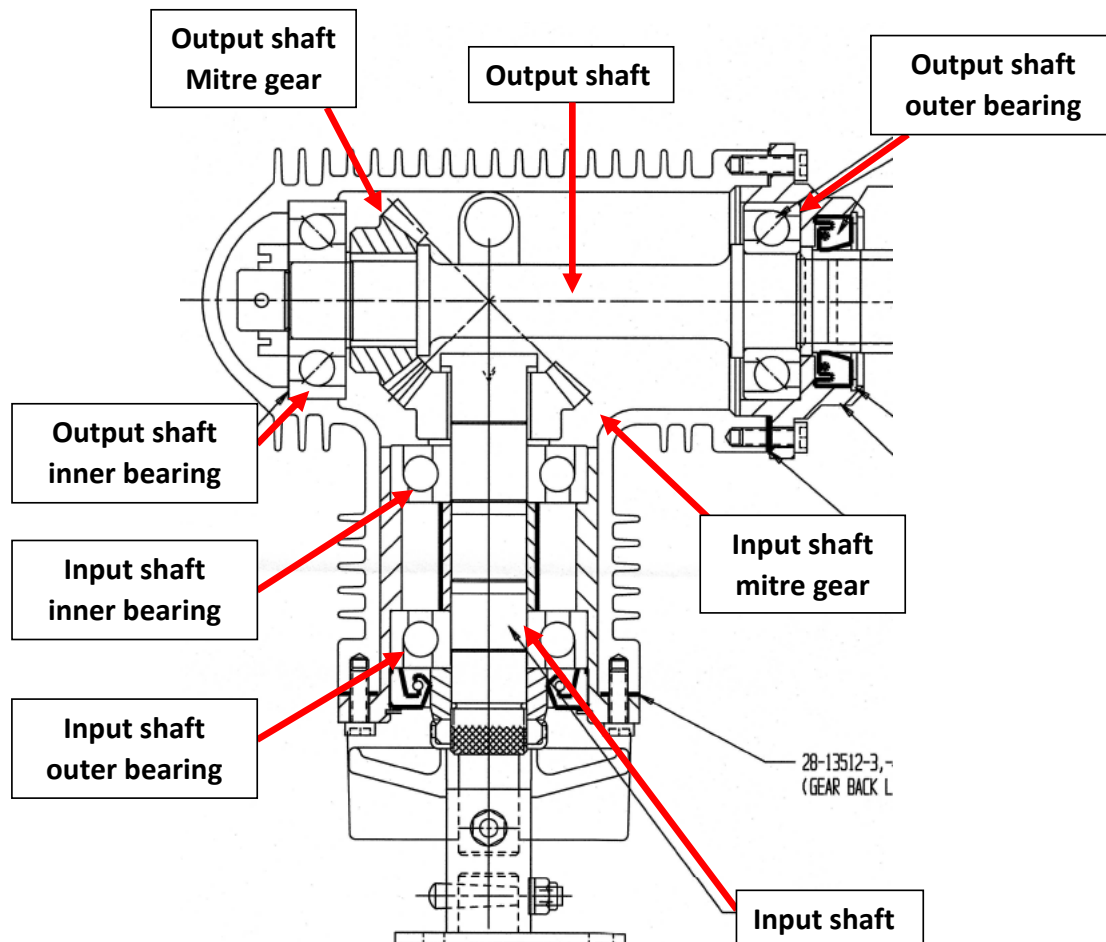
**Figure 5**

The TRGB case is manufactured from aluminium and contains an input and output shaft that are each supported by two bearings, with drive between the shafts provided by bevel gears (Figure 5). The same TRGB design is also fitted to Enstrom F-28A, 280, F-28C, 280C and 480 helicopters.

TRGB (reproduced with permission)

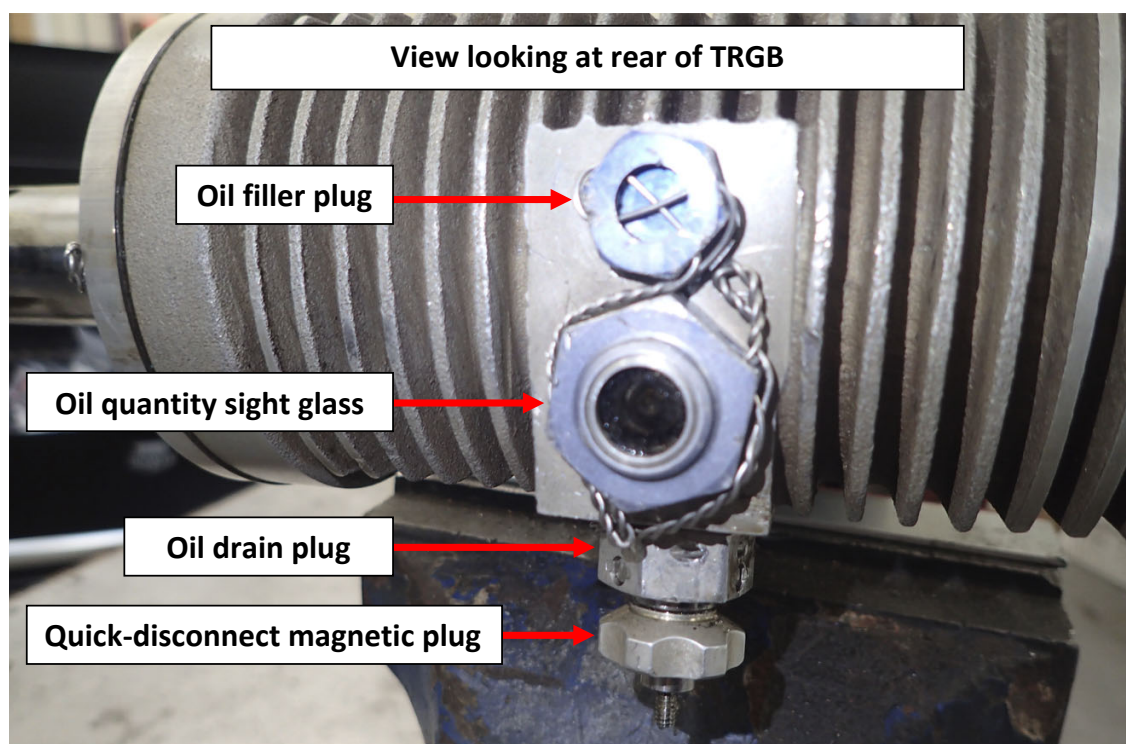
Figure 6

The bevel gears and bearings are splash lubricated by oil, with seals fitted to the input and output shafts to prevent oil loss from the unvented TRGB. At the rear of the TRGB case is an oil filler port and below this is an oil quantity sight glass⁶ (Figure 6). Early Enstrom helicopters were fitted with a flat sight glass but, in 2008, a dome shaped sight glass was introduced in response to customer feedback, to improve readability. The domed sight glass was fitted to all new TRGB's, and those overhauled by the manufacturer since 2008. G-OJBB was fitted with an original flat sight glass.

TRGB plugs and sight glass (G-OJBB)

The metallic fragments in the TRGB oil would have been created when ferrous bearing material was liberated as a result of spalling during the bearing failure sequence. From the photograph of the magnetic plug taken shortly after the helicopter was recovered (Figure 6)

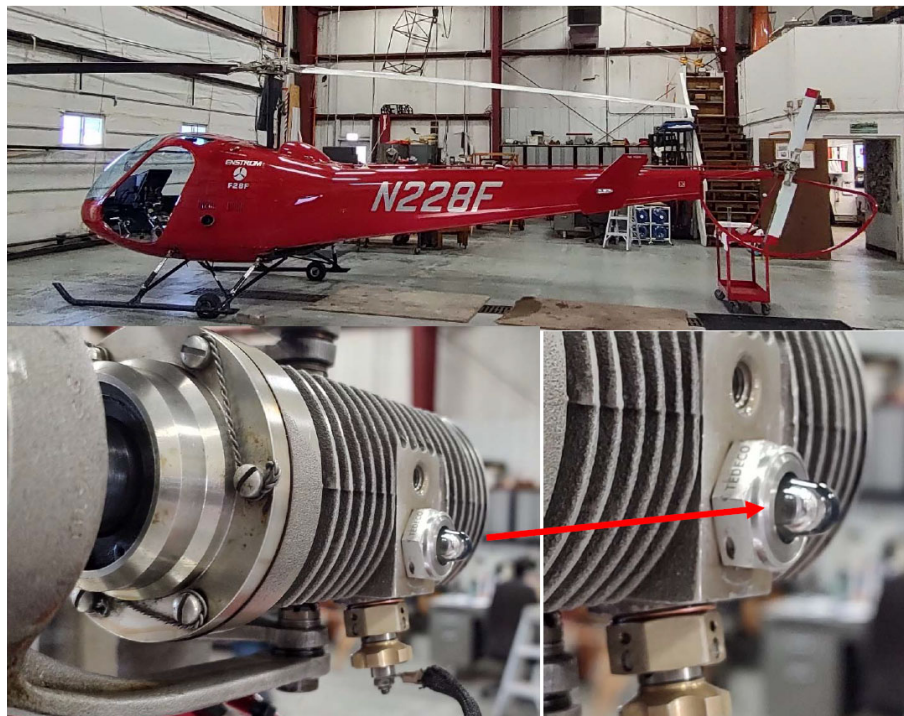
**Figure 16**

The manufacturer subsequently assessed the effect of the helicopter’s attitude on the sight glass oil level, with 18 ml of oil in the TRGB. This was done on an F-28F helicopter, which has the same geometry as the 280FX. The TRGB was fitted with a domed sight glass. With the ground handling wheels extended, the helicopter’s tail was 1.3° down from level and the oil was not visible in the sight glass (Figure 16). When the tail was lowered until it was approximately 5.5° below level, the oil level was at approximately the centre of the sight glass (Figure 17). Lowering the tail further to 8° below level resulted in only a slight change in the oil level (Figure 18).

Helicopter at 1.3° tail-down from level

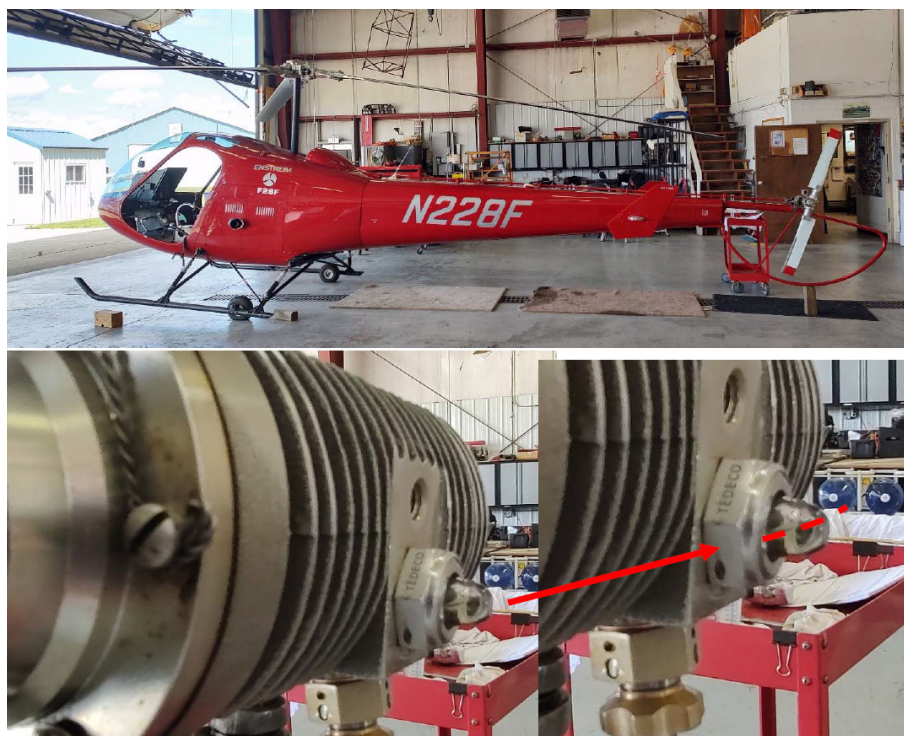
**Figure 17**

Helicopter at 5.5° tail-down from level

With 18 ml of oil in the TRGB, an amount close to that recovered from the TRGB after the accident, the manufacturer demonstrated that the helicopter's tail would have to be about 5.5° below level, in order for the oil level to be at the centre of the sight glass. At this attitude, the helicopter is noticeably nose-high/ tail-low (Figure 17) and the skids no longer parallel to the ground. The pilot did not report having to lower the helicopter's tail more than normal when checking the TRGB oil level following its return from the annual inspection in March 2021. However, if deposits had been present on the sight glass, this may have affected the pilot's ability to correctly read the oil level and may explain why he did not identify the low oil level during pre-flight checks.

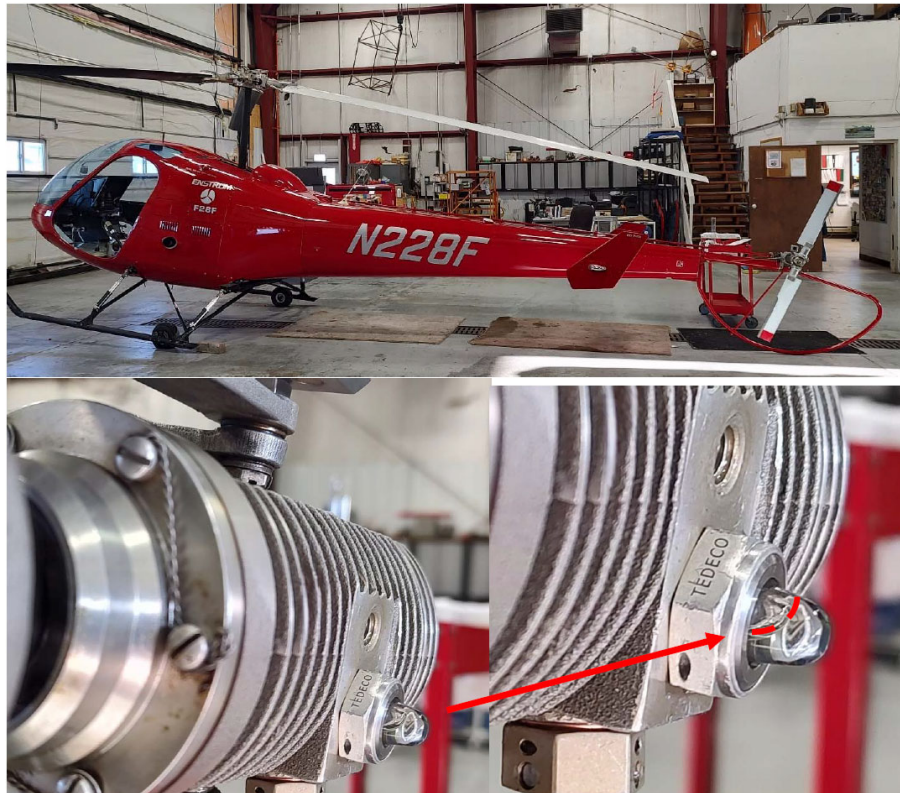
Figure 18

Helicopter at 8° tail-down from level
