## ACCIDENT

<b>Aircraft Type and Registration:</b>	Piper PA-23-250, G-BJNZ	
<b>No &amp; Type of Engines:</b>	2 Lycoming IO-540-C4B5 piston engines	
<b>Year of Manufacture:</b>	1979 (Serial no: 27-7954099)	
<b>Date &amp; Time (UTC):</b>	2 April 2022 at 1535 hrs	
<b>Location:</b>	Enfield, Greater London	
<b>Type of Flight:</b>	Private	
<b>Persons on Board:</b>	Crew - 1	Passengers - 3
<b>Injuries:</b>	Crew - None	Passengers - None
<b>Nature of Damage:</b>	Damage to the engines, propellers, landing gear, left flap and underside of the fuselage	
<b>Commander's Licence:</b>	Private Pilot's Licence	
<b>Commander's Age:</b>	67 years	
<b>Commander's Flying Experience:</b>	1,859 hours (of which 1,090 were on type) Last 90 days - 33 hours Last 28 days - 21 hours	
<b>Information Source:</b>	AAIB Field investigation

## Synopsis

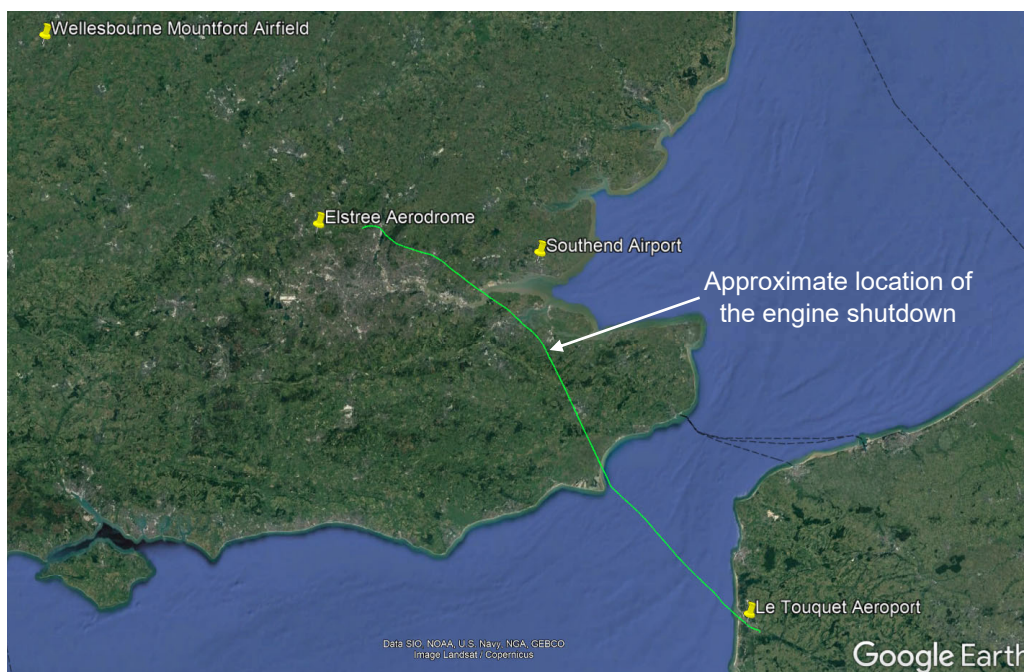
**Figure 1**

G-BJNZ radar trace showing the intended destination

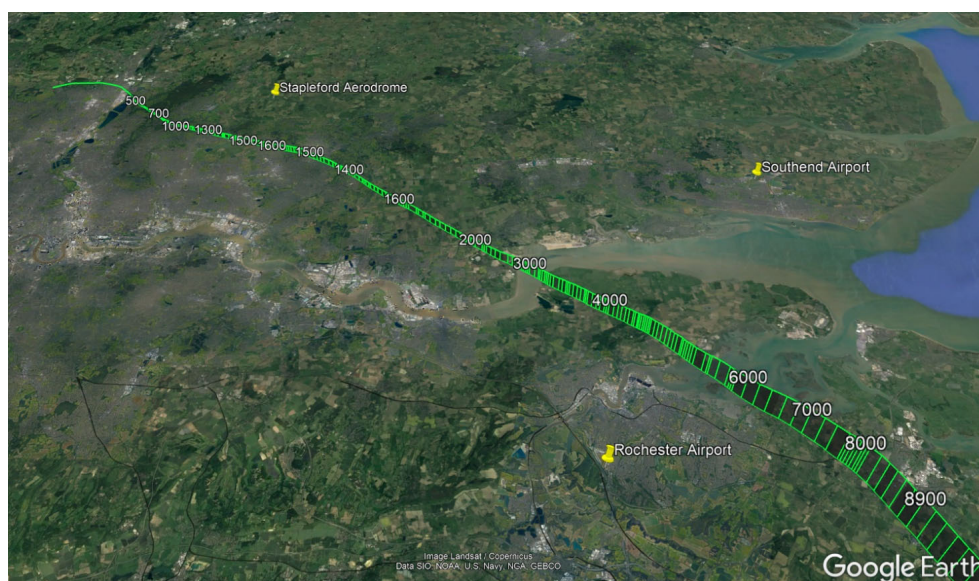
**Figure 3**

Radar trace following the engine shutdown showing altitude

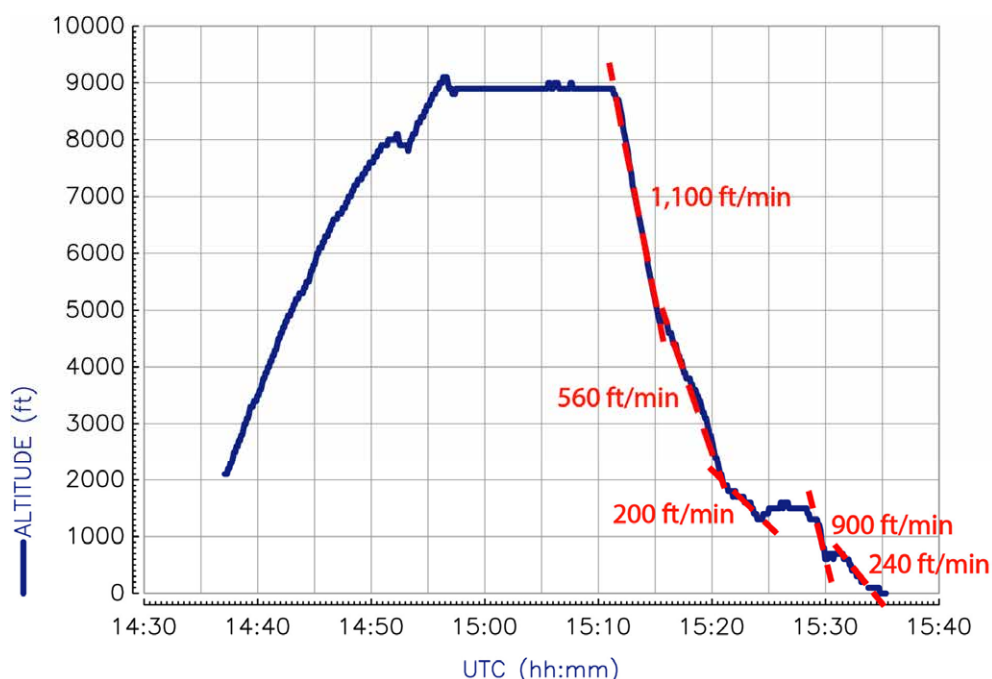
**Figure 4**

The attitude flown by the aircraft was recorded on radar (Figure 3) and is shown in profile in Figure 4. Average rates of descent are shown in red. The figure shows that on passing 2,000 ft the aircraft initially continued to descend at 200 ft/min before climbing briefly then descending again.

Altitude profile of the accident flight

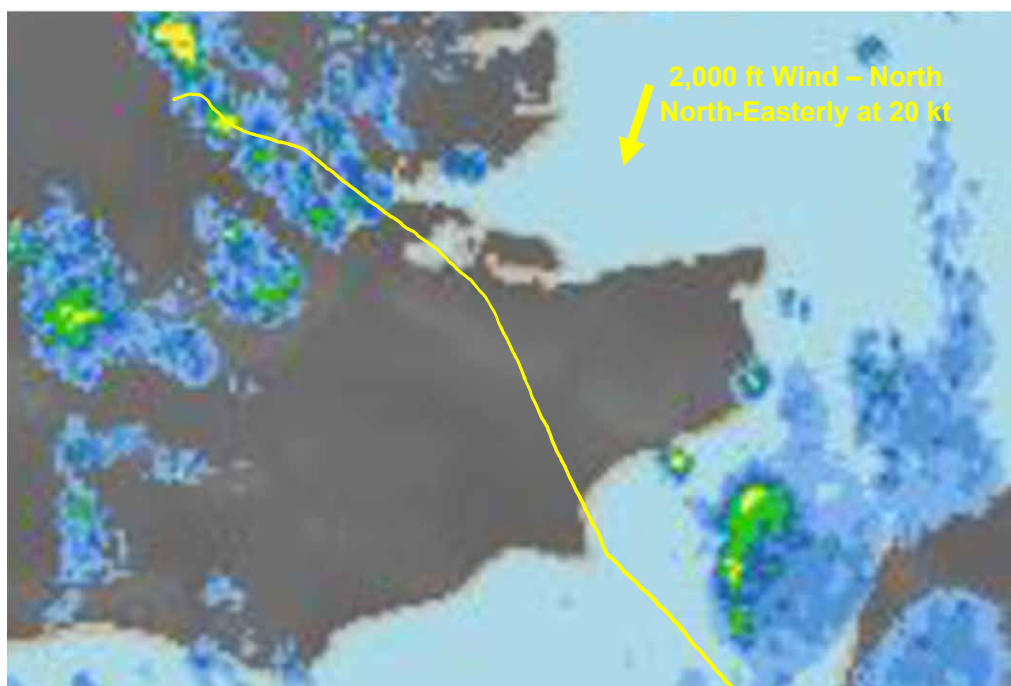
**Figure 12**

At the time of the accident rain showers were present across much of the UK. In the vicinity of the accident, satellite and radar records show cumuliform cloud and rain showers close to the aircraft's track. Figure 12 shows a weather radar image at 1530 hrs with the aircraft's track overlaid. Figure 2 shows the cloud ahead of the aircraft when the left engine was shutdown.

Weather radar image at 1530 hrs with the aircraft's track overlaid
