## ACCIDENT

<b>Aircraft Type and Registration:</b>	Freefly Systems Inc. Alta X	
<b>No &amp; Type of Engines:</b>	4 electric motors	
<b>Year of Manufacture:</b>	2021 (Serial no: Q848350)	
<b>Date &amp; Time (UTC):</b>	29 June 2022 at 1124 hrs	
<b>Location:</b>	Henley-on-Thames, Oxfordshire	
<b>Type of Flight:</b>	Commercial Operations (UAS)	
<b>Persons on Board:</b>	Crew - N/A	Passengers - N/A
<b>Injuries:</b>	Crew - N/A	Passengers - N/A
<b>Nature of Damage:</b>	Aircraft not recovered	
<b>Commander's Licence:</b>	Other	
<b>Commander's Age:</b>	53 years	
<b>Commander's Flying Experience:</b>	831 hours (of which 18 were on type) Last 90 days - 73 hours Last 28 days - 28 hours	
<b>Information Source:</b>	Aircraft Accident Report Form submitted by the pilot and further AAIB enquiries

## Synopsis

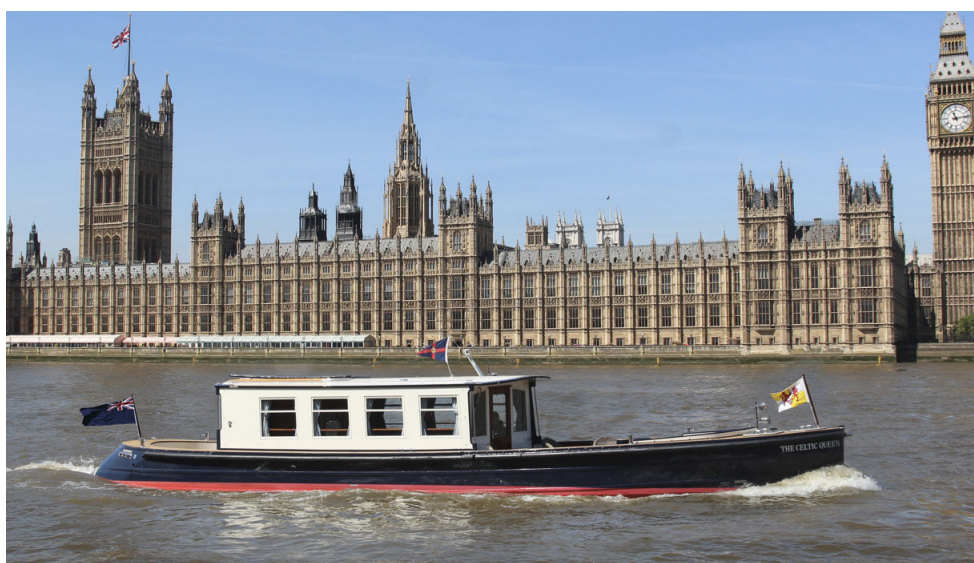
**Figure 4**

The Celtic Queen is a boat of approximately 20 m in length and 3 m wide (Figure 4), with a cabin of metal construction. At the bow and stern are seating areas for passengers.

The Celtic Queen (Photograph used with permission)

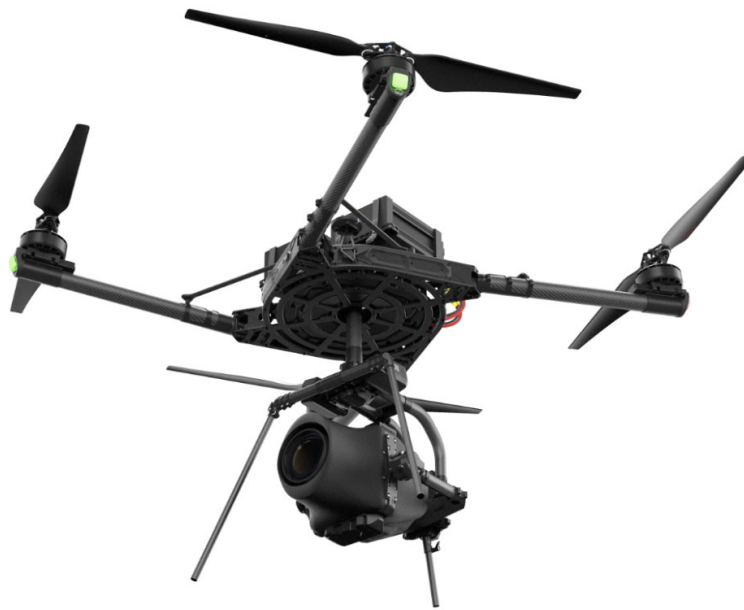
**Figure 8**

The Alta X (Figure 8) is an unmanned, electrically powered quadcopter with a maximum takeoff weight of 34.9 kg<sup>2</sup>. This type of aircraft relies upon its propulsion system for lift. The aircraft's rotors are 84 cm in length and, when the motor arms are extended for flight, the aircraft measures 2.28 m from rotor tip to rotor tip. During the accident flight the aircraft's takeoff weight was 28 kg, which included an underslung camera mounted on a gimbal.

Alta X (not the accident aircraft)
