Our Reference:  
FOI2022/07075  
Date:  
4 August 2022

**ENGINEERING OFFICER'S EXECUTIVE SUMMARY - SEFIT 11-0133-SI SUPPORT VEHICLE (SV) CARGO LIGHT 6 TONNE 4X4 EURO 4 MAN, FULL BOWMAN FIT VRN – HK76AB FRONT LEFT HAND WHEEL STATION FAILURE**

CLAMP ASSEMBLY FAILURE

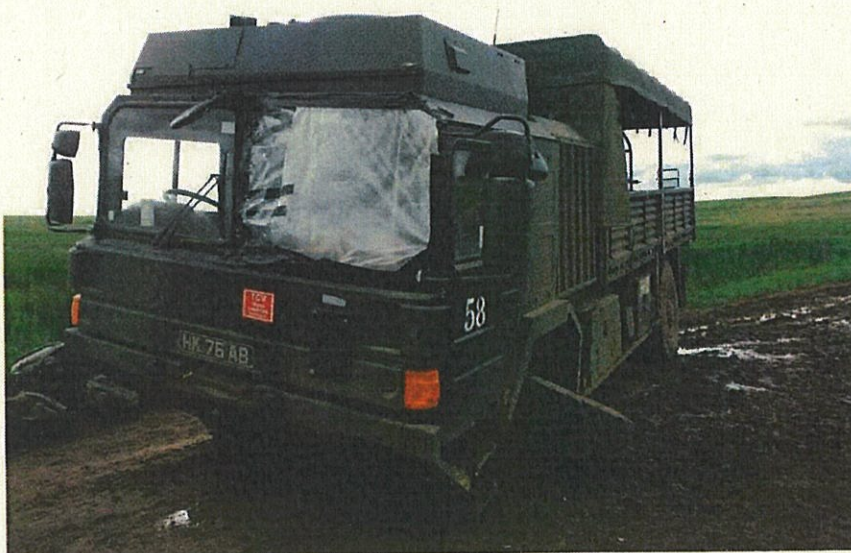
**Figure 1 – SV Cargo 6T, VRN – HK76AB**

1. In response to Reference A and in accordance with References B & C, [REDACTED] from the Serious Equipment Failure Investigation Team (SEFIT) British Army Training Unit Suffield (BATUS) (SEFIT (B)), deployed to Bingville Road, Grid Reference VA135898 on BATUS Military Training Area (MTA). The purpose of the deployment was to conduct an engineering investigation of the subject vehicle, held by Contemporary Operating Environment Force (COEFOR) (Figure 1).

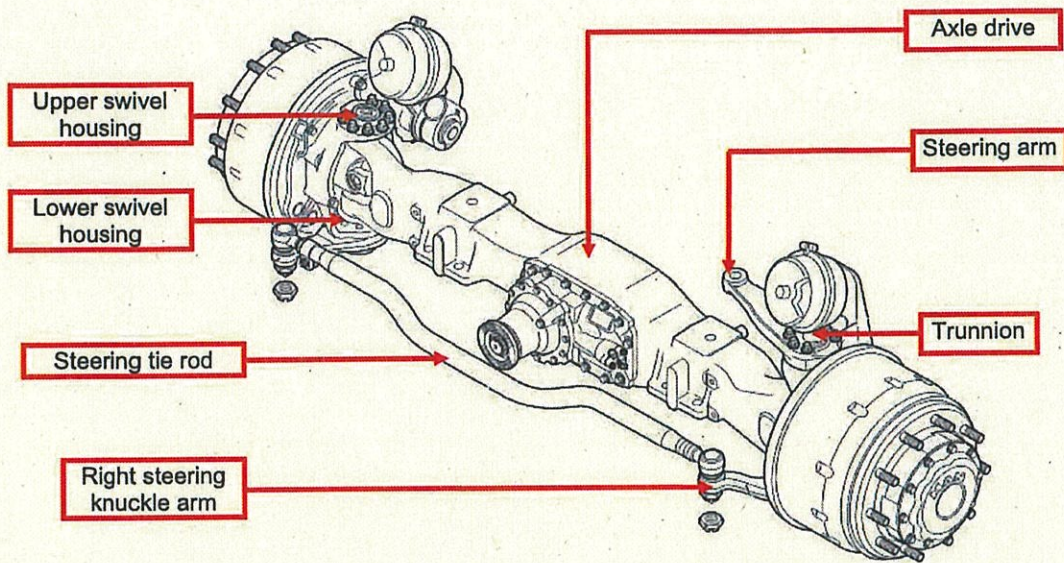
Figure 2 – Front axle, view from RH rear

4. A full technical description of the subject vehicle is currently unavailable. The following has been extracted from Reference D and the investigators knowledge of the equipment which is pertinent to this investigation:
- The front steering planetary axle is a cast steel alloy construction consisting of the LH and RH wheel stations, the axle drive, steering and braking components. Steering is achieved via a steering arm which is connected to the RH wheel station. A steering tie rod transfers the steering motion to the LH wheel station. Each wheel station is connected to the main axle body by means of cast upper and lower swivel housings. These fit over upper and lower trunnions housed in the axle body allowing the wheel stations to pivot (Figure 2).

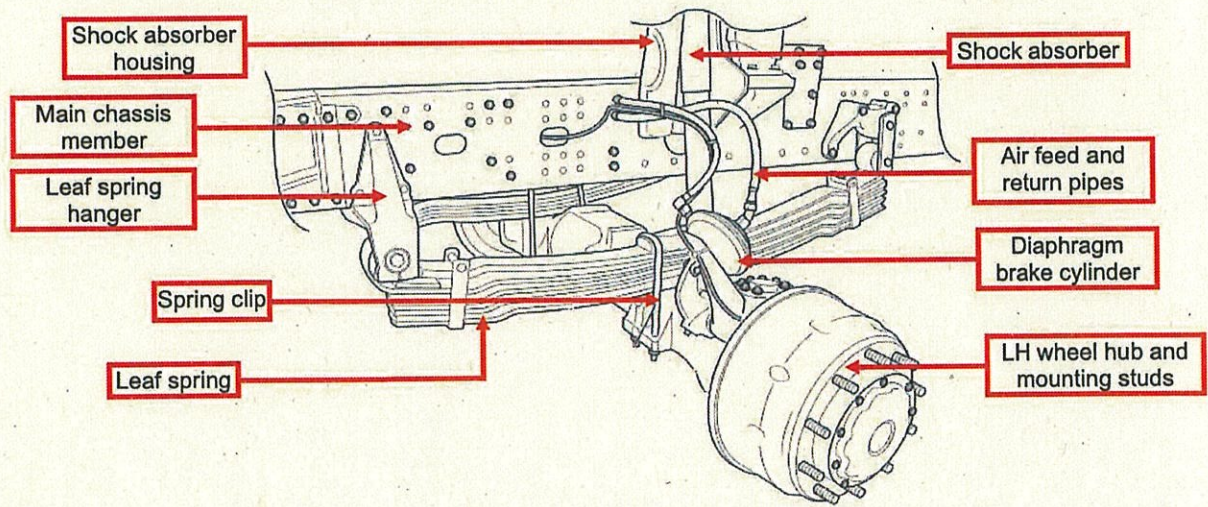
Figure 3 – Front LH wheel station

b. The axle assembly is attached to the leaf spring by means of 2 spring clips. The leaf springs are connected to the main chassis member by means of leaf spring hangers. A shock absorber is connected at its lower end to the axle assembly and to the main chassis member via a shock absorber housing and mount at its upper end. Each wheel station is fitted with a diaphragm brake cylinder, compressed air feed and return pipes, and electrical cabling (inside a shroud) for brake signal and error information (Figure 3).

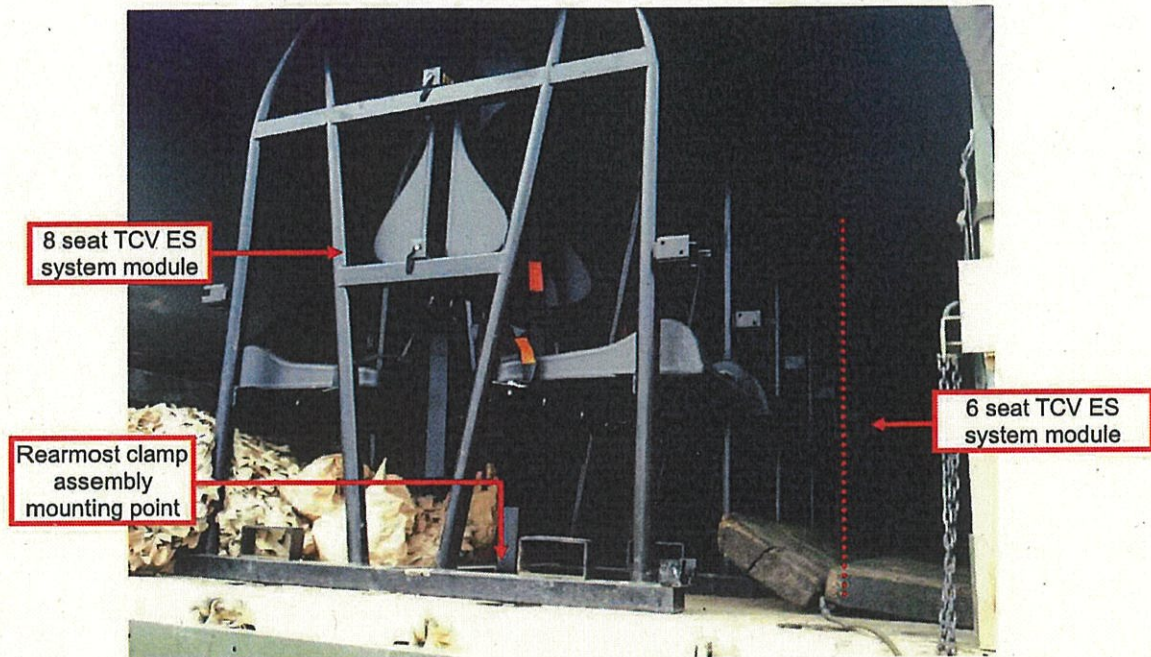
Figure 6 – TCV ES system fitted to subject vehicle

- a. Both the 6 and 8 seat TCV ES modules were still connected to the cargo bed of the subject vehicle (Figure 6). The 6 seat module had all 3 clamp assemblies fitted. The 8 seat module had the centre and foremost clamp assembly fitted.

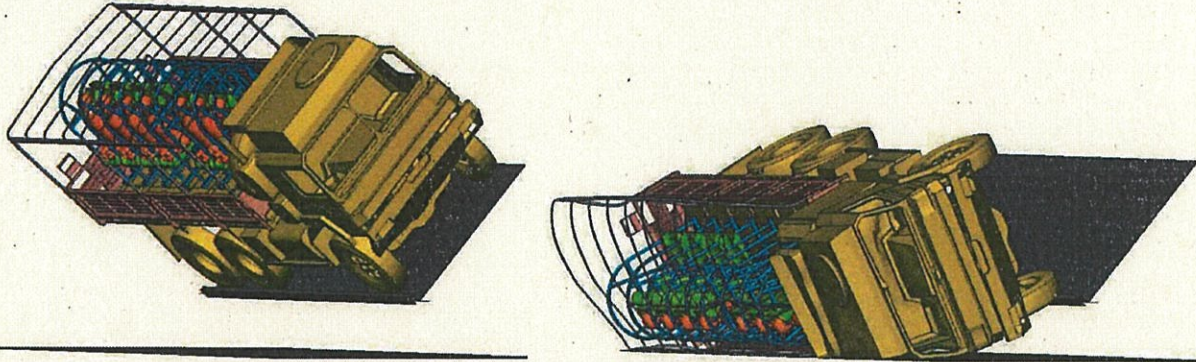
Fig 2.1 : Truck Tilt Images

An HX58 truck model, with Mk2 8 and 6 seat TCVES systems mounted on the load bed, including 14 x 95kg occupant mass, was placed on the tilt table. The whole assembly was pre-tilted to the point at which the vehicle centre of gravity just passed the tile table lip. Finite element analysis was initiated allowing the vehicle to tip and drop under gravity, to the rigid floor 800mm below.

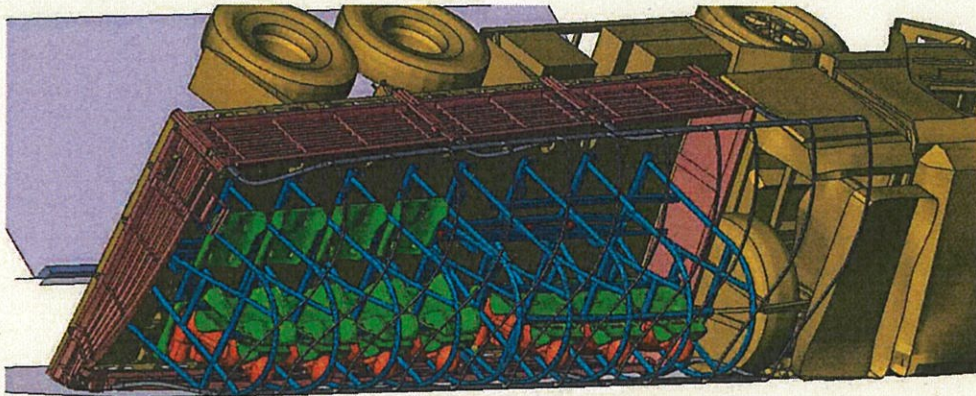
The load bed & chassis twists, causing greater deformation towards the rear of the frames.

The rear roll hoops distort around the load bed frame

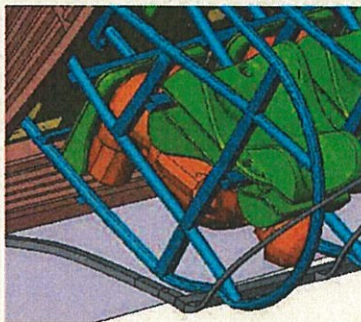
The central seat spine and roll hoops bow slightly under the weight of the occupants

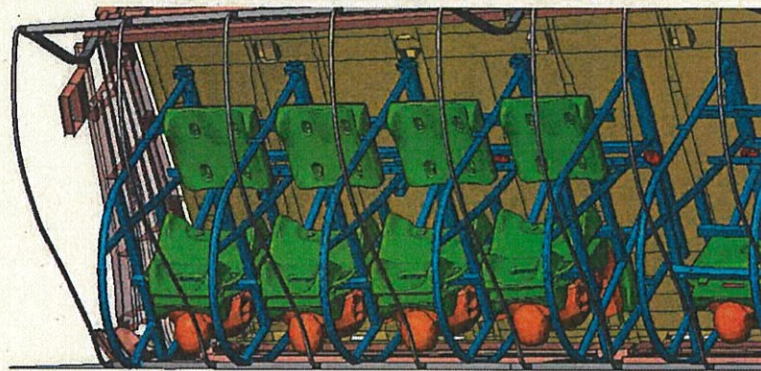
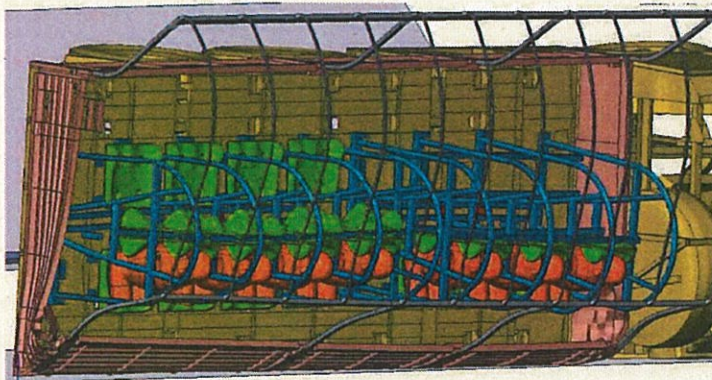
The frames are predicted to remain intact and suffer generally low levels of distortion

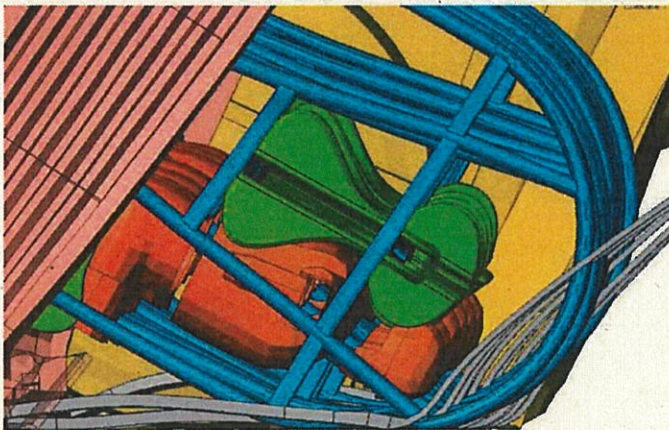
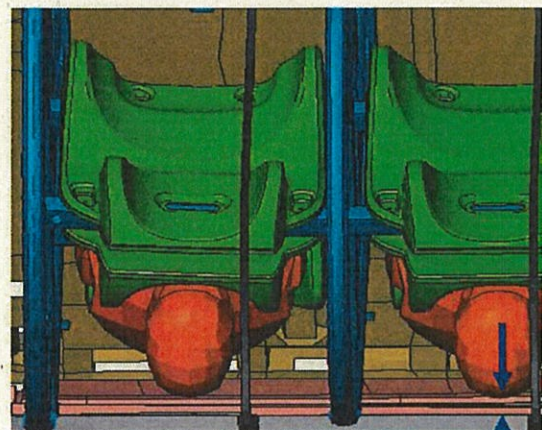
The roll frames prevent the ground from encroaching into the occupant volume for all seating positions.

The load bed frame upper beam comes within 36mm of the occupant helmet volume

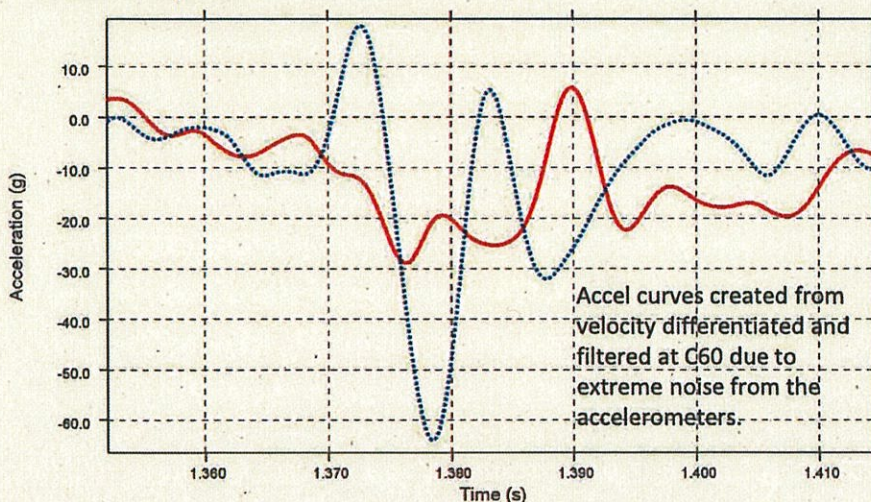
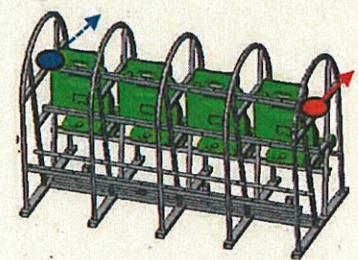
Graph 3.1 : Acceleration of 8 seat TCVES frame in local lateral axis during initial ground impact

ECE regulation 66 is a test of structural strength and survival space around the occupants. It is not a test of occupant injury. However, for reference in any potential future development work, lateral accelerations of the frame at occupant shoulder height are presented below for the instant of frame to ground impact. These could potentially be used to assess the actions of the occupants.

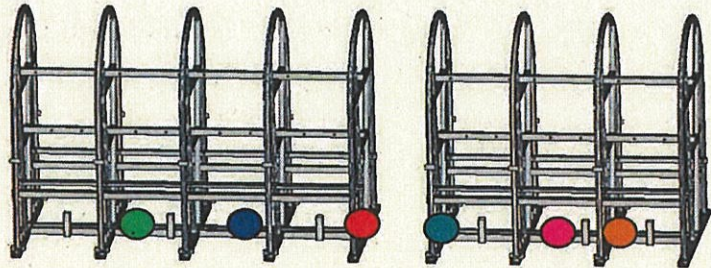
The peak force, acting normal to the floor predicted through the worst case fixing under ECE66 Tilt impact was approximately **22kN**.

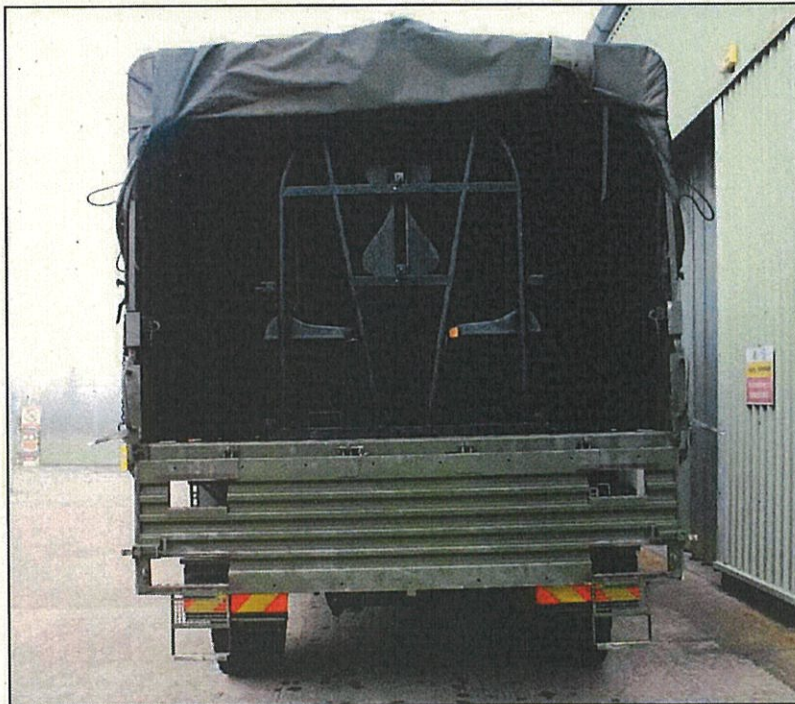
**Figure 1 – Troop Carrying Vehicles Enhanced Seating System (TCV ES)<sup>1</sup>**

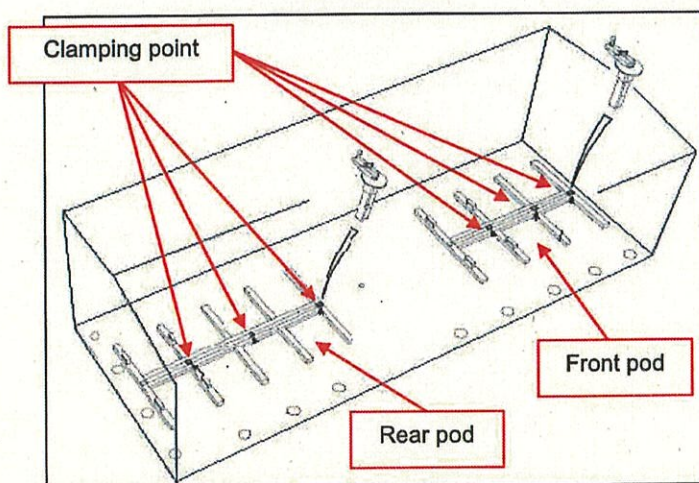
- The installation layout of the clamps for the TCV ES Mk 2 pods when fitted to MAN SV Cargo 6T 4X4 is detailed in Reference D, Installation Instruction Number 6 (Inst Instr No 6) (Figure 2). It further details the need to lock the locking handle down post tightening procedure.

Figure 2 – Clamp assembly layout

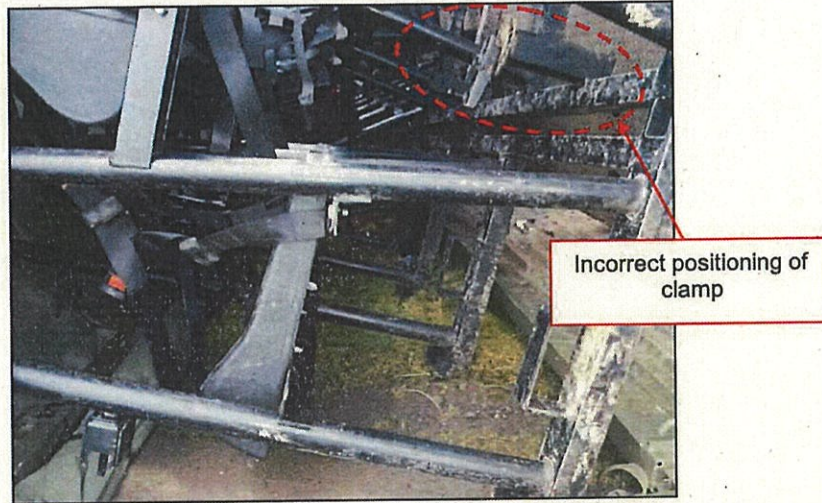
b. Further examination of the pictures identified that a clamp still located in the TCV ES Mk 2 rear pod was incorrectly positioned (Figure 4). No other clamps were visible on the rear pod.

**Figure 4 – Incorrectly positioned rear pod clamp**

- (1) Instigates an inspection programme to ensure the correct fitment of all currently installed seating systems and reiterates to users of TCV ES the correct procedure for fitting the seating arrangement in accordance with Reference D and the enhanced measures for securing it as detailed in Reference E.
- (2) Ensure all holding units are aware of the requirement to keep TCV ES records as detailed in Reference C.
- (3) Update relevant AESP's in accordance with Reference E.
- (4) Enter this incident into the Equipment Hazard Log and monitor for future trends.

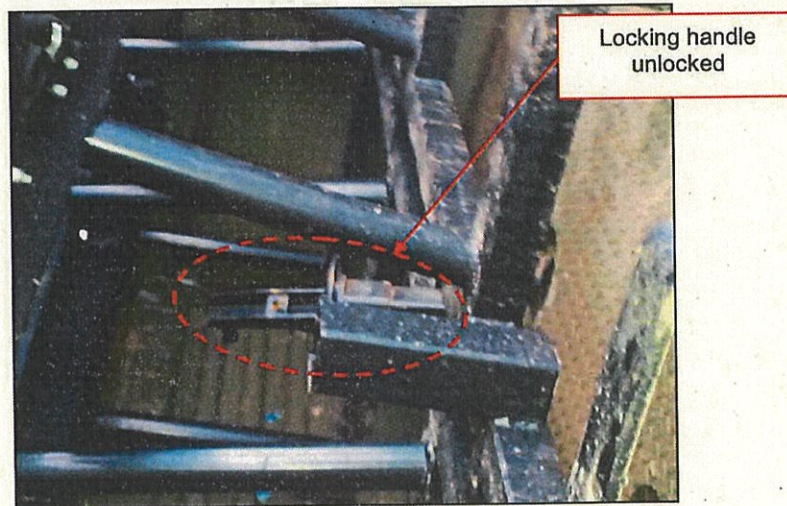
c. Examining the photos taken of the front pod showed that one clamp had been correctly positioned however the clamp handle was not in the locked position, indicating that it had been incorrectly secured to the cargo platform (Figure 5). No other clamps were visible on the front pod.

**Figure 5 – Incorrectly secured front pod clamp**

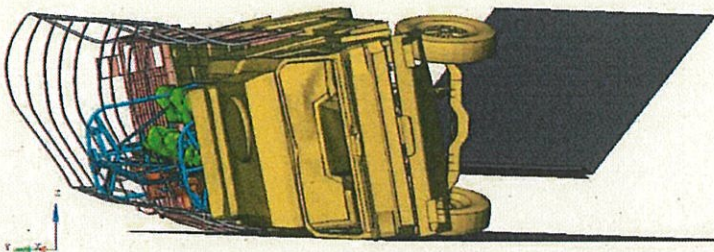
The TCVES frame impacts the ground

The truck slides outwards and rolls back onto it's side

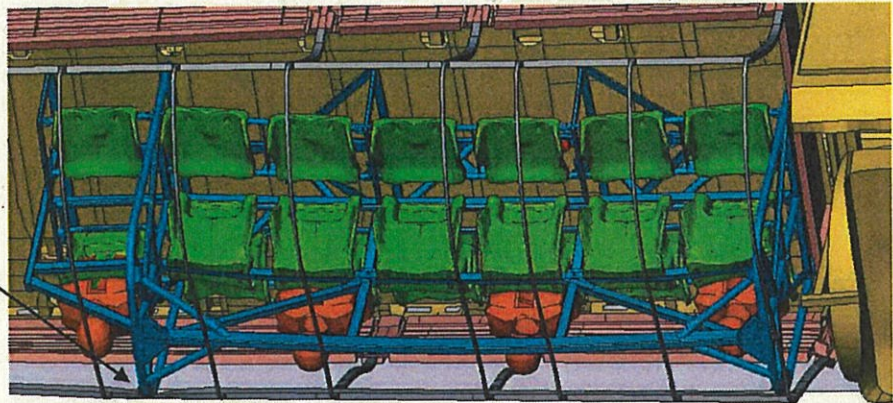
Initial TCVES Impact  
The rear roll hoop and load bed frame suffer local deformation at the impact point

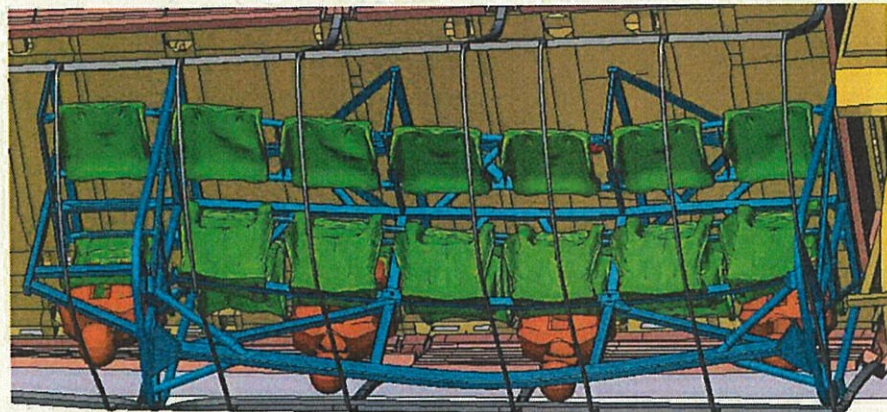
Mid Impact  
The roll hoops suffer low levels of deformation and as a result stop very abruptly. The large occupant mass acting through the central frame continues downwards, bending the central beams

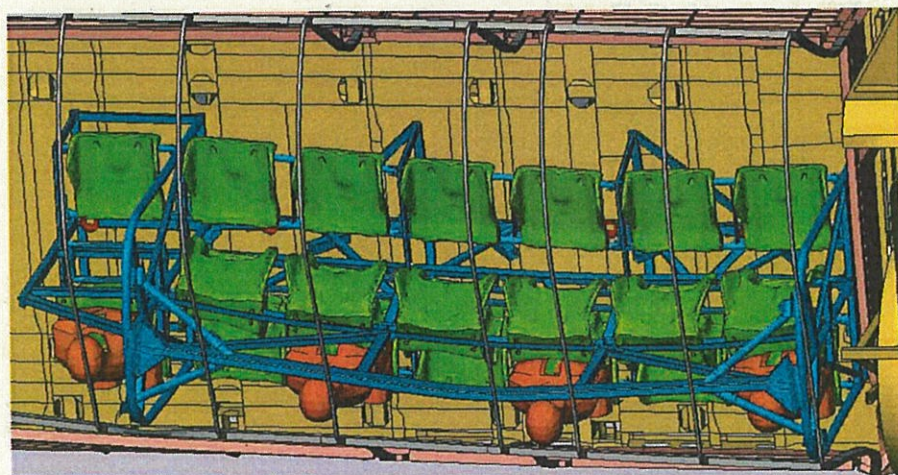
Post Impact  
The frame is bowed & some of the clasp joints have separated (see overleaf) but the overall frame assembly remains intact.

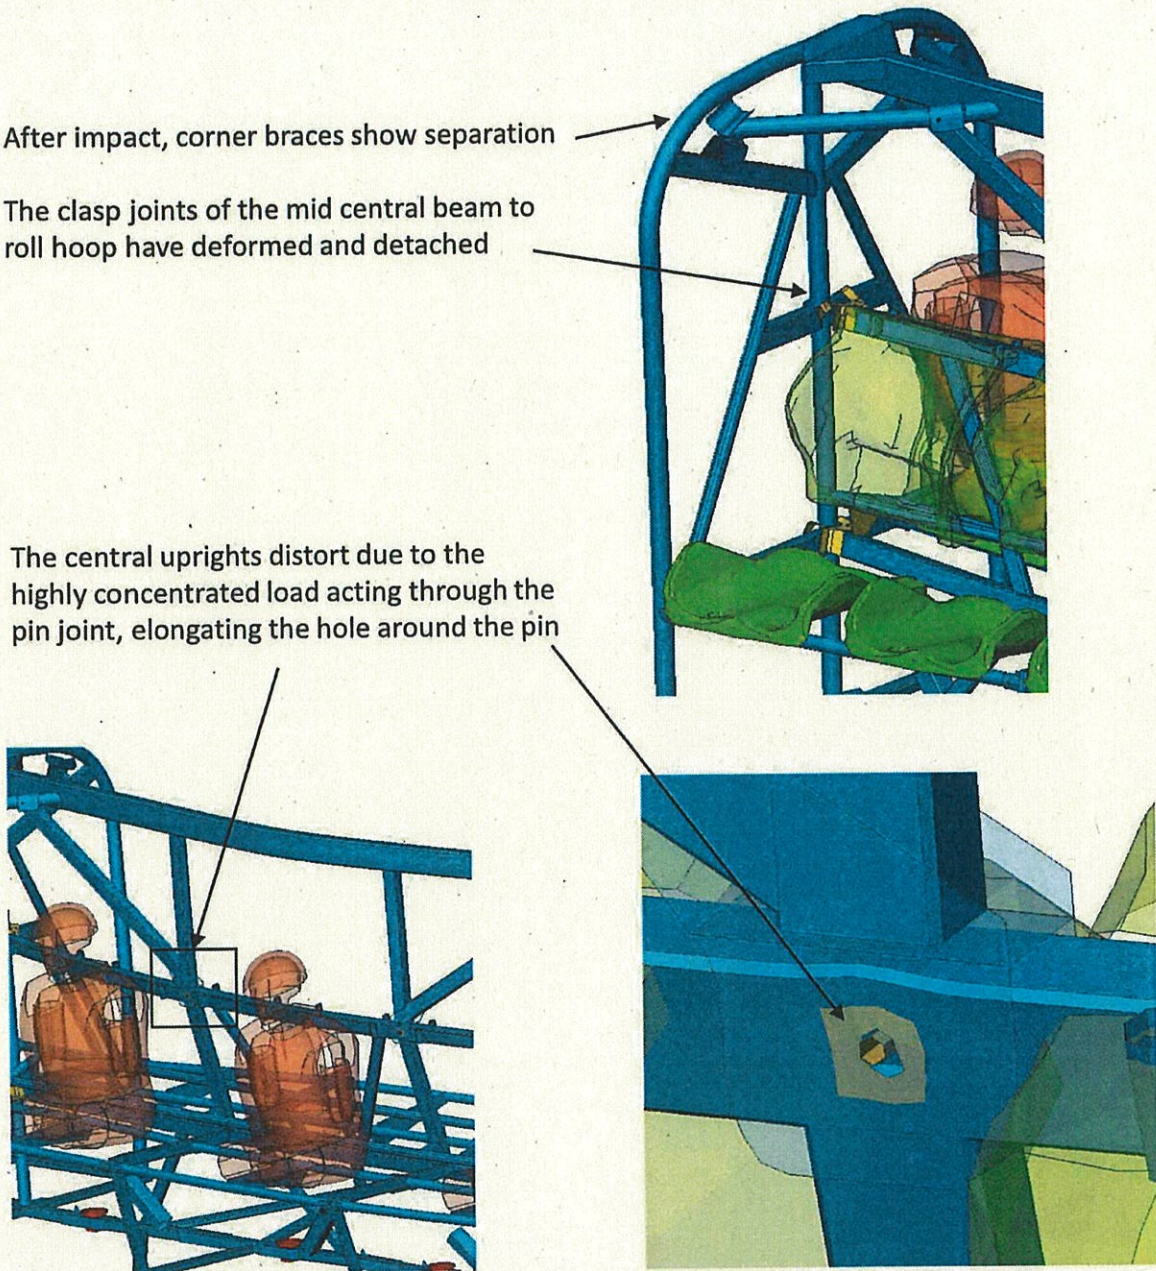
After impact, corner braces show separation

The clasp joints of the mid central beam to roll hoop have deformed and detached

The central uprights distort due to the highly concentrated load acting through the pin joint, elongating the hole around the pin

Despite some joint separation, enough connectivity remains in the other frame connections to retain the system integrity.

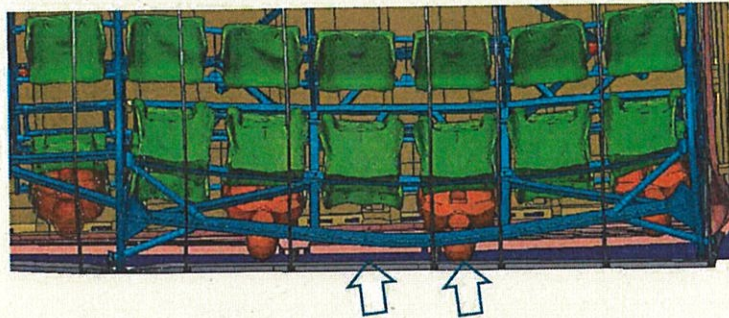
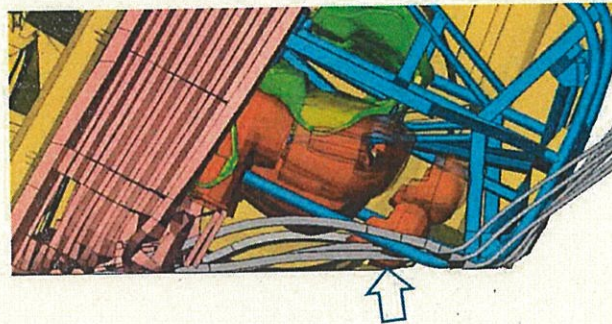
For the majority of the occupant seats, the roll frame prevents the ground from encroaching into the occupant volume.

For the central seats, impact side, the bending of the central seating beams result in the ground just touching, but not compromising the 95%tile occupant volume.

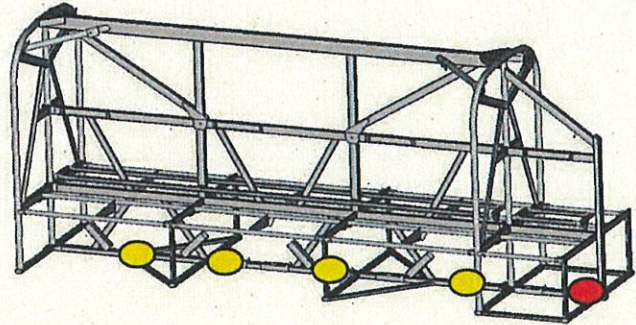
The peak force, acting normal to the floor predicted through the worst case fixing under ECE66 Tilt impact was **47kN**. This occurred at the rearmost fixing

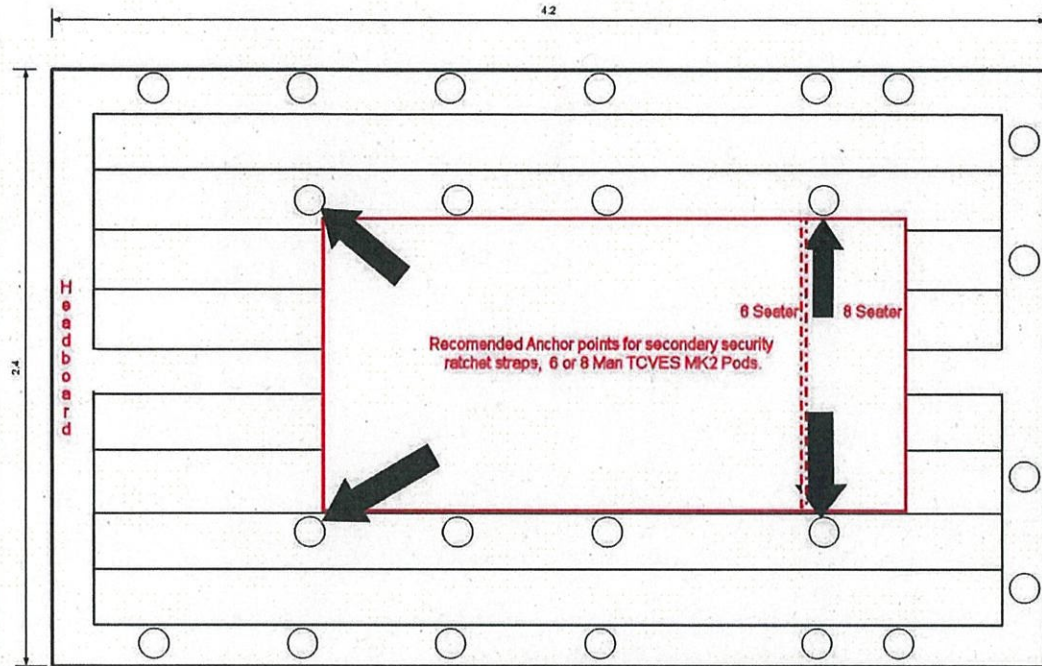
Fig 6- Daf 4T Load bed layout

TCVES MK2 sets fitted to DAF 4T ratchet strap fitting guide

Re-position the ratchet straps to use the inner anchor points and re-tighten, leaving them in place.
