ACCIDENT

Aircraft Type and Registration:	Beech F33A, G-MOAC	
No & Type of Engines:	1 Continental Motors Corp IO-550-B piston engine	
Year of Manufacture:	1989 (Serial no: CE-1349)	
Date & Time (UTC):	9 September 2022 at 1615 hrs	
Location:	Alderney Airport, Guernsey	
Type of Flight:	Private	
Persons on Board:	Crew - 1	Passengers - 2
Injuries:	Crew - None	Passengers - None
Nature of Damage:	Damage to leading edge of right wing and outer leading edge of left wing. Aircraft damaged beyond economic repair	
Commander's Licence:	Private Pilot's Licence	
Commander's Age:	83 years	
Commander's Flying Experience:	2,520 hours (of which 2,313 were on type) Last 90 days - 13 hours Last 28 days - 4 hours	
Information Source:	Aircraft Accident Report Form submitted by the pilot

Synopsis

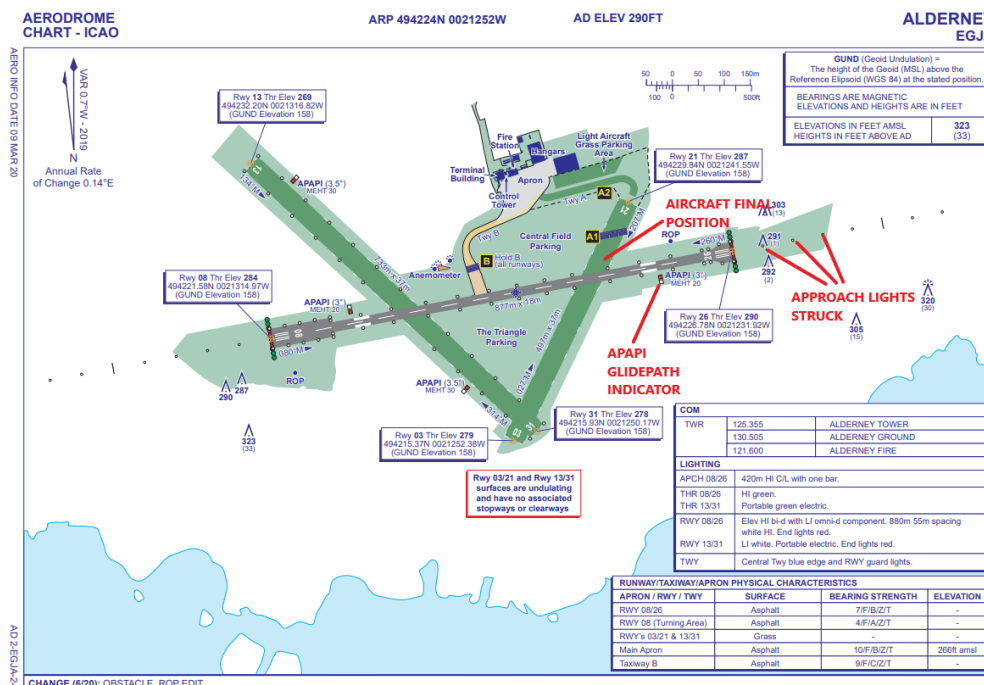
Figure 2
Alderney Airport Chart

Alderney Airport (Figure 2) is the only airport on Alderney. The main runway, 08/26, is 880 m (2,887 ft) long and is mainly asphalt. Runway 26 has an APAPI glidepath indicator positioned 150 m from the threshold and adjacent to the touchdown markings. The approach lighting system on Runway 26 consists of a series of high intensity centreline lights with one cross

bar, extending 420 m from the threshold. The ground slopes up towards the Runway 26 threshold and therefore the approach lights are mounted on pylons. The first of the three light masts that the aircraft struck was 175 m from the threshold.
