SERIOUS INCIDENT

Aircraft Type and Registration:	DHC-1 Chipmunk 22, G-BXHA	
No & Type of Engines:	1 De Havilland Gipsy Major 10 Mk 2 piston engine	
Year of Manufacture:	1952 (Serial no: C1/0801)	
Date & Time (UTC):	22 March 2022 at 1410 hrs	
Location:	Sevenoaks, Kent	
Type of Flight:	Training	
Persons on Board:	Crew - 2	Passengers - None
Injuries:	Crew - None	Passengers - N/A
Nature of Damage:	Cracked propeller and boss blocks	
Commander's Licence:	Airline Transport Pilot's Licence	
Commander's Age:	38 years	
Commander's Flying Experience:	9,000 hours (of which 5 were on type) Last 90 days - 70 hours Last 28 days - 16 hours	
Information Source:	Aircraft Accident Report Form submitted by the pilot and additional enquiries by AAIB

Synopsis

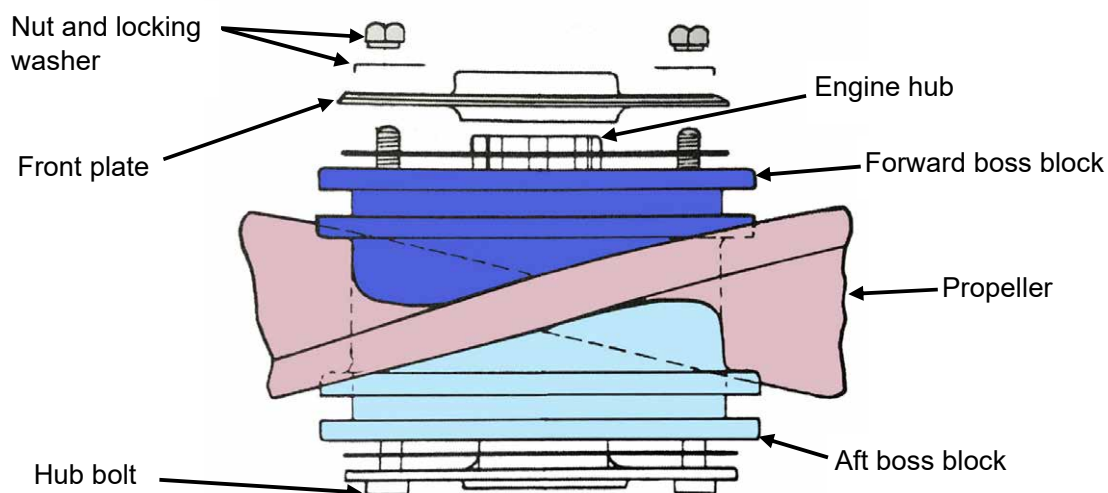
Figure 1

The propeller is paired with forward and aft boss blocks made from cast aluminium (Figure 1).

Propeller assembly arrangement
