Rail Accident Investigation Branch

# Rail Accident Report

**Track damage between Pencoed and Llanharan,  
South Wales  
6 March 2021**

Report 03/2023  
February 2023

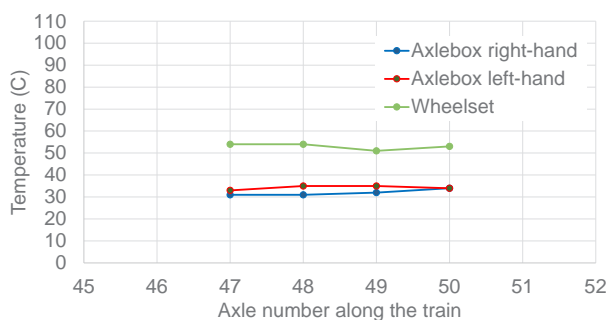
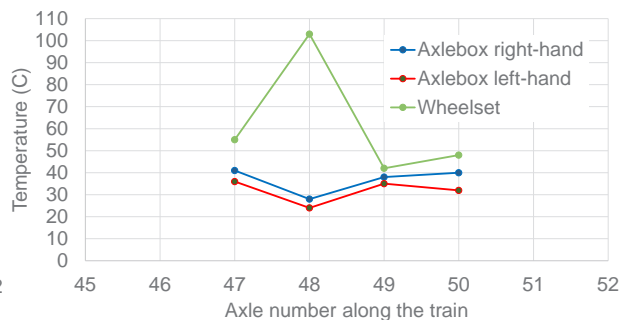
- 78 Train 6A11 passed the HABD located in Pembrey at 22:59 hrs. RAIB reviewed the trace recorded for wagon GERS89016 on the HABD and concluded that there was no indication of any wheelset sliding as all wheels and axleboxes on the wagon were measured at very similar temperatures (figure 11 – left). This is confirmed by the CCTV footage of the train passing Llanelli station at 23:02 hrs which does not show any evidence of sparks being generated at the wheel/rail interface (figure 12) as would be expected if a wheelset had locked up.

- 79 Train 6A11 subsequently passed the HABD located at Briton Ferry at 23:52 hrs (figure 11 – right). The trace recorded for wagon GERS89016 on the HABD shows that the wheels of the trailing wheelset of the leading bogie were now running significantly hotter than the other wheels and that the axleboxes for that wheelset were cooler than the other axleboxes on this wagon. When a wheelset is sliding, the axlebox bearings will not be generating heat as they are not rotating, and significant heat will be generated in the wheels at the wheel/rail interface through friction. RAIB therefore interpreted these traces as indicating that, by the time the train passed Briton Ferry, the trailing wheelset of the leading bogie of wagon GERS89016 was, or had recently been, sliding.<sup>11</sup>

Wagon GERS89016 at Pembrey

Wagon GERS89016 at Briton Ferry

Figure 11: HABD records.<sup>12</sup>

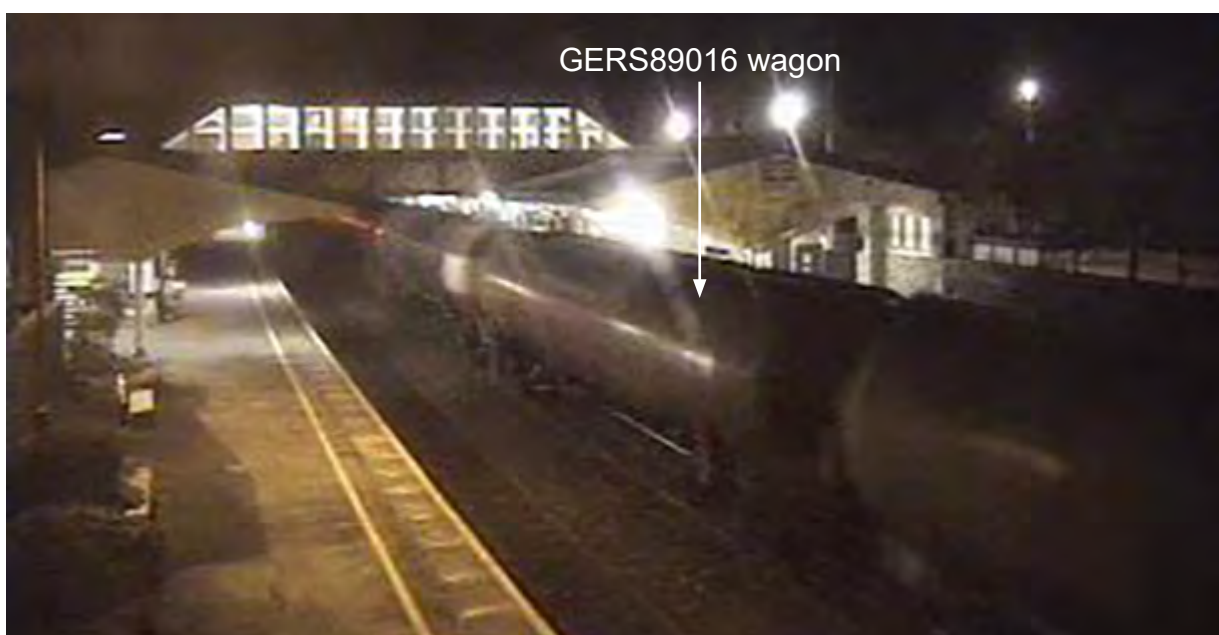
Figure 12: Wagon GERS89016 at Llanelli station.

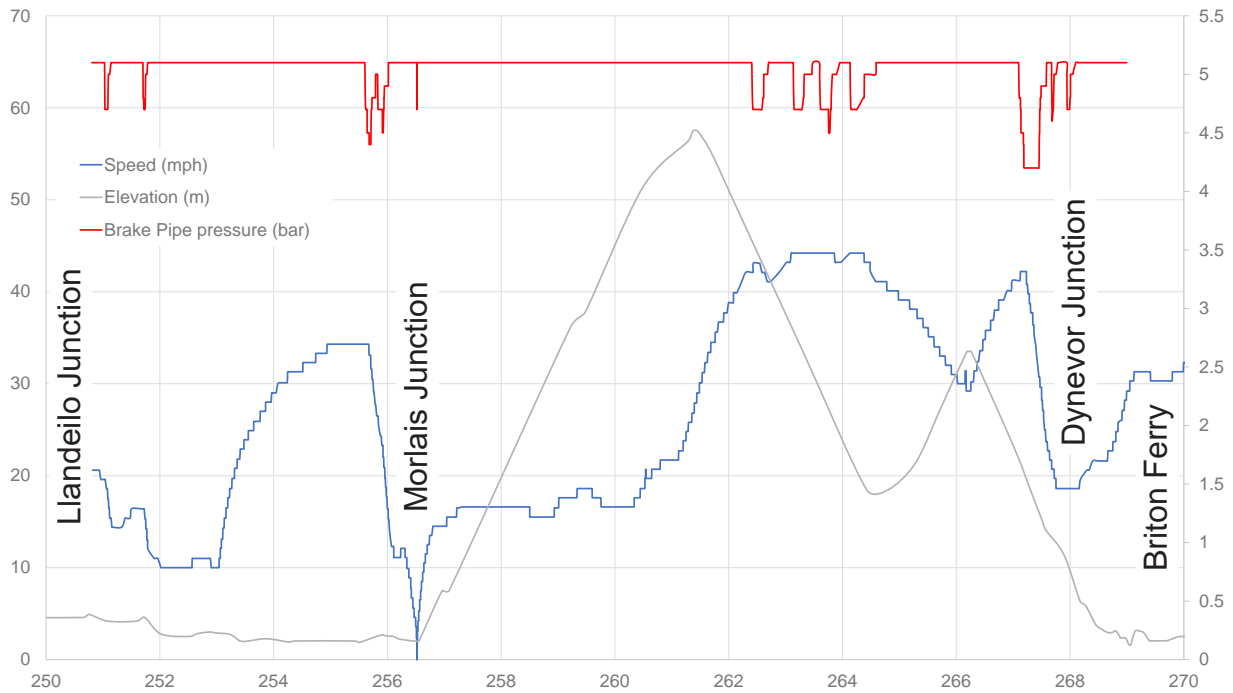
- 80 The on-train data recorder (OTDR) from the locomotive forming train 6A11 indicated that there were a number of braking events during the trip from Llandeilo Junction to Briton Ferry (figure 13). RAIB commissioned a study<sup>13</sup> of the trip from Llandeilo Junction to Briton Ferry over the Swansea District line to determine whether any of the braking events along that line could have resulted in a wagon wheelset locking up and sliding.
- 81 The study concluded that there were braking events along the Swansea District line which could have been sufficient to lock up a wheelset, provided that the adhesion level was very low (0.05 or less). In particular, the study concluded that the braking event which took place as the train was descending from Lonlas Tunnel towards Dynevor Junction was the most likely source of the wheel slide as this was the largest brake application.

Figure 13: Brake applications along the Swansea District line.

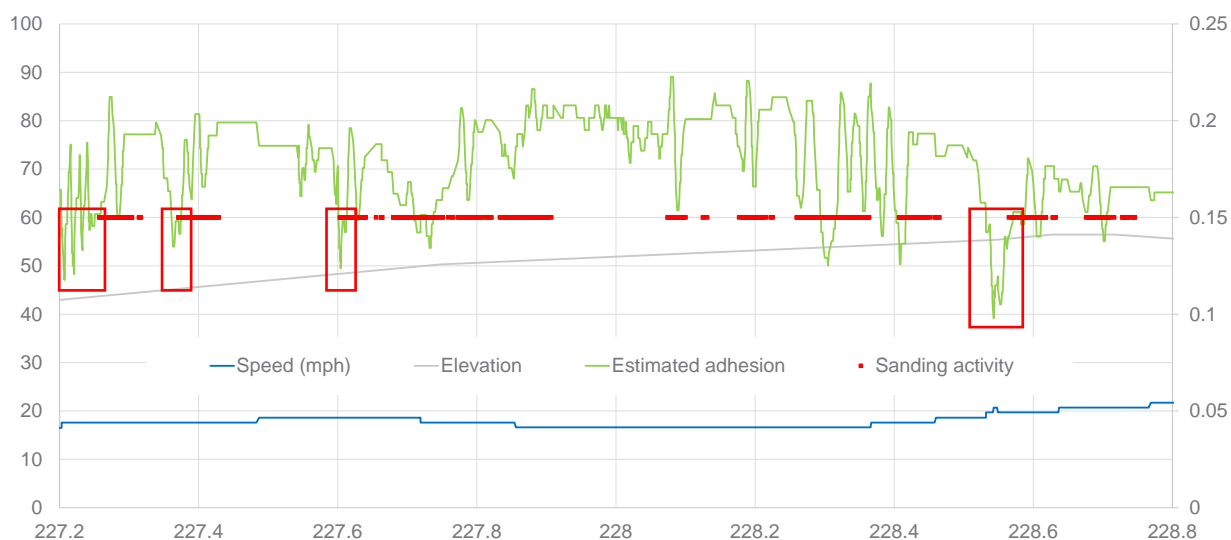
Figure 16: Detailed analysis of the adhesion curve for locomotive 60015.

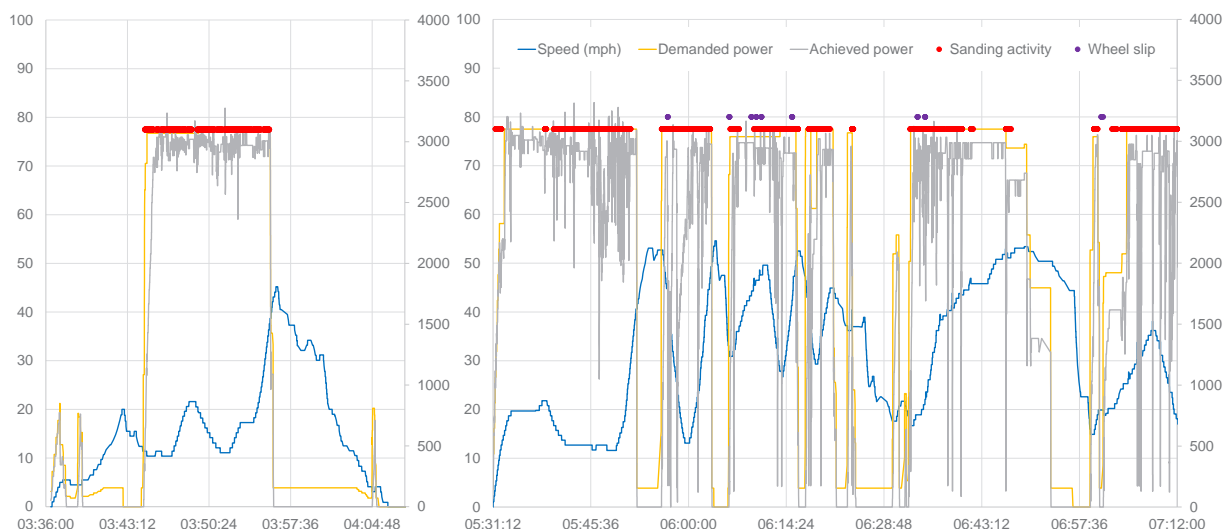
127 Figure 20 shows the analysis of the OTDR data from the locomotive involved in the Ferryside accident, presented in the same way as in figure 14, which shows data from the locomotive involved at Pencoed. Figure 20 shows numerous activities of the anti-slip function of the traction control system and associated sanding, combined with several instances of wheel slip activities being recorded. This suggests that the Ferryside locomotive (number 60001) was struggling for adhesion throughout its journey on the day of the accident and hence that very low adhesion was a possible causal factor to the Ferryside accident. RAIB's report into this accident has been updated accordingly by inclusion of an addendum.

Figure 20: Analysis of the OTDR data for locomotive 60001 on 30 October 2017.

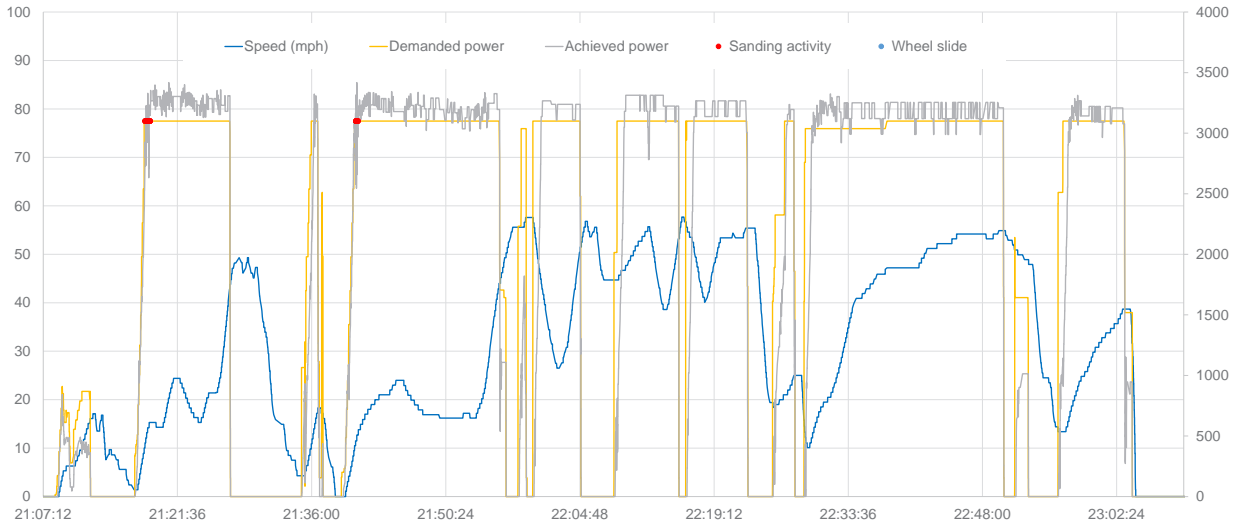
- 130 RAIB revisited the OTDR data of the locomotive (number 60062) involved in the Llangennech accident to determine whether there were signs of low adhesion being experienced during the journey. Figure 21 shows the analysis of the OTDR data presented in the same way as in figures 14 and 20. Figure 21 shows a very small amount of activity of the anti-slip function of the traction control system on departure from a standstill, combined with sanding activity. This suggests that the locomotive was not experiencing conditions of very low adhesion on its journey.

Figure 21: Analysis of the OTDR data for locomotive 60062 on 26 August 2020.
