AAIB Bulletin S1/2023

SPECIAL

SERIOUS INCIDENT

Aircraft Type and Registration:	Bombardier CL-600-2B16 (604), D-AAAY
No & Type of Engines:	2 General Electric CF34-3B turbofan engines
Year of Manufacture:	2004 (Serial no: 5602)
Date & Time (UTC):	10 August 2022 at 1640 hrs
Location:	In the climb after departing Farnborough Airport, Hampshire
Type of Flight:	Commercial Air Transport (Passenger)
Persons on Board:	Crew - 3 Passengers - 7
Injuries:	Crew - None Passengers - None
Nature of Damage:	Damaged contact in number 1 system flap retract relay
Commander's Licence:	Airline Transport Pilot's Licence
Commander's Age:	56 years
Commander's Flying Experience:	13,091 hours (of which 5,655 were on type) Last 90 days - 102 hours Last 28 days - 41 hours
Information Source:	AAIB Field Investigation

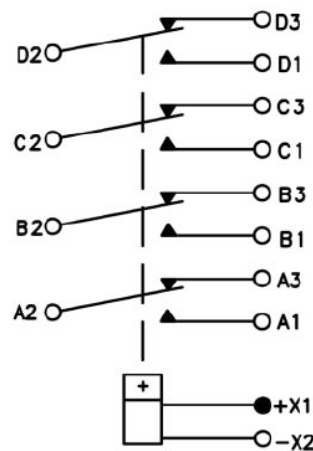
Figure 1

The schematic layout of the relay pins is shown in Figure 1. When the relay is de-energised:

- Contacts A1, B1, C1 and D1 are OPEN.
- Contacts A2, B2, C2 and D2 are the input to be switched.
- Contacts A3, B3, C3 and D3 are CLOSED.
- Contacts +X1 and -X2 provided electrical power to the operating coil, when energised.

Schematic of relay pin arrangement in the de-energised condition

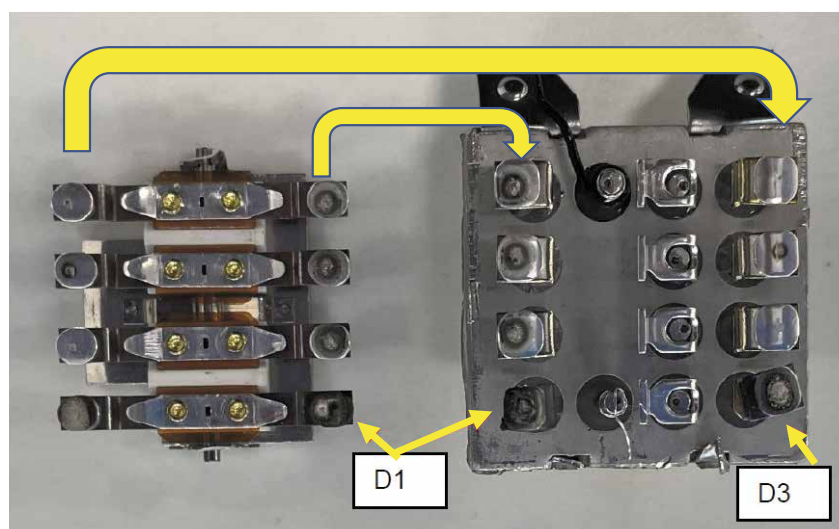
The relays from D-AAAY were dismantled to allow examination of the contacts. All four relays had the same part number; Figure 5 shows the disassembled contacts of relay K3CE.

General arrangement of relay contacts, disassembled.
Arrows show how the part on the left connects to the part on the right

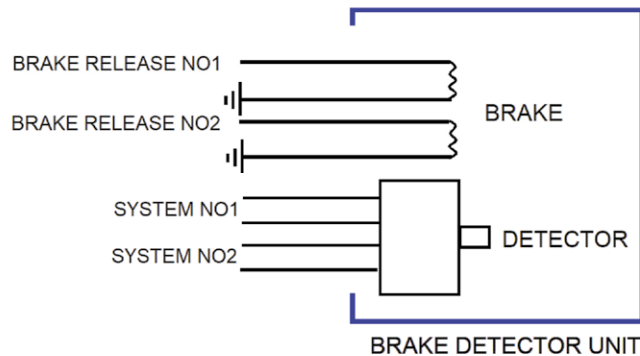
Figure 11

The aircraft was fitted with two BDU's, one on each wing. Each consists of a 28 V DC solenoid operated brake and a speed sensor detector unit (Figure 11). The investigation considered the effect of the solenoid operated brake on the relay, as their electrical power is switched by the D contacts in each of the four extend and retract relays. To provide redundancy each brake solenoid has two operating coils, one powered by each operating system, and each system powers an operating solenoid in each of the two BDU's; these are connected in parallel. The brake solenoids are energised to release the brake and are de-energised to apply the brake.

Schematic of BDU Brake Solenoid arrangement

Laboratory testing of the BDU coil resistance indicated they were within specification. The current and voltage during solenoid switching was measured using an oscilloscope (Figure 12). When the solenoid was de-energised a transient voltage spike of up to approximately 300 V was seen, and this spike regularly exceeded 150 V during repeated switching. The voltage spike is likely to be the back electro motive force (EMF) which is a known feature of inductive loads and is caused by the current to the solenoid coil decaying and inducing the EMF after the electrical supply has been switched off. There was no protection or suppression provided within the flap operating system to prevent or reduce this back-EMF.
