ACCIDENT

Aircraft Type and Registration:	Reims Cessna FRA150M, G-BDNR	
No & Type of Engines:	1 Rolls Royce O-240-E piston engine	
Year of Manufacture:	1976 (Serial no: 284)	
Date & Time (UTC):	1 August 2021 at 1426 hrs	
Location:	Approx 4 miles NNE of Retford Gamston Airport, Nottinghamshire	
Type of Flight:	Training	
Persons on Board:	Crew - 1	Passengers - 1
Injuries:	Crew - None	Passengers - 1 (Minor)
Nature of Damage:	Nose leg collapsed, prop bent and engine cowling damaged. Subsequent engineering inspection found number 3 cylinder and piston had detached in flight	
Commander's Licence:	Commercial Pilot's Licence	
Commander's Age:	21 years	
Commander's Flying Experience:	534 hours (of which 300 were on type) Last 90 days - 223 hours Last 28 days - 59 hours	
Information Source:	AAIB Field Investigation

Synopsis

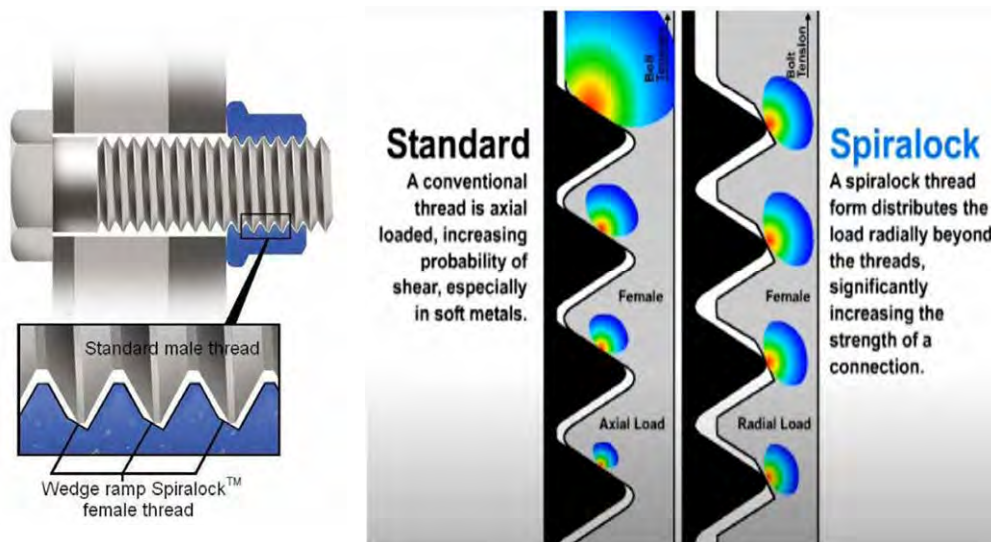
Figure 9

During the tests of the different combinations of nuts and studs in Table 2, it was noted that the majority of the new TCH nuts were stamped with the letters 'SPL,' indicating that they employed Spirallock⁷ technology. Spirallock is an anti-vibration technology which uses a 30° wedge ramp at the root of internal threads (Figure 9).

Spirallock anti-vibration thread
Images used with permission

As the clamp load increases, the wedge eliminates the radial clearance that allows fasteners to loosen under vibration. This spreads the clamp load more evenly and allows a lower torque requirement than conventional threads.
