ACCIDENT

Aircraft Type and Registration:	Piper PA-28-140, G-BCJN
No & Type of Engines:	1 Lycoming O-320-E3D piston engine
Year of Manufacture:	1974 (Serial no: 28-7425350)
Date & Time (UTC):	4 August 2022 at 0935 hrs
Location:	Cotswold Airport, Gloucestershire
Type of Flight:	Training
Persons on Board:	Crew - 1 Passengers - 1
Injuries:	Crew - 1 (Minor) Passengers - 1 (Minor)
Nature of Damage:	Beyond economic repair
Commander's Licence:	Commercial Pilot's Licence
Commander's Age:	24 years
Commander's Flying Experience:	526 hours (of which 230 were on type) Last 90 days - 71 hours Last 28 days - 32 hours
Information Source:	AAIB Field Investigation

Synopsis

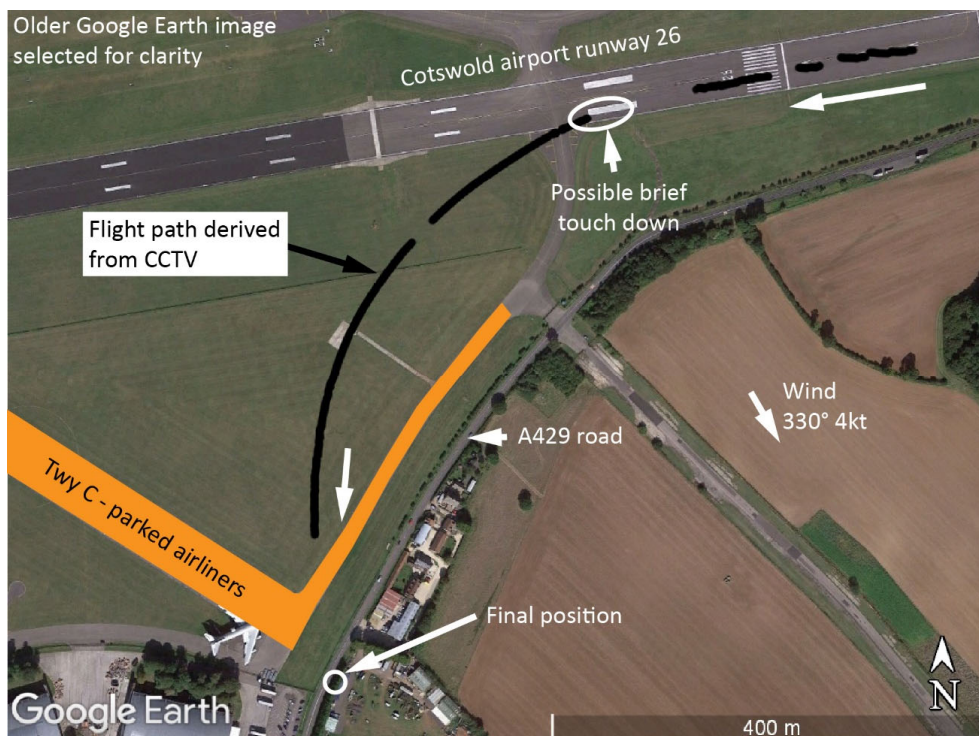
Figure 2

CCTV from the airport showed that the aircraft continued descending to touch down near the threshold of the runway, then turned sharply left and became airborne again. Once airborne, the aircraft continued to turn left but only climbed to approximately 20 ft agl. It passed over a fence approximately 100 m from the left side of the runway and then continued towards a row of parked airliners on Taxiway C, close to the southern perimeter (Figure 2). The aircraft descended as it approached the line of parked aircraft. It passed under the wing of an Airbus A319 and touched down as it passed between the A319 and an Airbus A321. The right wing tip struck the nose landing gear leg of the A321 severing the outboard section of the right wing. The aircraft then continued across the grass, passed through the aircraft perimeter fence and crossed the A429 road, which runs just outside the airport perimeter. The aircraft encountered no cars as it crossed the road, but struck trees surrounding a vehicle yard and came to rest in a ditch alongside the road.

Kemble Airport diagram
