ACCIDENT

Aircraft Type and Registration:	Extra EA 300/L, G-ZXEL
No & Type of Engines:	1 Lycoming AEIO-540-L1B5 piston engine
Year of Manufacture:	2006 (Serial no: 1224)
Date & Time (UTC):	19 June 2022 at 1555 hrs
Location:	Near Duxford Airfield, Cambridgeshire
Type of Flight:	Private
Persons on Board:	Crew - 1 Passengers - None
Injuries:	Crew - None Passengers - N/A
Nature of Damage:	Damage to vertical tail, rudder and elevator
Commander's Licence:	Commercial Pilot's Licence
Commander's Age:	46 years
Commander's Flying Experience:	4,641 hours (of which 524 were on type) Last 90 days - 39 hours Last 28 days - 22 hours
Information Source:	Aircraft Accident Report Form submitted by the pilot and further enquiries by the AAIB

Synopsis

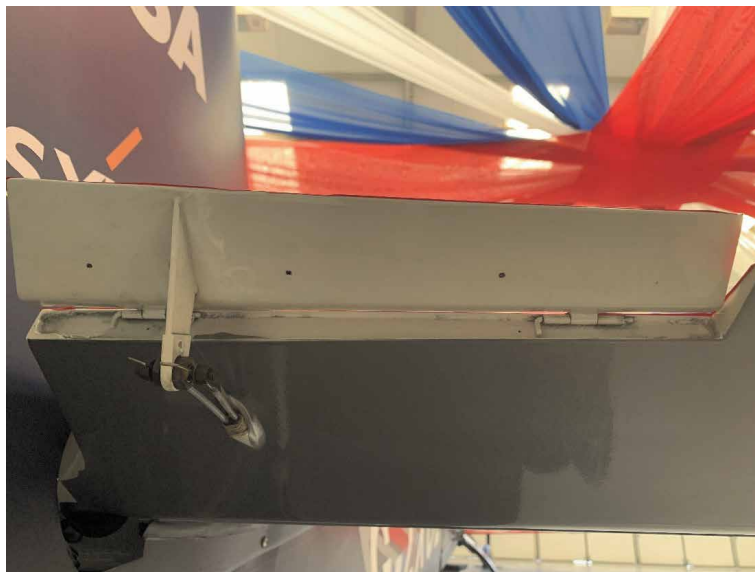
Figure 1

The elevator trim tab of the Extra 300 is attached to the inboard trailing edge of the right elevator with two hinges. The trim tab is actuated via two control cables attached to a pitch horn on the lower side of the trim tab (Figure 1).

Intact elevator trim tab shown in the full up position
