# ***AAIB Bulletin***

***4/2023***

Bombardier CL-600-2B16 (604 variant)	D-AAAY	10-Aug-22	3
--------------------------------------	--------	-----------	---

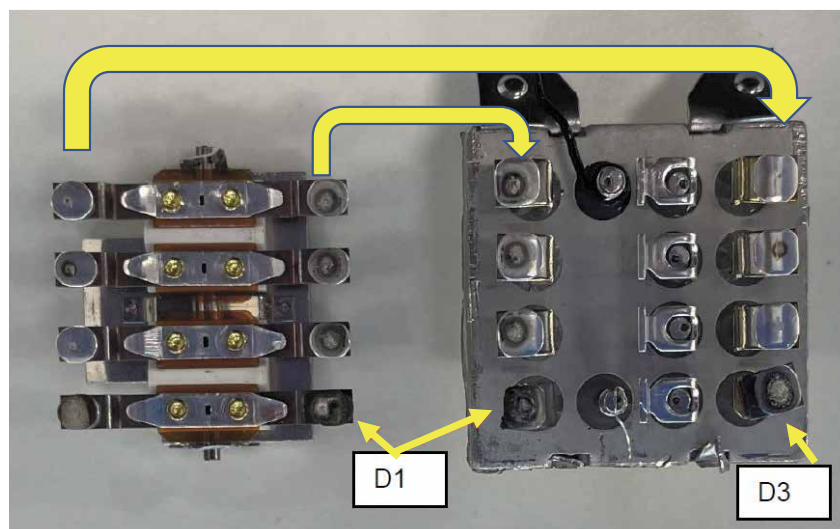
**Figure 5**

General arrangement of relay contacts, disassembled.  
Arrows show how the part on the left connects to the part on the right

Prior to full disassembly, the contacts were examined using an optical microscope and significant damage was found on the D contacts on relays K1CE, K2CE and K3CE. The damage to the D1 contact on relay K3CE is shown in Figure 6.

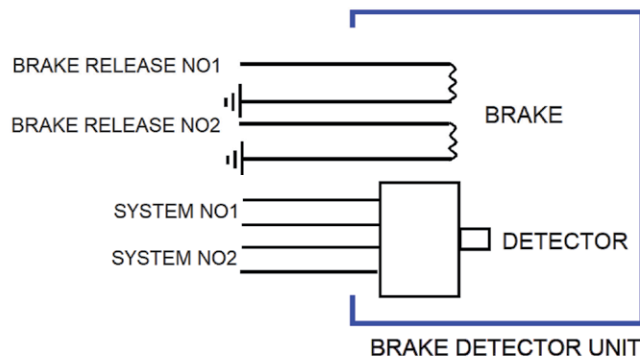
**Figure 11**

The aircraft was fitted with two BDU's, one on each wing. Each consists of a 28 V DC solenoid operated brake and a speed sensor detector unit (Figure 11). The investigation considered the effect of the solenoid operated brake on the relay, as their electrical power is switched by the D contacts in each of the four extend and retract relays. To provide redundancy each brake solenoid has two operating coils, one powered by each operating system, and each system powers an operating solenoid in each of the two BDU's; these are connected in parallel. The brake solenoids are energised to release the brake and are de-energised to apply the brake.

Schematic of BDU Brake Solenoid arrangement

During laboratory testing, when the BDU solenoids were de-energised, a transient voltage spike was seen to peak at up to 300 V and regularly exceeded 150 V. This spike is caused by a back-EMF, which could cause arcing across the D contacts. There is no protection within the electrical system to suppress this back-EMF.

It is recommended that Bombardier Aviation introduce a modification on the Challenger 600 series of aircraft to protect the D contacts within the extend and retract relays of the flap operating system from unsuppressed back-EMF electrical arcing.

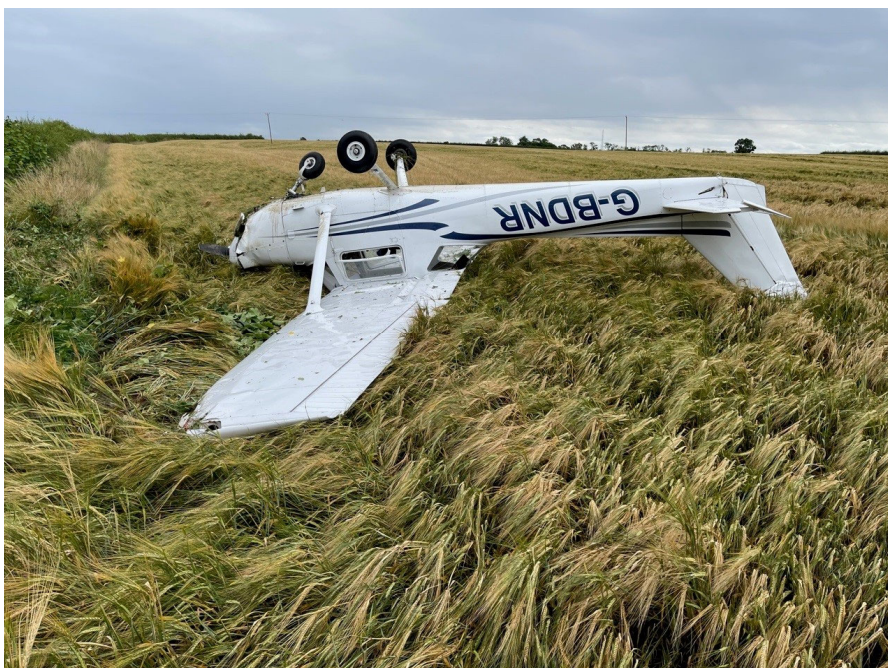
**Figure 1**

After hitting a hedge, the aircraft came to rest upside down

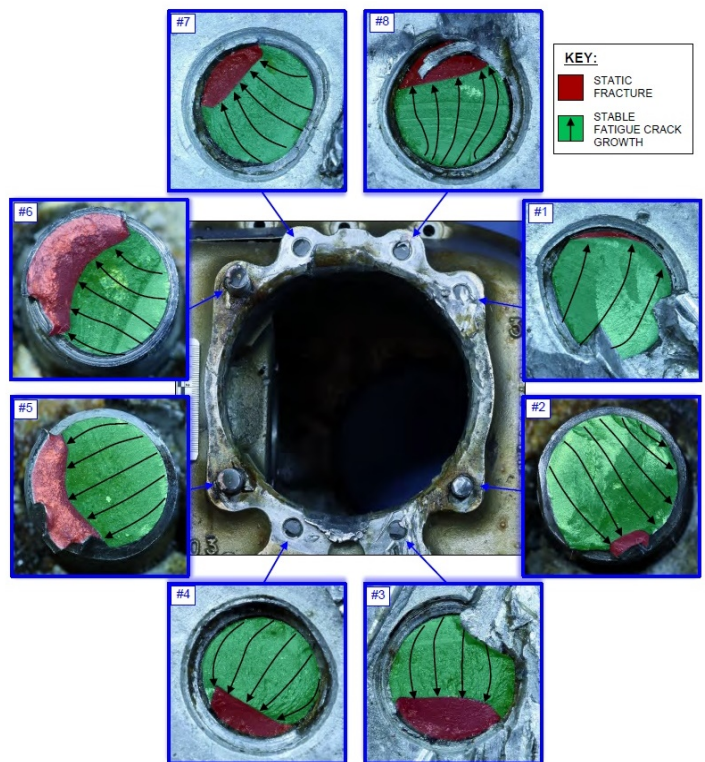
**Figure 5**

Directions and extent of fatigue crack growth

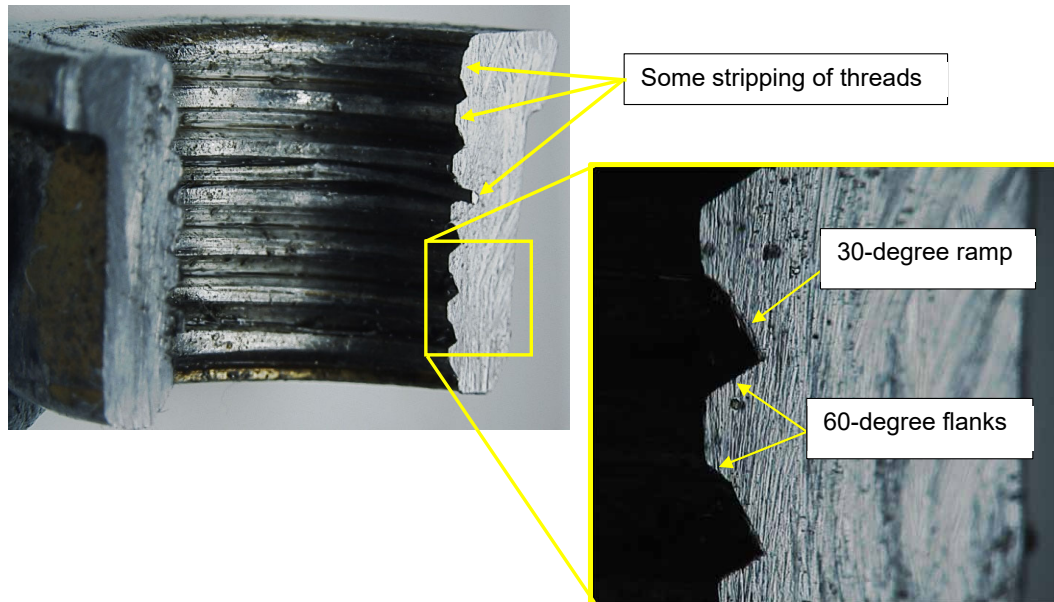
**Figure 7**

Two types of TCH nuts were used during the tests; one of the samples from Test 3 used a nut employing Spirallock<sup>6</sup> technology (Figure 7) where a 30° ramp had been manufactured between the thread roots which was designed to resist loosening (See Spirallock section below).

Test 3 - Section of Continental Spirallock nut showing stripped threads (left) and 30° Spirallock ramp (right)

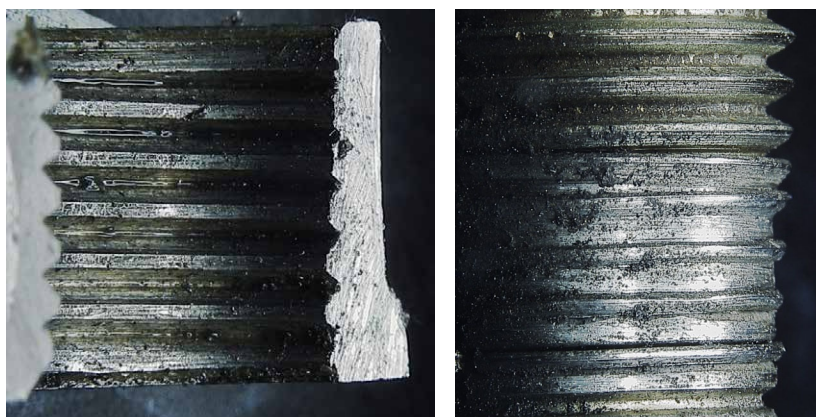
**Figure 8**

Test 4 used legacy nuts from an old RR O-240 engine which had a standard 60° thread profile (Figure 8). All TCH nut types tested resulted in similar stud failures when torqued.

Test 4 - Section of Continental legacy nut showing some thread stripping (left) and distorted threads on the associated stud (right)

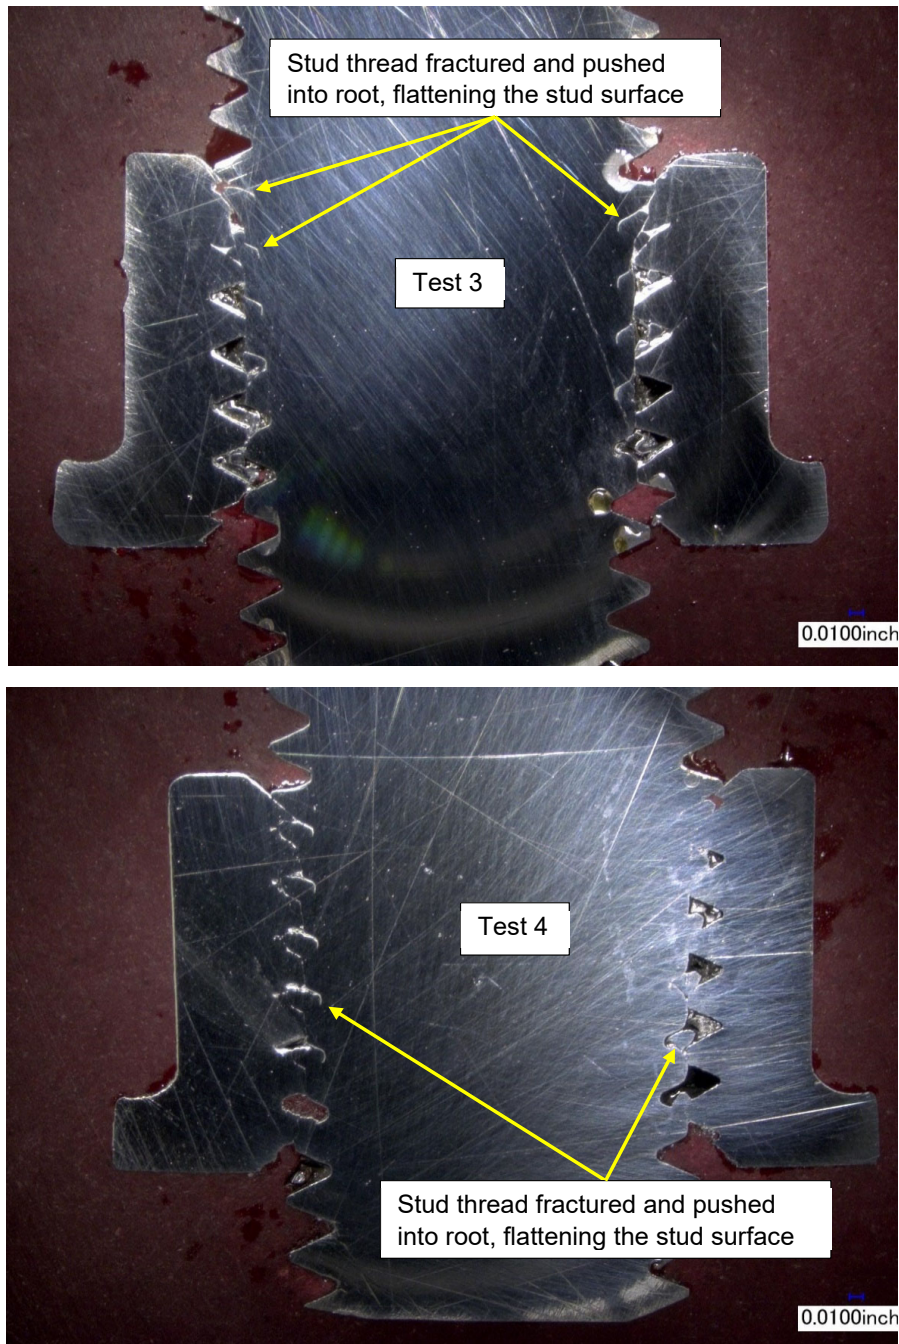
**Figure 10**

Sectioned samples from Tests 3 and 4 showing failure mechanism  
Images used with permission

The manufacturer sectioned and examined some of the failed nuts and studs from Table 2 (Test samples 3 and 4), and the results can be seen in Figure 10. They show the stud threads had been damaged by the nuts in both samples. The broken thread crowns were pushed into their roots creating a flat section around the stud's circumference which caused the nuts to lose torque. Note both samples sectioned had not used Spiralock nuts.

The manufacturer found that the base nuts had a higher tensile strength of 180 Ksi<sup>9</sup> than the studs, 140 Ksi. This mismatch of tensile strength allowed the nuts to fracture the crown of the stud threads creating a flat surface around the circumference, which probably contributed significantly to the torque failures. When an AM stud was used with a matching tensile strength to the nut, the nut torqued up to 55 ft/lbs before failure, 53% above the maximum torque value (Figure 11).
