ACCIDENT

Aircraft Type and Registration:	Mudry Cap 10B, G-BXBU	
No & Type of Engines:	1 Lycoming AEIO-360-B2F piston engine	
Year of Manufacture:	1980 (Serial no: 103)	
Date & Time (UTC):	12 August 2021 at 0920 hrs	
Location:	Lower Colley Farm, Buckland St Mary, Somerset	
Type of Flight:	Private	
Persons on Board:	Crew - 1	Passengers - 1
Injuries:	Crew - 1 (Fatal)	Passengers - 1 (Fatal)
Nature of Damage:	Aircraft destroyed	
Commander's Licence:	Private Pilot's Licence	
Commander's Age:	69 years	
Commander's Flying Experience:	1411 hours (of which 648 were on type) Last 90 days - 15 hours Last 28 days - 4 hours	
Information Source:	AAIB Field Investigation

Synopsis

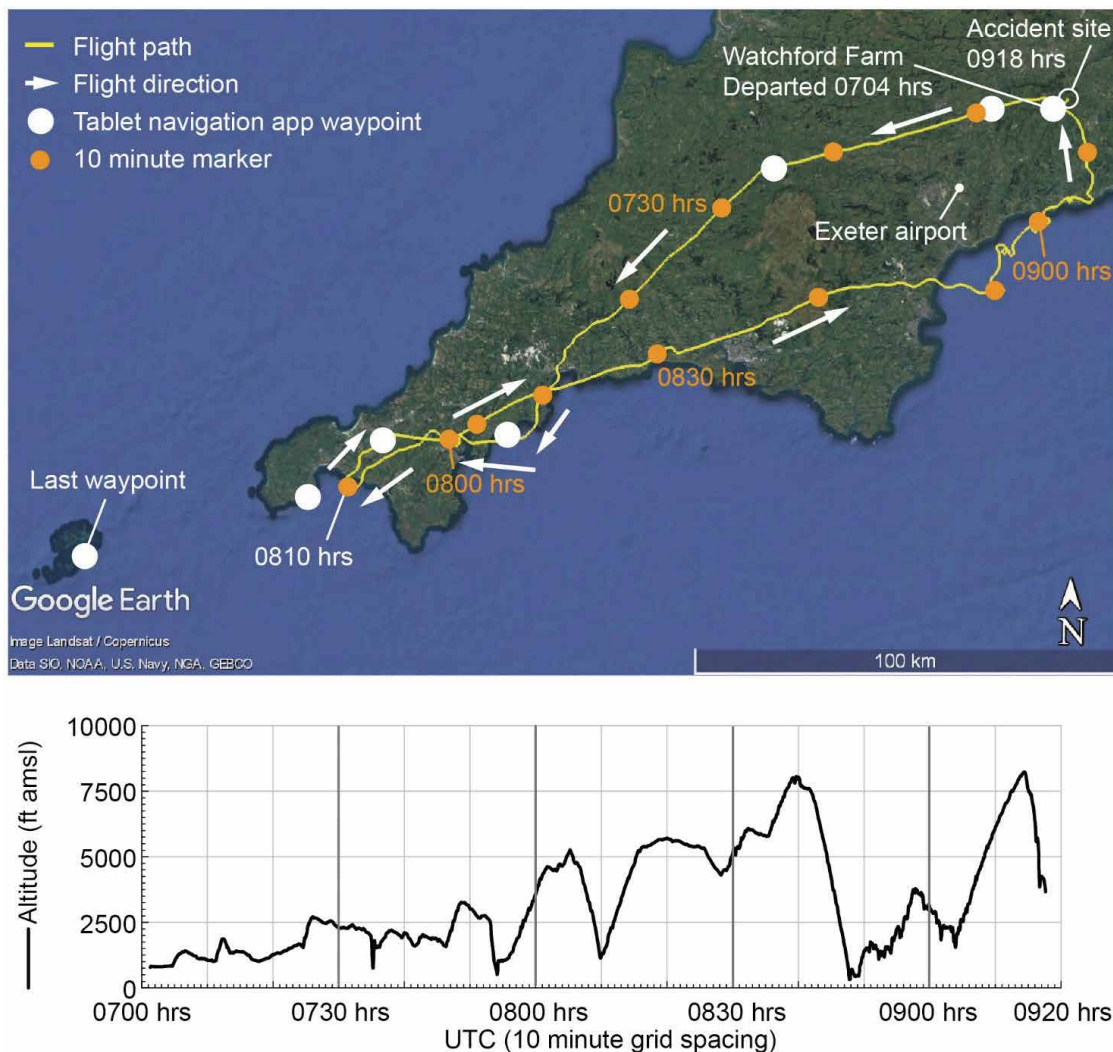
After departure, the aircraft flew south-westerly as planned towards Cornwall. As the aircraft passed north of Cudrose, it began a descent to 1,000 ft over the sea before turning right to head east away from the planned destination. It continued in a north-easterly direction, passing to the north of Torquay then out over Lyme Bay. While over the sea, the aircraft reached a minimum of 320 ft momentarily before completing three 180° turns and two 360° orbits. It then began to fly north from Lyme Regis toward Watchford Farm climbing to a peak altitude of 8,200 ft amsl (Figure 1).

Figure 1
Aircraft planned route and flight path

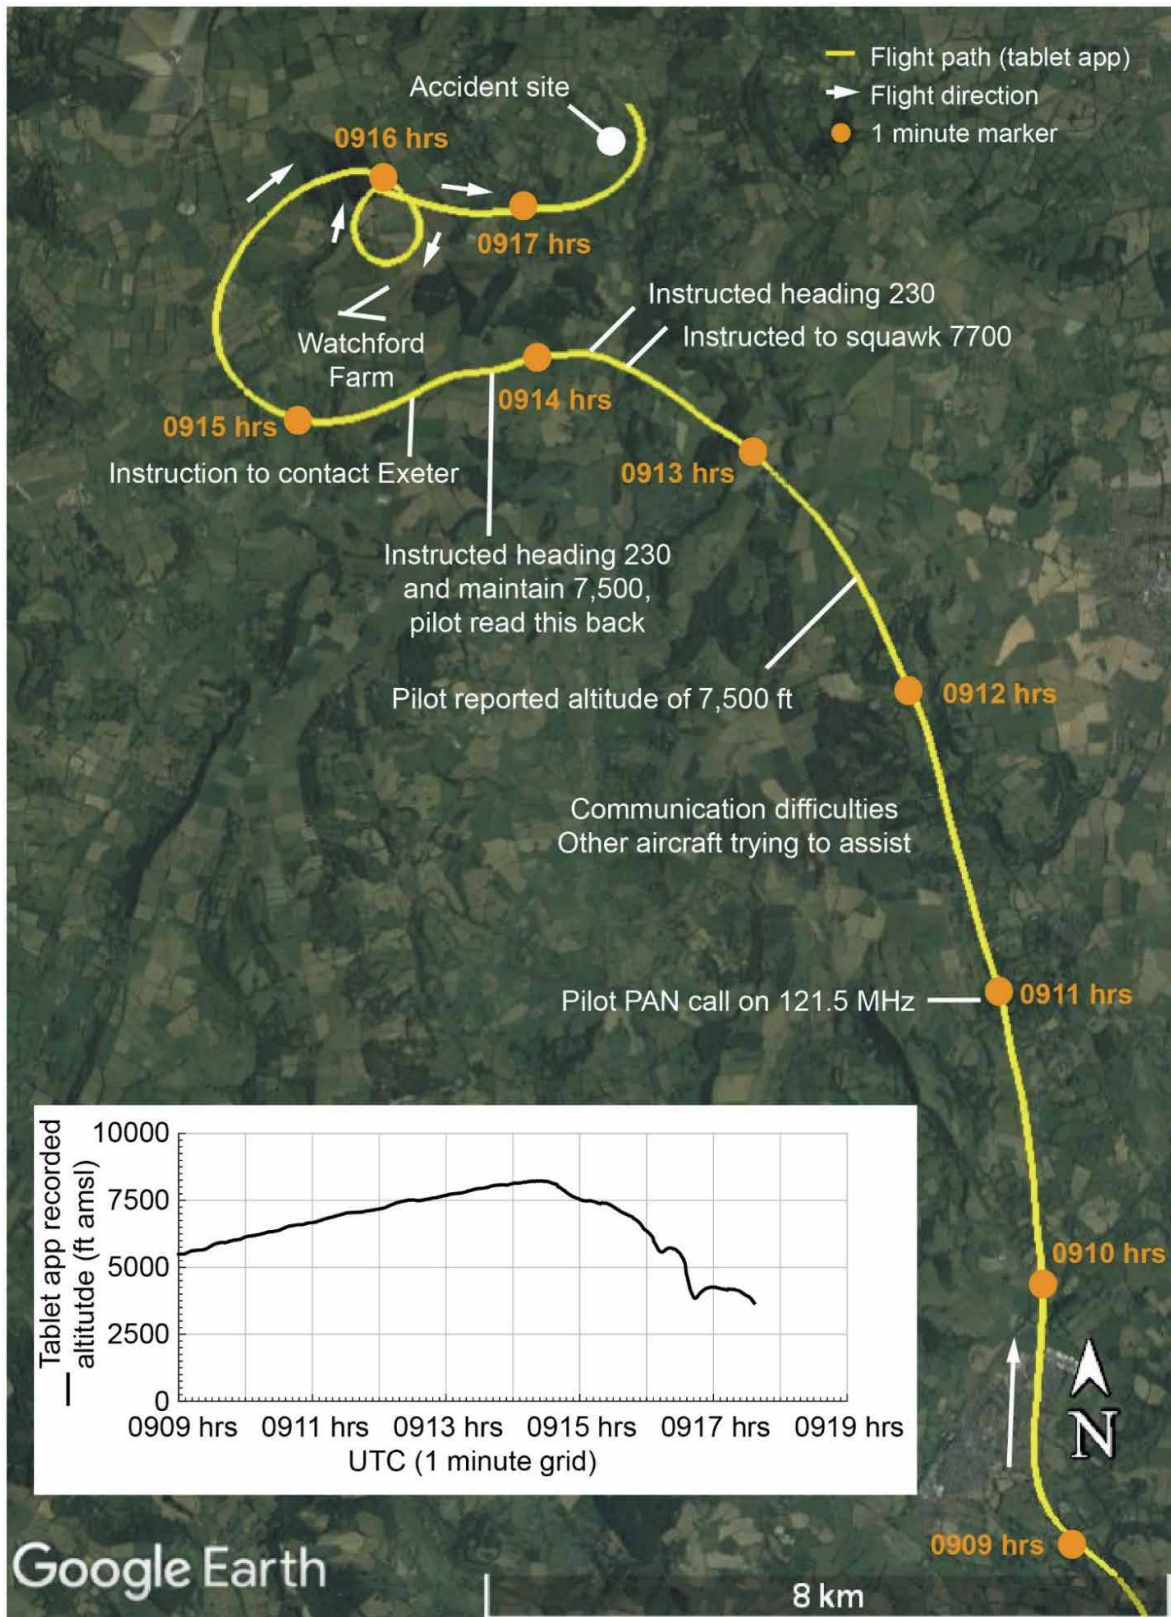
Figure 2

Flight path during D&D communications
(Note that this is not a comprehensive listing of the RT)

The pilot made another PAN call on 121.5 MHz at 0911 hrs, stating he was in “REAL TROUBLE” as he was stuck above thick cloud and he didn’t know what to do (Appendix 2). He finished his radio transmission by stating “I NEED TO DIVERT TO SOMEWHERE ER CLOSE TO ME WHERE I CAN LAND”. Several witnesses in other aircraft who heard the call described the pilot sounding anxious and stressed. The PAN call was initially acknowledged by two commercial aircraft in the vicinity prior to a response from the D&D controller who stated “... YOUR PAN IS ACKNOWLEDGED...”. In response, the pilot stated his altitude was 7,500 ft and that he had a fuel endurance of 1.5 hours. The transponder on G-BXBU had not been used throughout the flight, but at the request of the D&D controller the pilot switched it on and set the emergency squawk of 7700.

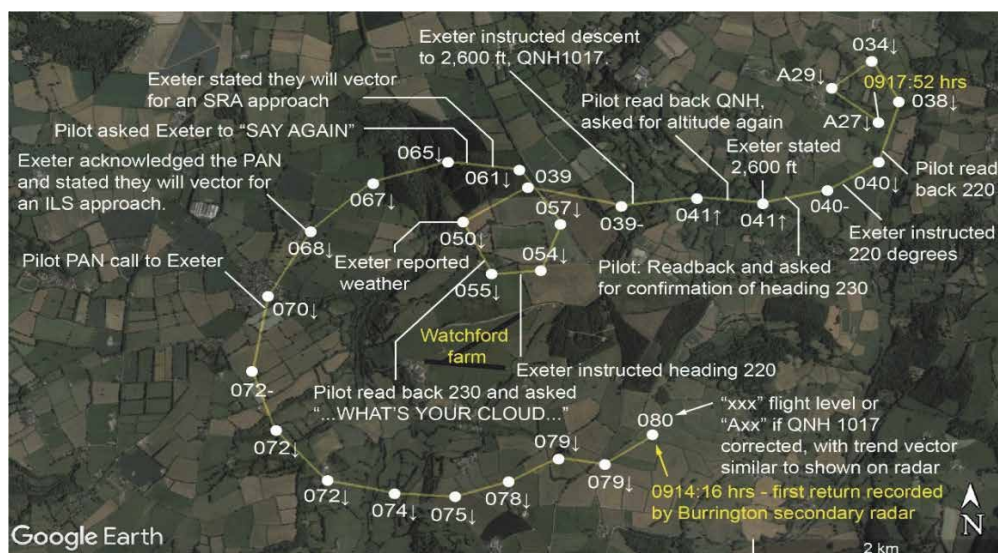
Figure 3

Flight path and flight level / altitude radar during Exeter communications
(Note that this is not a comprehensive listing of the RT)

At 0914 hrs the controller observed the aircraft descending and not maintaining the assigned heading. At 0916 hrs the radar track showed the aircraft levelling briefly around 4,000 ft. Without having noticed this, the controller instructed G-BXBU to descend to 2,600 ft, which was the minimum safe altitude⁵, aiming to prevent the aircraft descending below that.

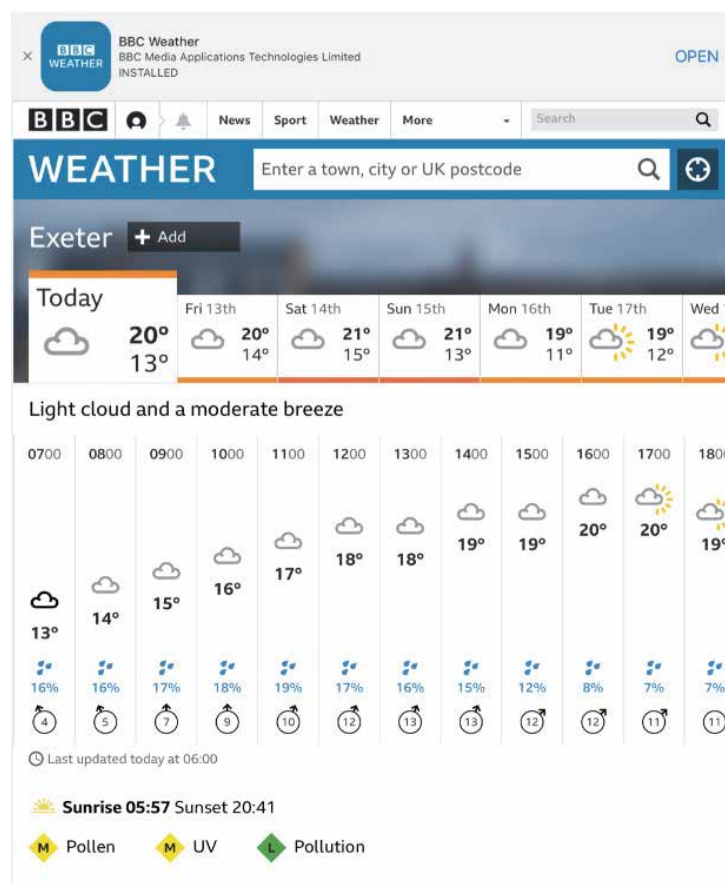
The data from the tablet was reviewed for other relevant activity outside of the use of the app. It showed that at 0519 hrs on the day of the accident, weather information for St Mary's (Isles of Scilly), Sidmouth, Bodmin and Exeter was checked on a BBC website. The tablet contained a screenshot of the weather information for Exeter taken at 0519 hrs (Figure 9). As the information is not intended for aviation use, it provided insufficient cloud information for aviation use, summarising the weather as "*Light cloud and a moderate breeze*".

Figure 9
Screenshot from the tablet – (times are UTC +1)

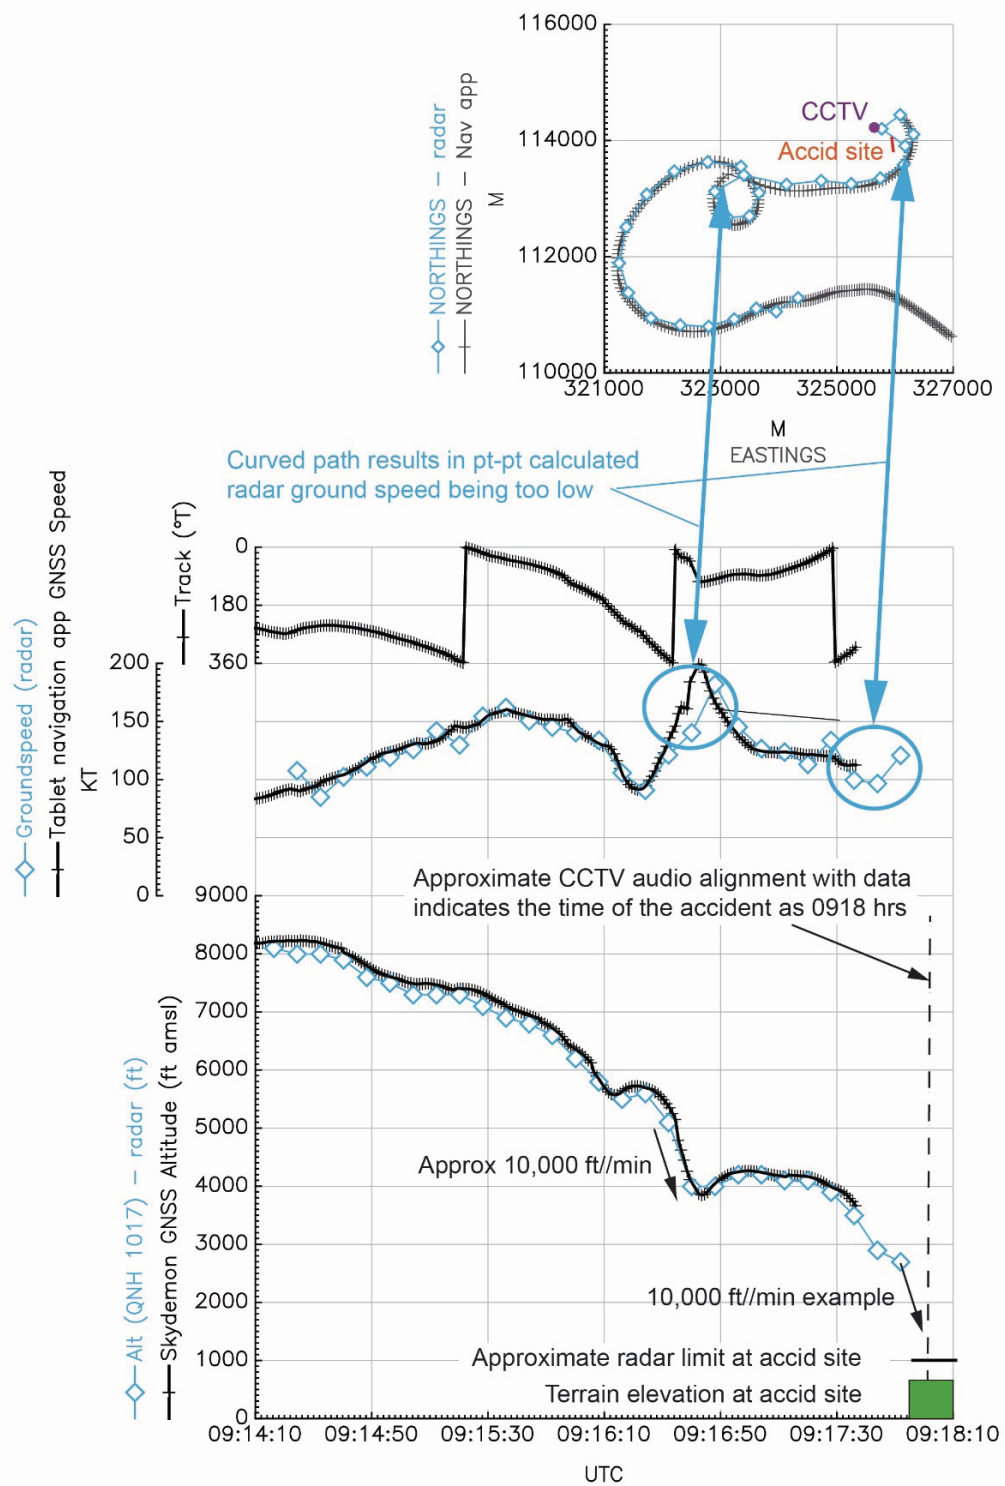
The aircraft was fitted with an ATC transponder but was not detected by secondary radar until the D&D Cell asked the pilot to switch the transponder on. The secondary radar recordings from Clee Hill and Burrington radar facilities were provided. Burrington radar provided the most complete recording of the end of the flight but stopped approximately 2,000 ft above the accident site. Figure 10 shows the data for the duration of the secondary radar recording and data from the navigation app over the same period.

The CCTV camera recordings included audio. Audio from one of the cameras captured the sound of the aircraft propeller intermittently for about 90 seconds before the aircraft contacted the ground. The pitch of the audio varied in this period, reflecting a combination of a higher propeller speed due to airspeed or throttle changes, and distortion of the pitch by travelling towards or away from the audio recording device.

**Figure 10**

End-of-flight radar, navigation app data and CCTV audio signature data

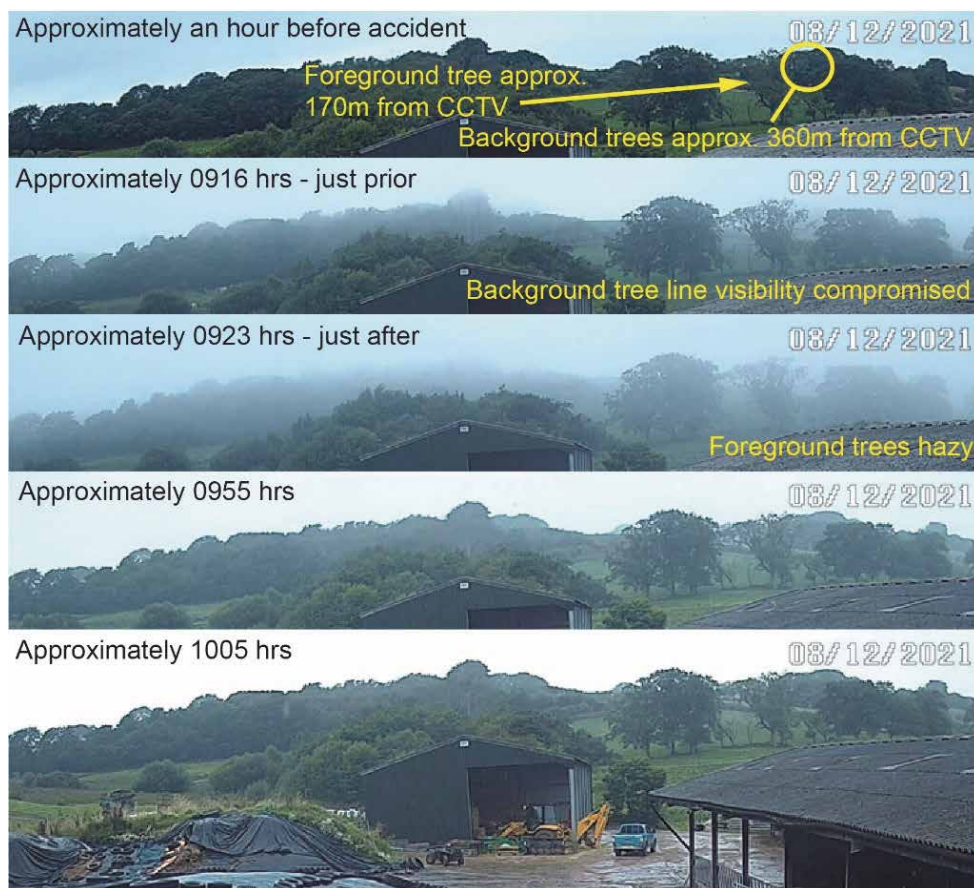
CCTV from a local farm did not show the aircraft but provided evidence of the visual conditions before, during and after the accident (Figure 11). The times shown compensate for errors in the embedded timestamps.

The tree line that is about 360 m from the camera was clearly visible in the recorded image an hour before the accident but was no longer visible in the period leading up to and after the accident. Trees about 170 m from the camera also became hazy at about the time of the accident. Ground level visibility significantly improved over the next hour.

Figure 11

Cropped snapshots from one of the CCTV cameras on a local farm showing changing visibility in the area

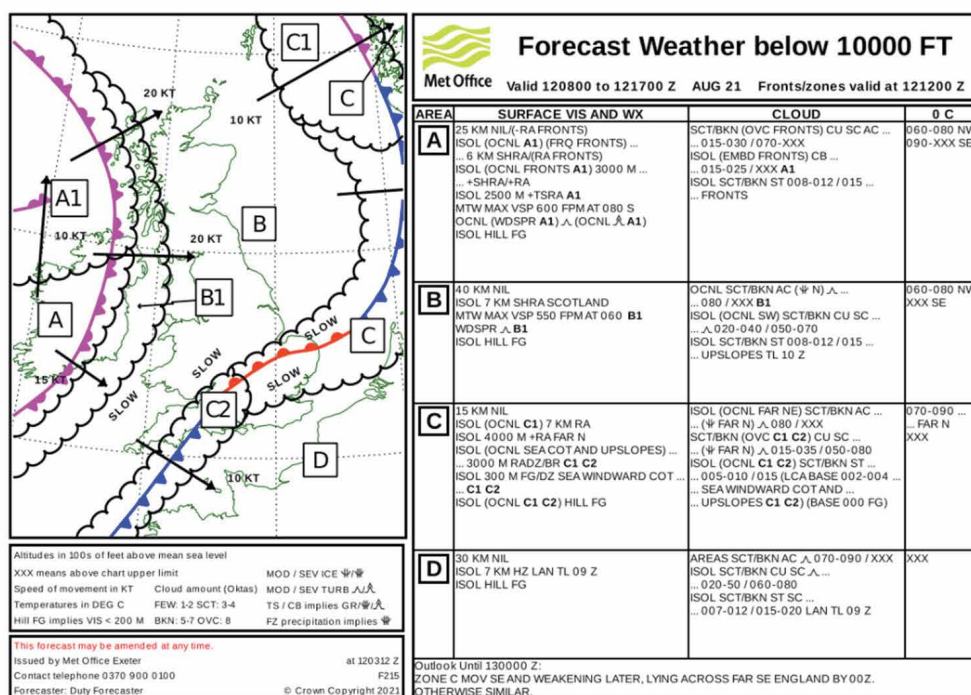
Figure 12

Met Office forecast for below 10,000 ft

'Conditions [in area C2] were expected to be generally 15KM visibilities [sic], but occasional areas of rain with 7000 m visibilities, isolated (occasional for upslopes) areas of rain and drizzle or mist with visibilities of 3000 m, and occasional areas of hill fog. There were expected to be isolated areas of scattered/broken altocumulus with bases of 8000 ft and tops of 10000 ft or above, overcast cumulus or stratocumulus cloud with bases 1500-3000 ft and tops of 5000-8000 ft, occasional areas of scattered or broken stratus with bases 500-100 ft and tops 1500 ft, locally bases of 200-400 ft on upslopes and at the surface in the hill fog. The freezing level was expected to be at or above 10,000FT.'

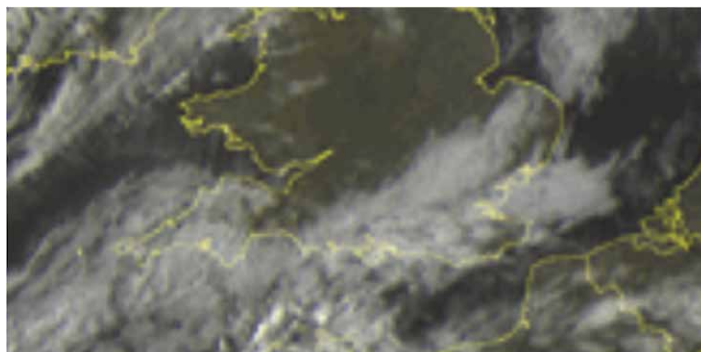
Witnesses who were flying locally at the time of the accident described the weather conditions as 'intermittent IMC' with areas of VMC between 3,000 ft and 4,000 ft. Figures 13 and 14 shows satellite imagery of the cloud cover along the south coast.

Figure 13

Satellite image at 0700 hrs

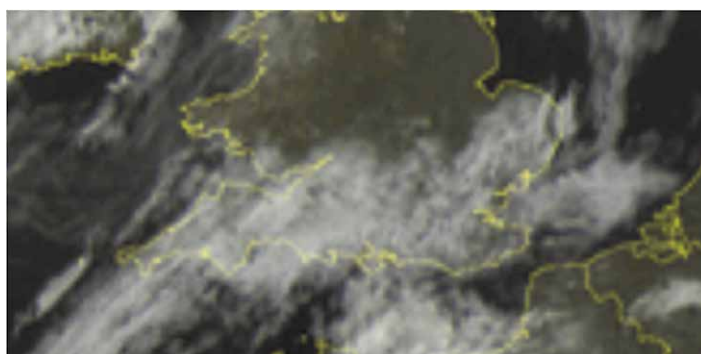
Figure 14

Satellite image at 0915 hrs

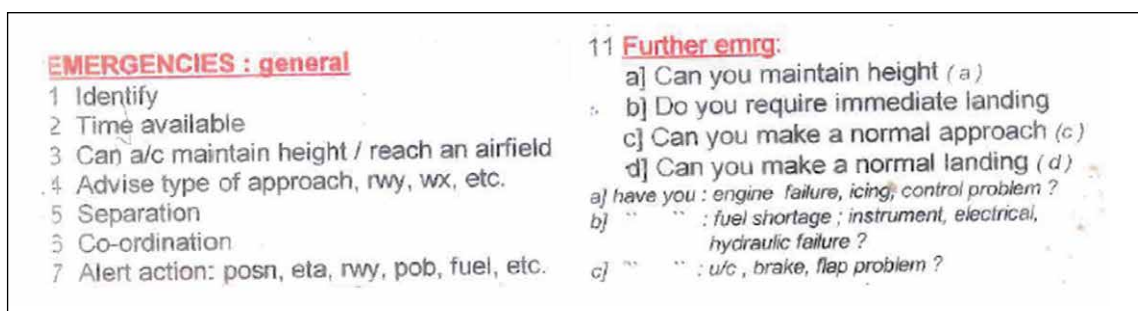
Exeter Airport did not have a procedure specifically for dealing with VFR traffic stuck above cloud, but the '*Emergencies: general*' aid memoire was available to controllers (Figure 15).

Figure 15

Exeter Airport '*Emergencies: general*' and '*Further emergency*' procedures

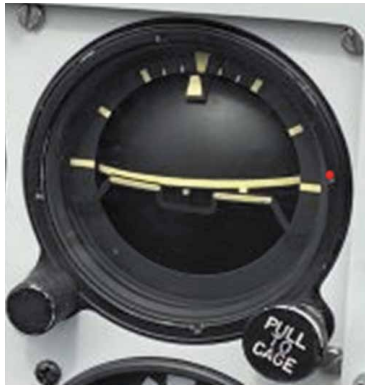
G-BXBU was not certified to fly in IMC or icing conditions. It did however have some instruments installed which would aid IMC flight, such as an attitude indicator (AI). The AI on G-BXBU was a Horizon Bendix J-8 model (Figure 16), featuring yellow markings on an entirely black background. In more modern AI's the symbolic sky and ground have representative colourings that are more instinctive in helping pilots to determine the attitude of the aircraft without outside visual reference (Figure 17).

Figure 16

Horizon Bendix J-8 Model

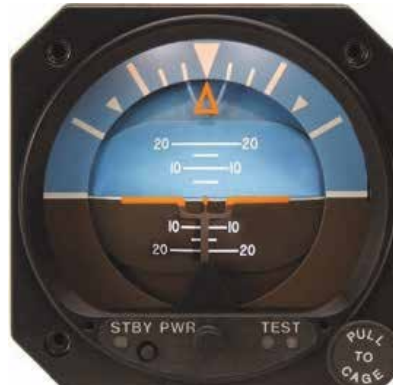
Figure 17

Example of modern AI design
